**INSPECTION REPORT
River Ouse Riverbank**

**Report 22594-H-RP-001-R0
20 November 2024**

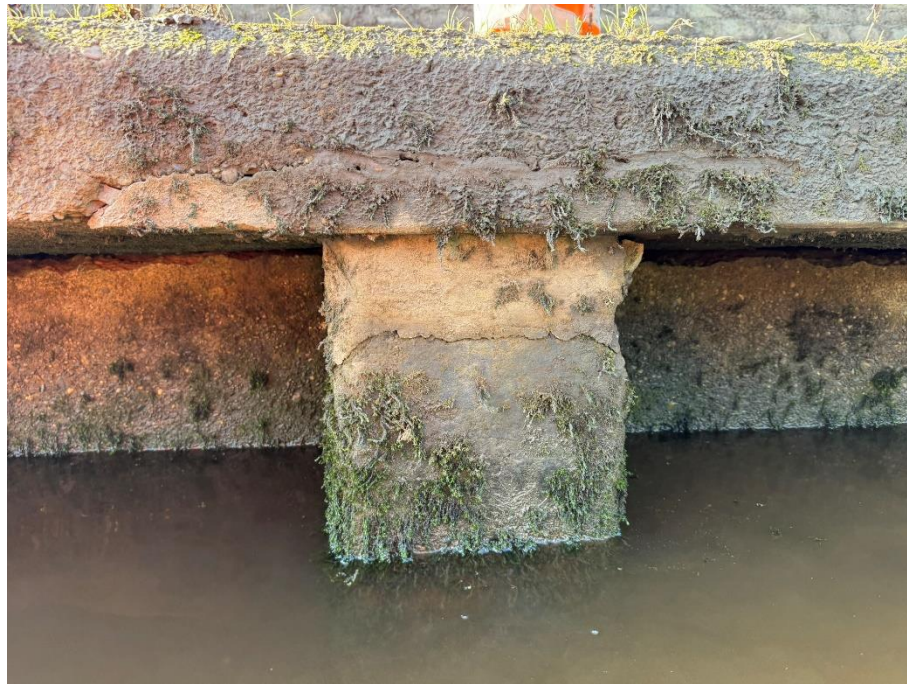
05 Cracking at the top of the pile and side of the capping beam. Retaining wall is ok.

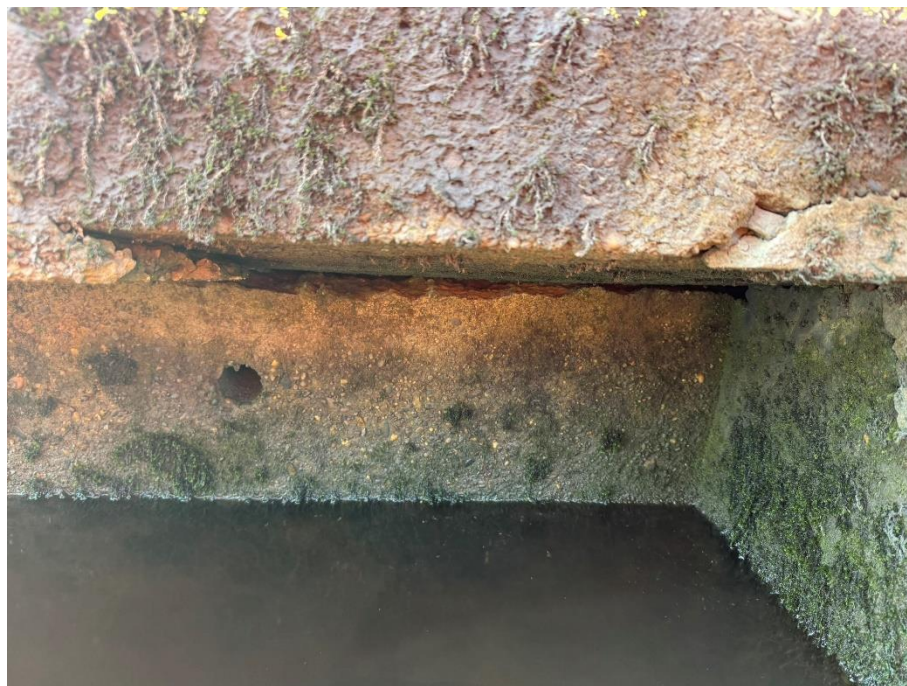
06 Cracking in the capping beam. Retaining wall okay.

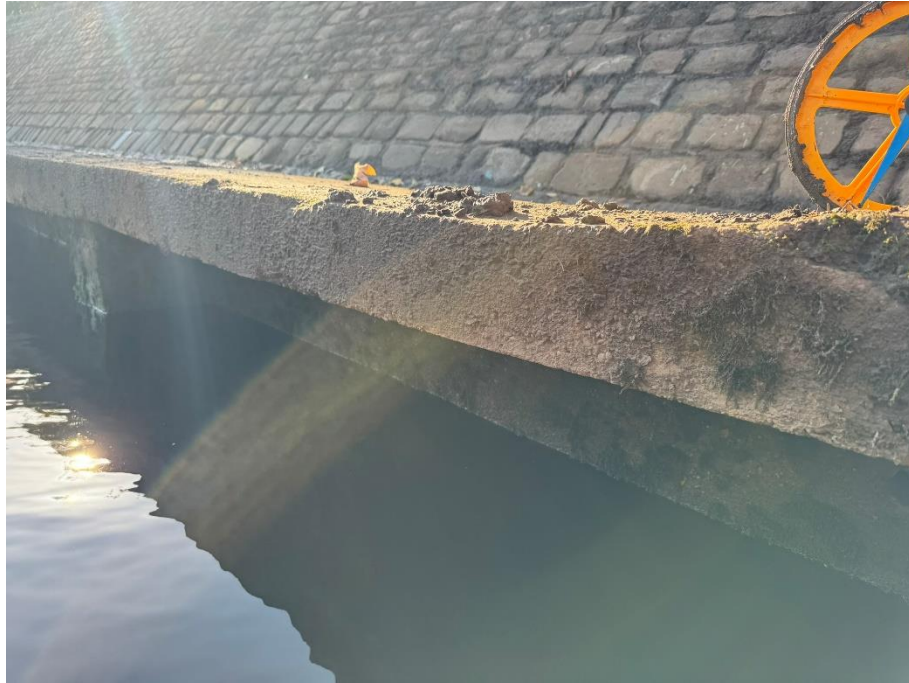
07 Photo of capping beam in ok condition.

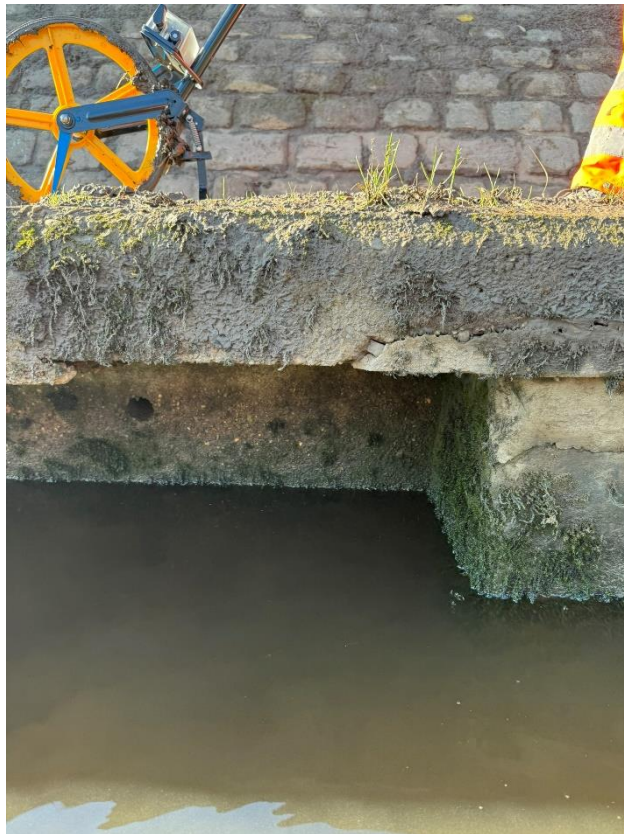
08 Cracking in capping beam and top of the pile.

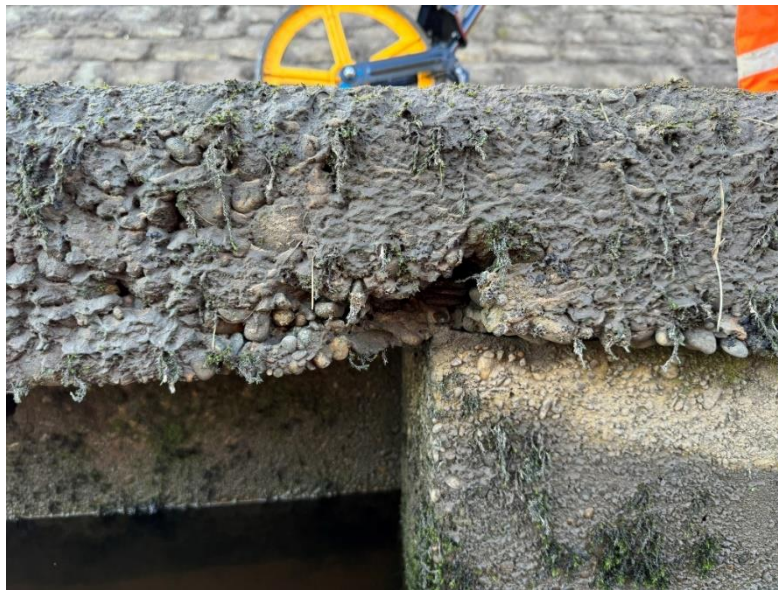
14 Spalled concrete under the capping beam with exposed and corroded steel reinforcement.

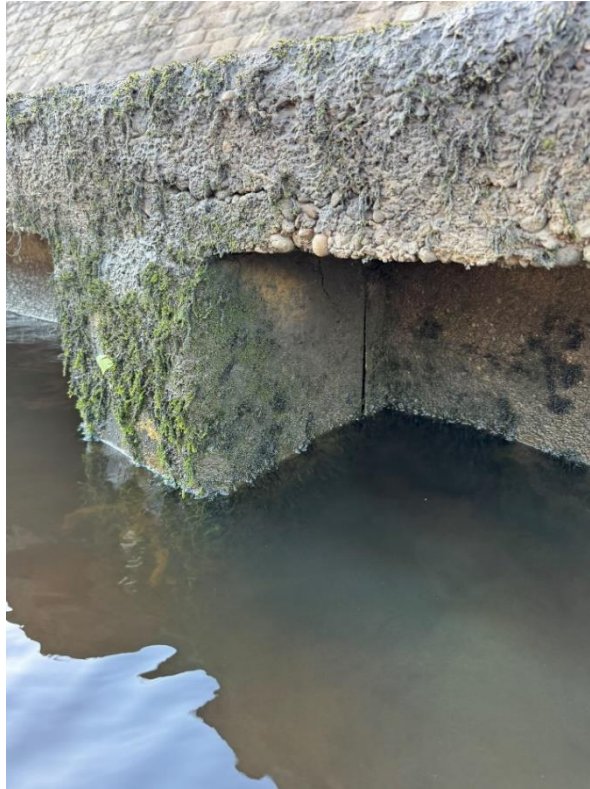
17 Aggregate visible at the surface of the capping beam. Crack at the back of the pile.

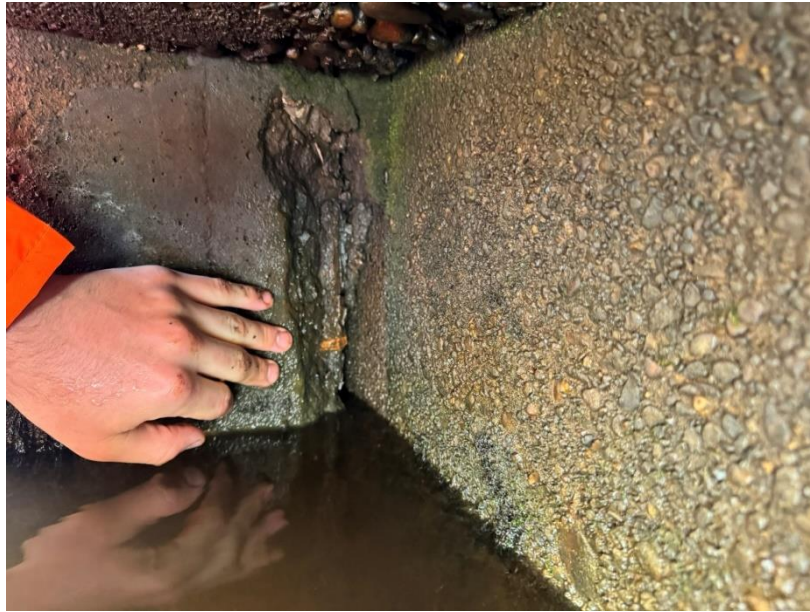
21 Spalling at the back of the pile with exposed and corroded steel reinforcement.

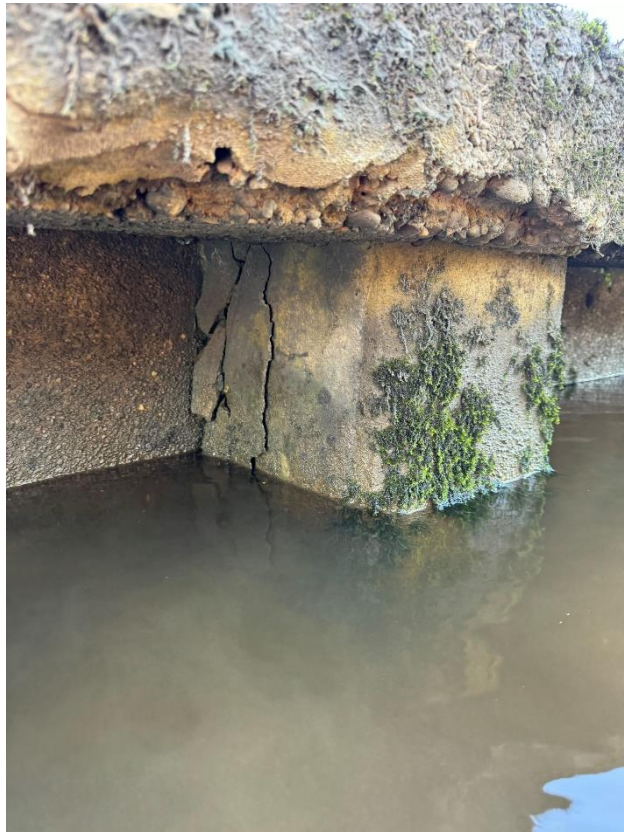
22 Spalling at the back of the pile and underside of the capping beam.

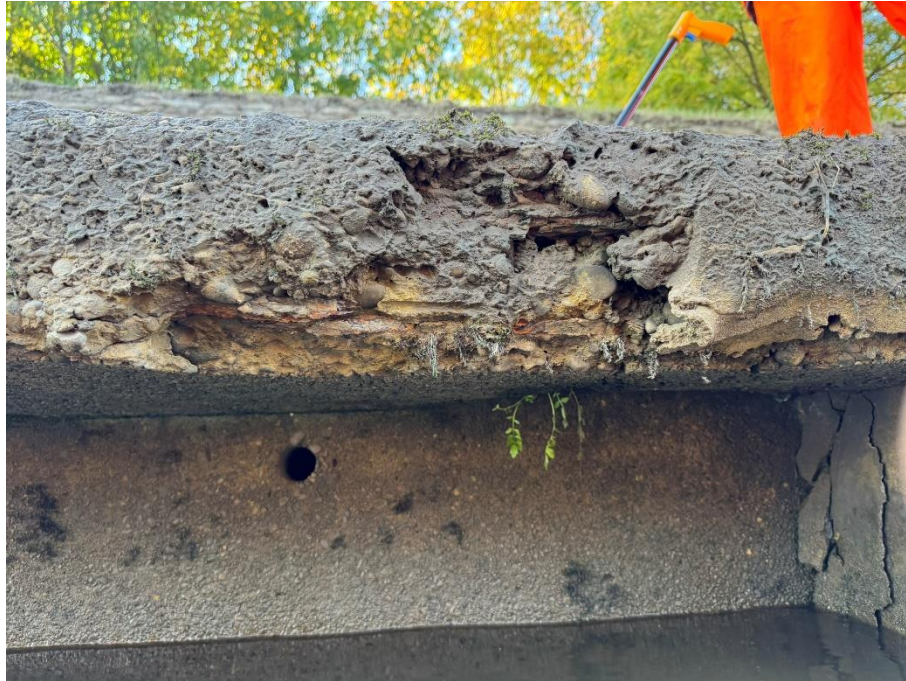
- 23** Concrete spalling and exposed corroded steel reinforcement on the capping beam. Cracking to the rear of the pile.

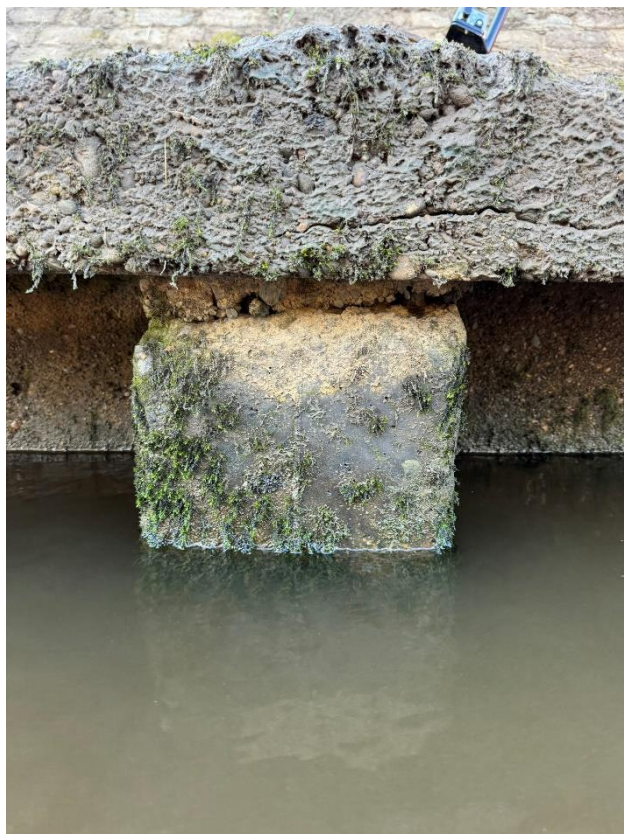
- 24** Cracking in the side of the capping beam. Concrete spalling at the top of the pile with exposed corroded steel reinforcement.

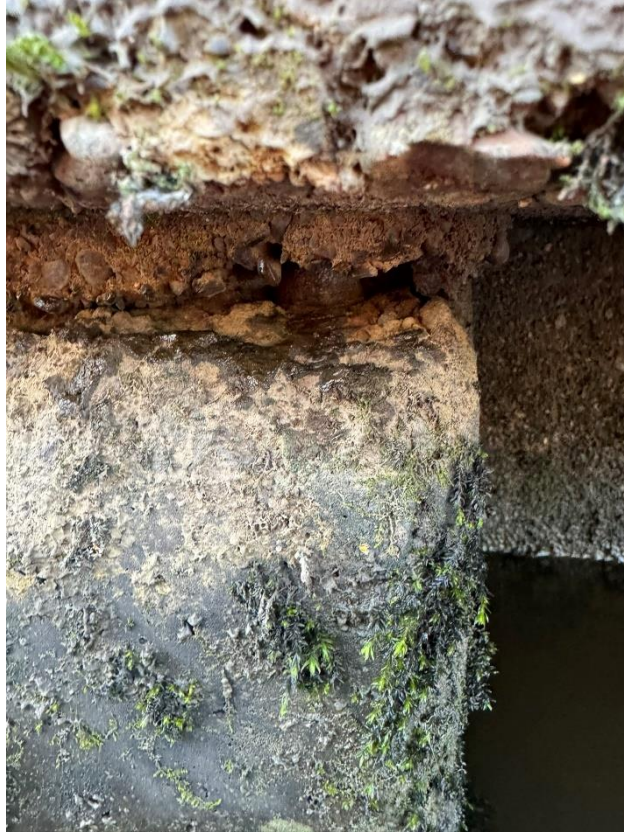
25 Close up of concrete spalling at the top of the pile with exposed corroded steel reinforcement.

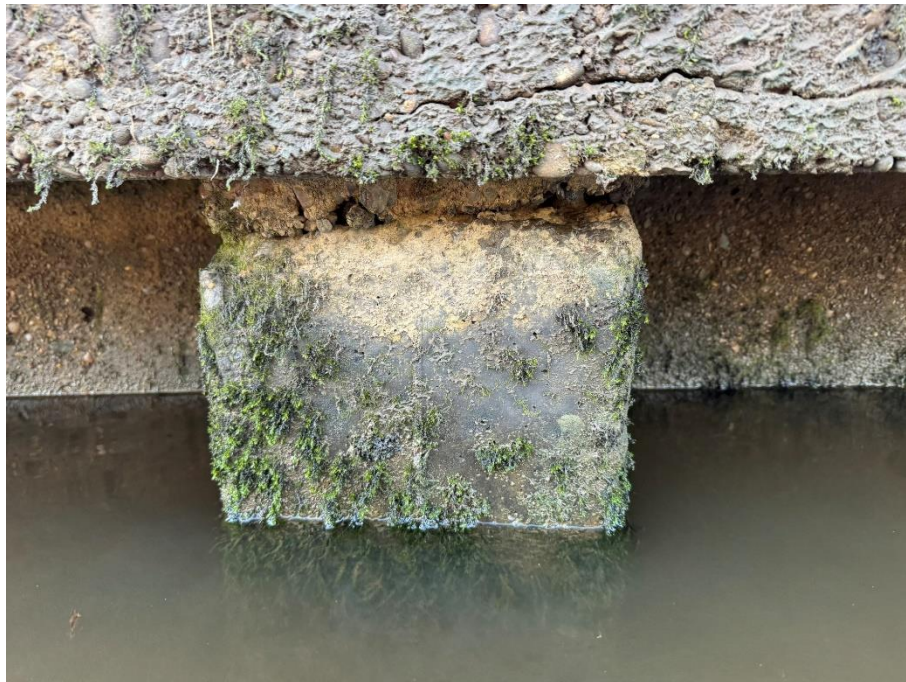
26 Close up of concrete spalling at the top of the pile with exposed corroded steel reinforcement.

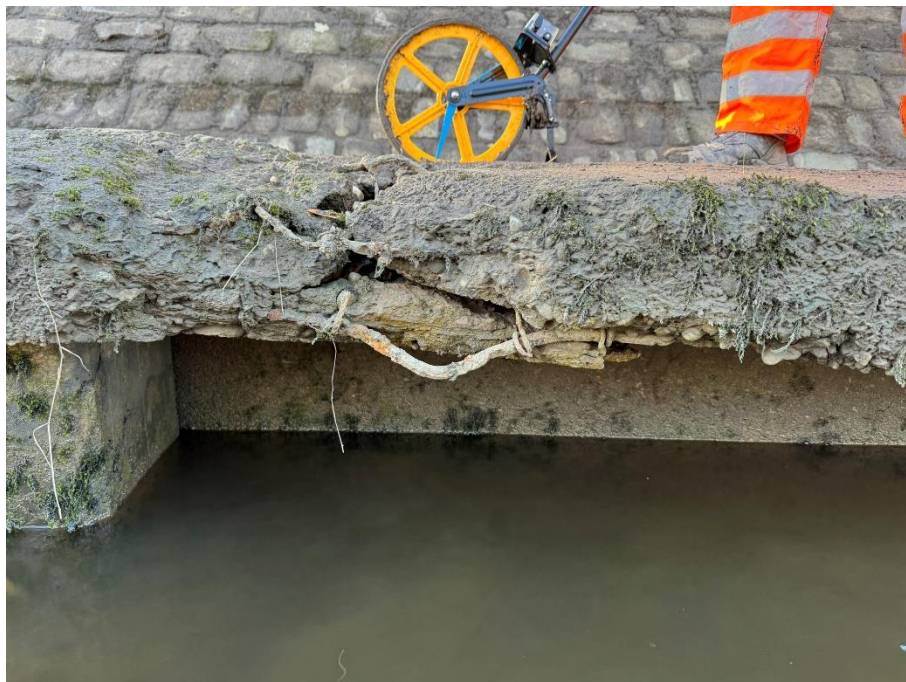
28 Severe cracking in the capping beam, with concret spalling. Exposed, deformed and corroded steel reinforcement.

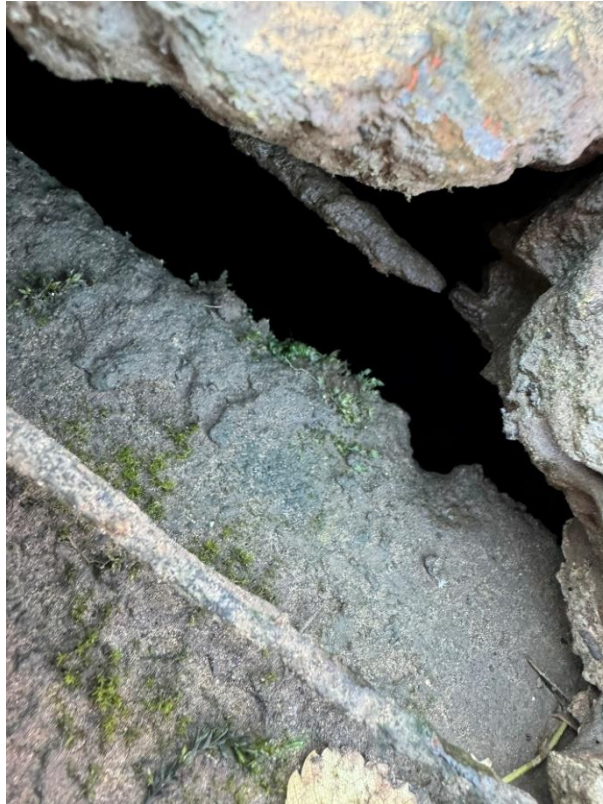
- 29 Top of retaining wall is visible through the capping beam. There is a void behind the retaining wall.

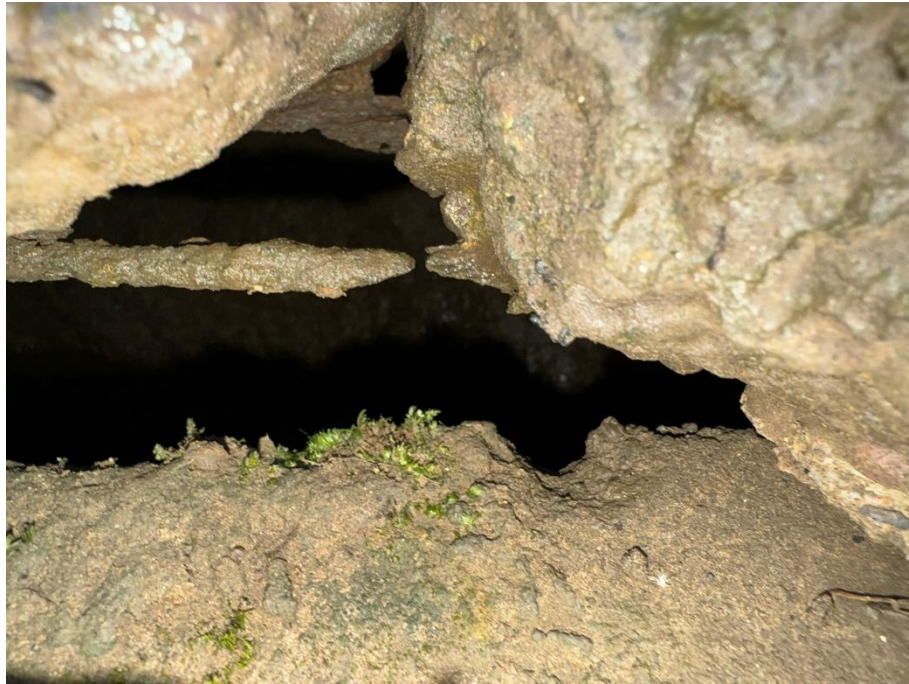
- 31** Top of retaining wall is visible through the capping beam. There is a void behind the retaining wall.

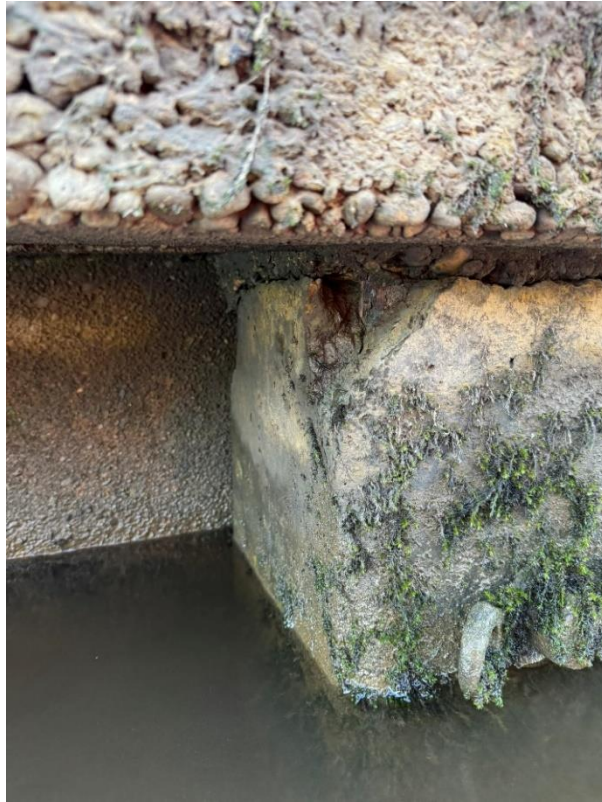
35 Spalling on on the top of the concrete pile, exposed steel reinforcement.

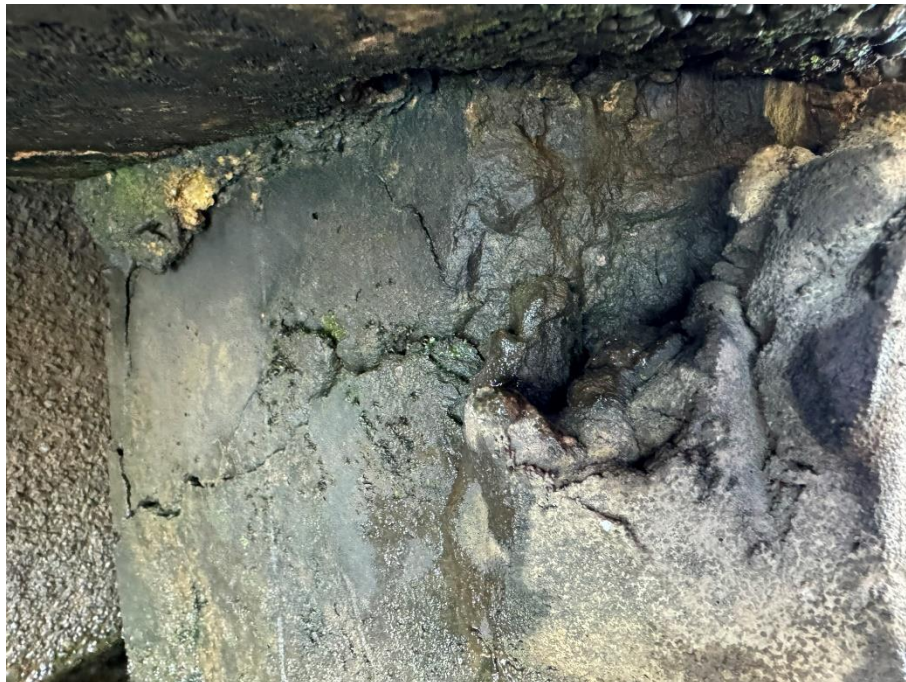
46 Spalling of concrete at the top of the pile.

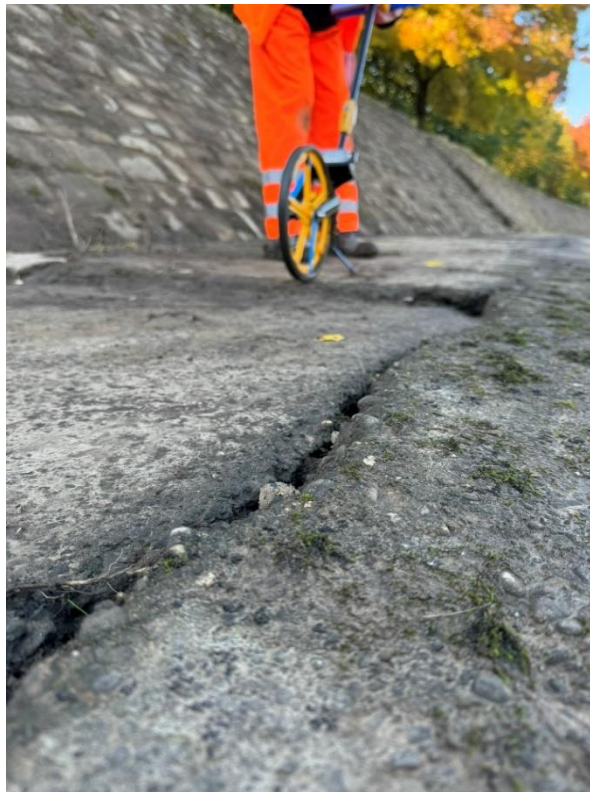
60 Crack between the concrete path and capping beam.

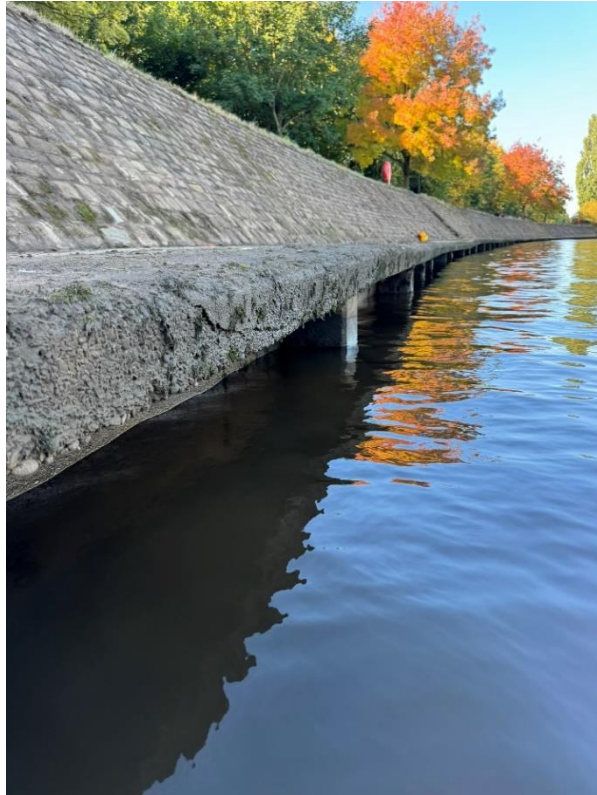
75 Capping beam in ok condition.

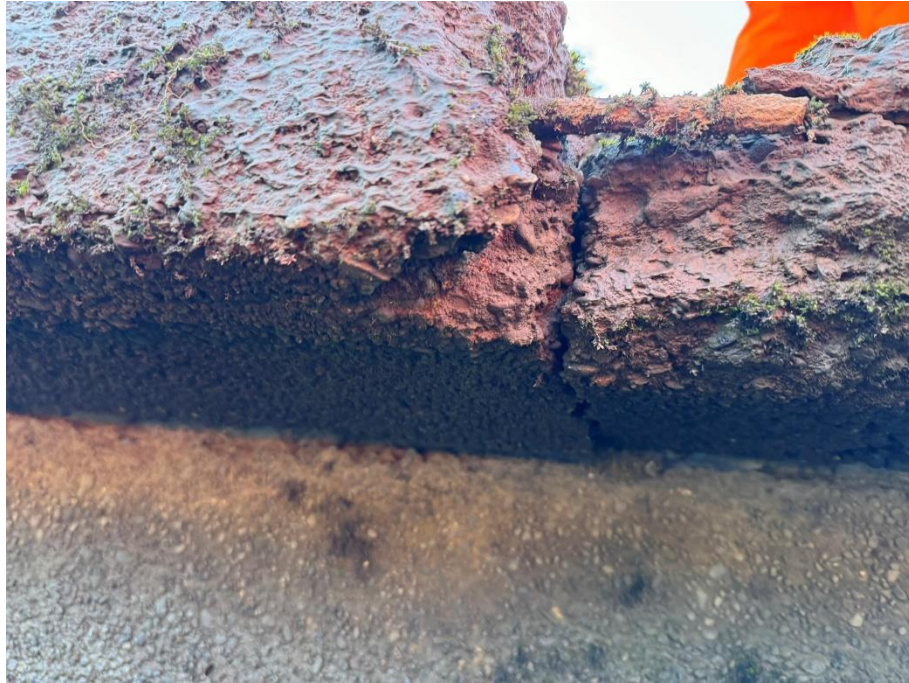
81 Large section loss in capping beam with exposed steel reinforcement. Crack through the width of the capping beam.

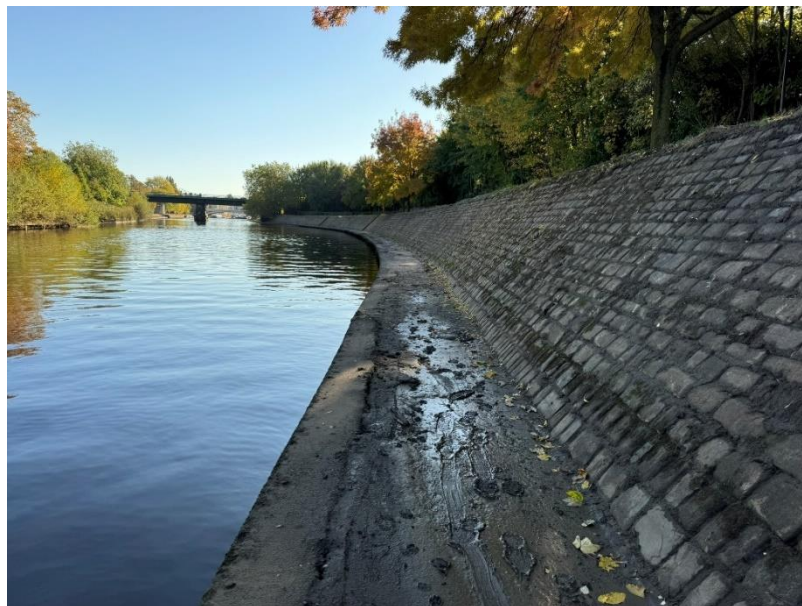
- 12** View from the concrete path looking eastwards, towards the Scarborough Rail Bridge that is visible in the background. Silt build-up on path.

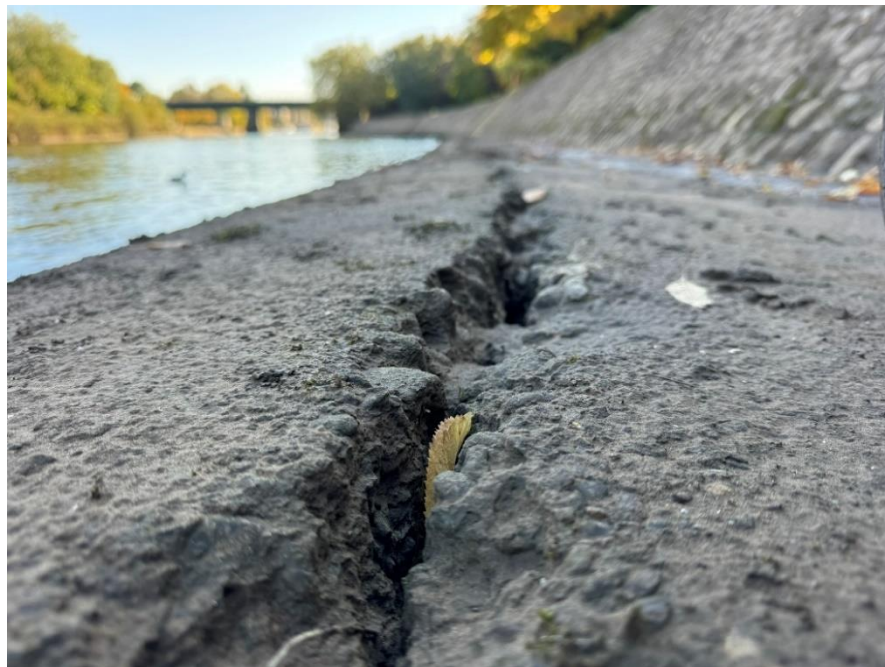
34

Large crack between the capping beam and concrete path.

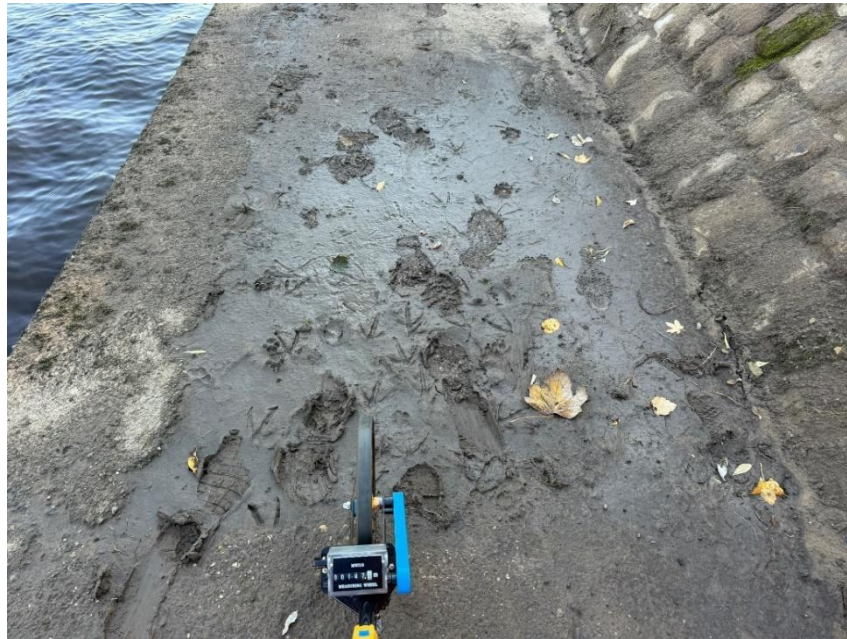
59

Build-up of silt on top of the concrete path.

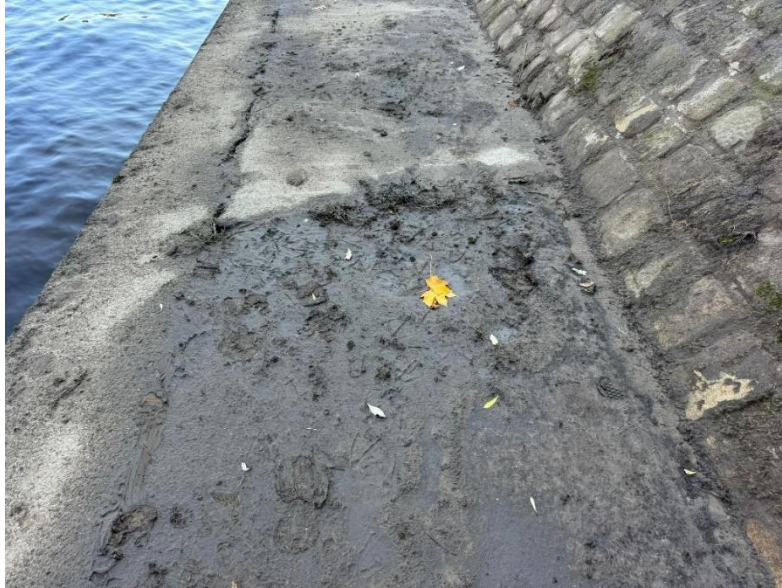
62 Build-up of silt on top of the concrete path. Large crack in the slab propagating from the capping beam to the bottom of the pitched stone.

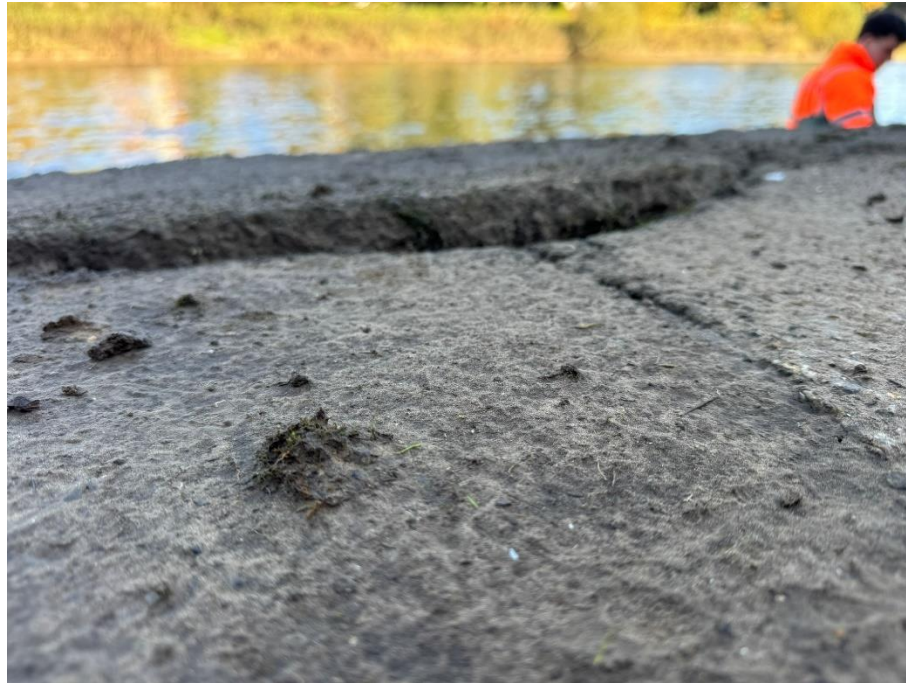
- 65** Crack between the capping beam and concrete path. The capping beam is moving away from the concrete path.

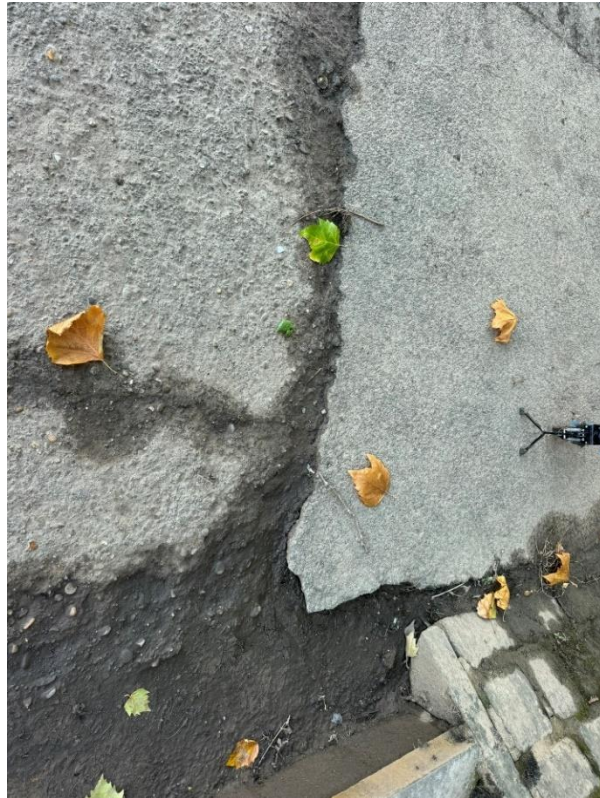
89

Step in the concrete path, corner is a trip hazard.

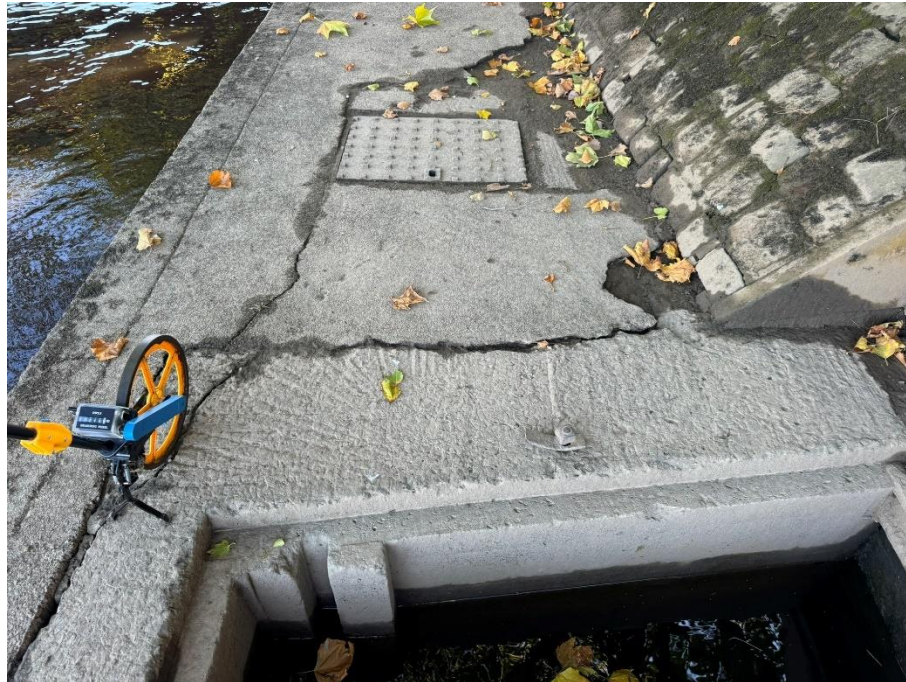
93

Cracking in the concrete path around manhole.

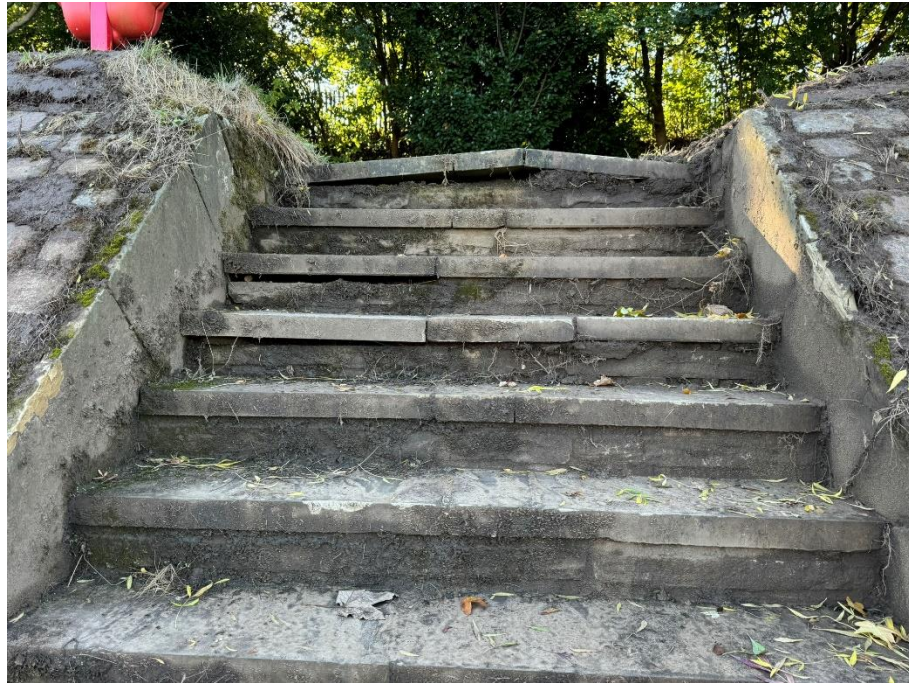
125

Embankment steps, top step needs relaying.

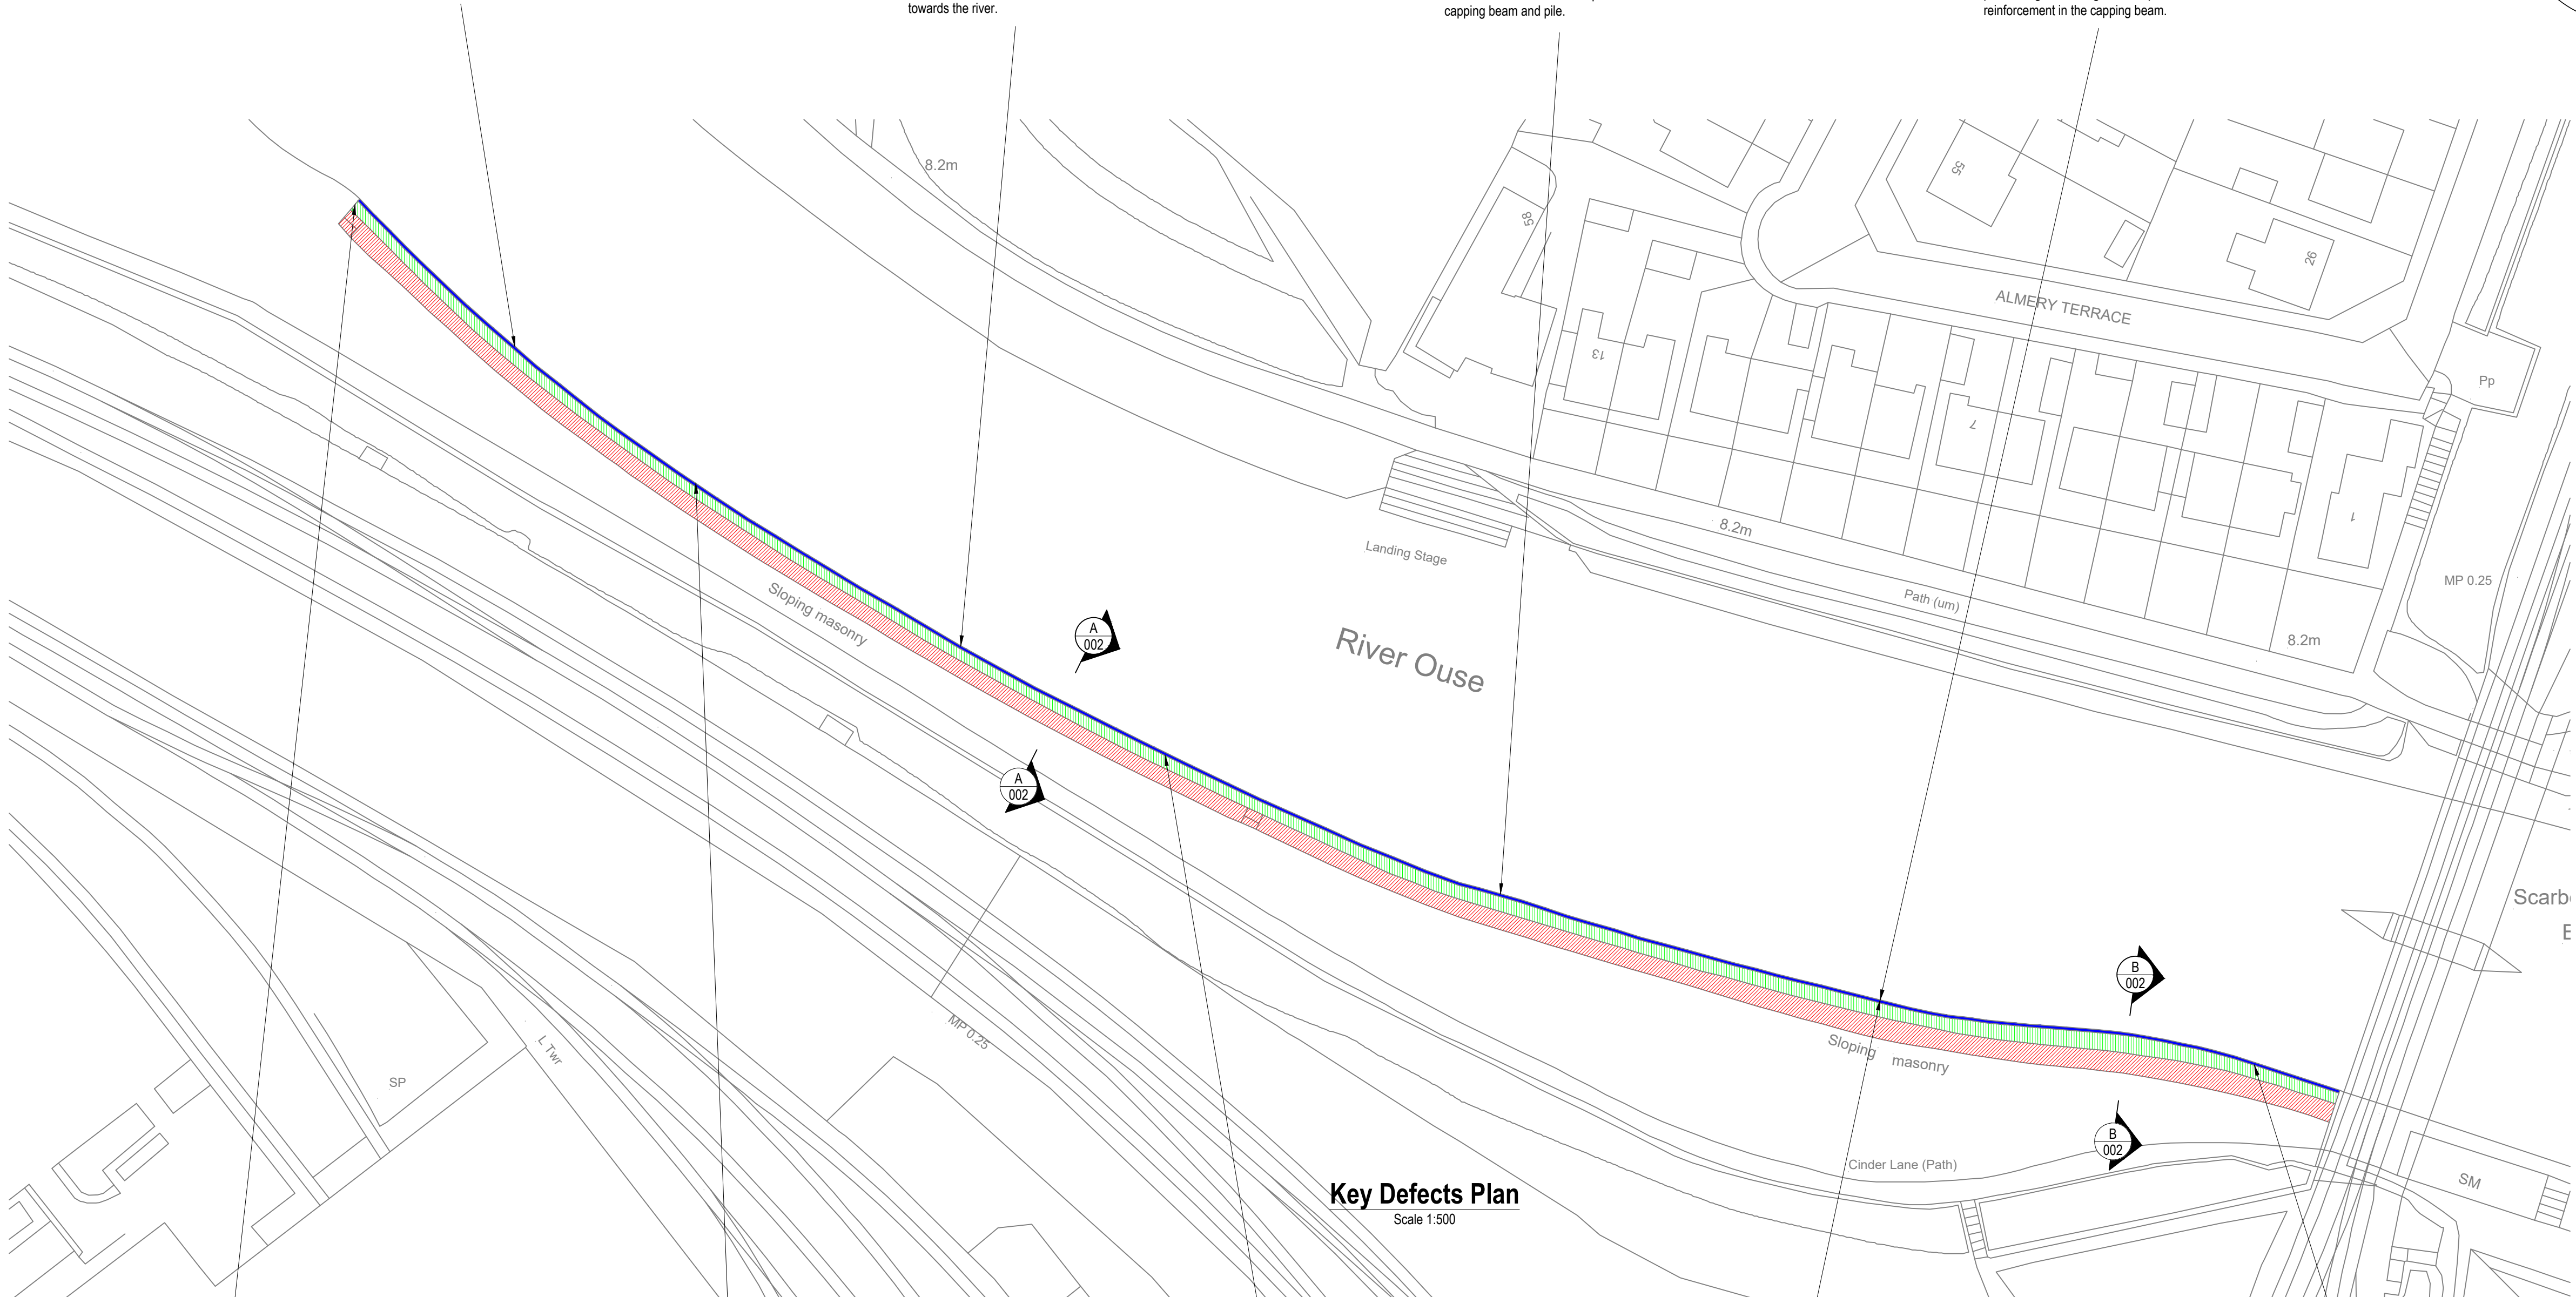
Chainage 176m
Failed capping beam, no longer sufficiently supported and breaking away from concrete path. Large cracking and exposed steel reinforcement in the capping beam.

3. Beam moving away from the slab, creating a large crack between the two. The beam is clearly tilting, about its minor axis, towards the river. Exposed steel reinforcement on the underside of the beam.	Pre-existing, condition is worse.	Capping Beam	4E	Demolish beam, recast identical beam. Concrete (<0.5m ³) Steel (<80kg)	H
