ANNEX 2

TYPICAL CONDITION PHOTOGRAPHS

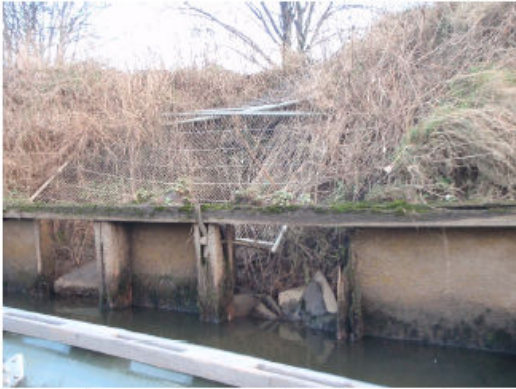
Downstream length: hole in wall & bank

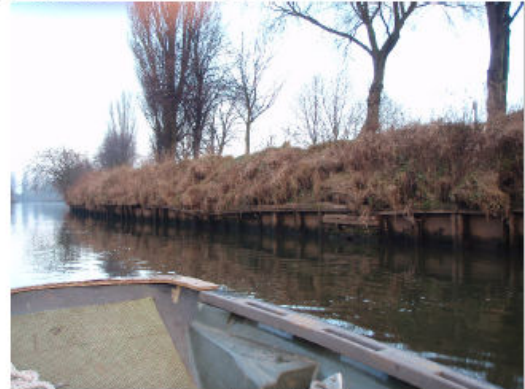
Downstream length: general view

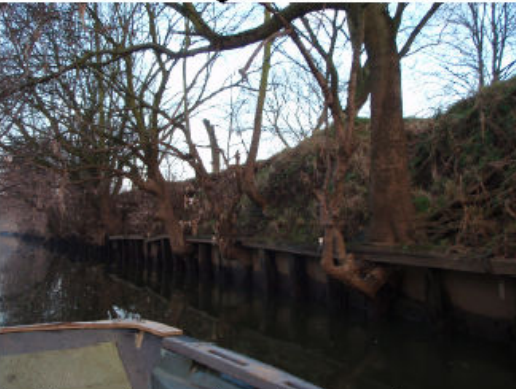
Downstream length: tree damage

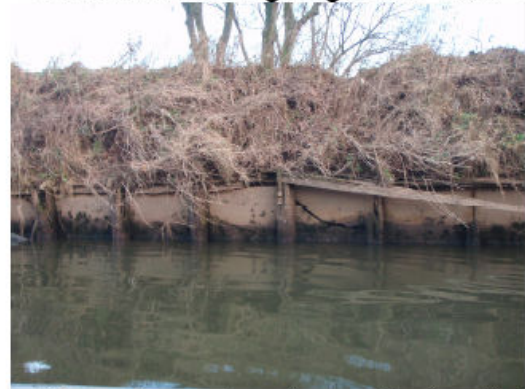
Downstream length: cracked wall

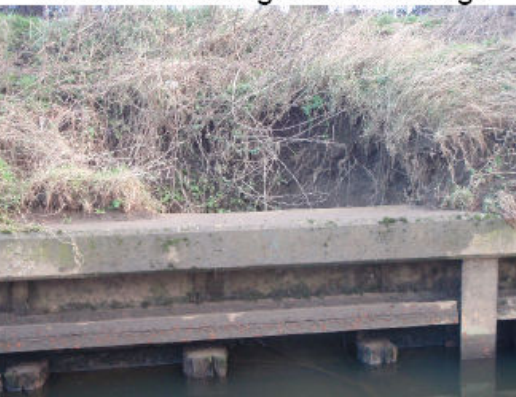
Upstream length: previous repair with hole in bank. Currently repairable

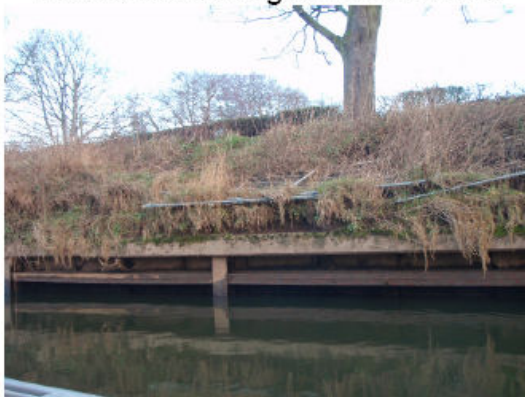
Upstream length: hole in bank covered with steel mesh fence

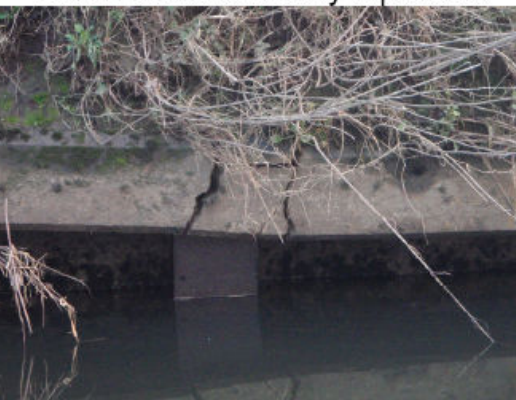
Upstream length: failed repair, replacement required

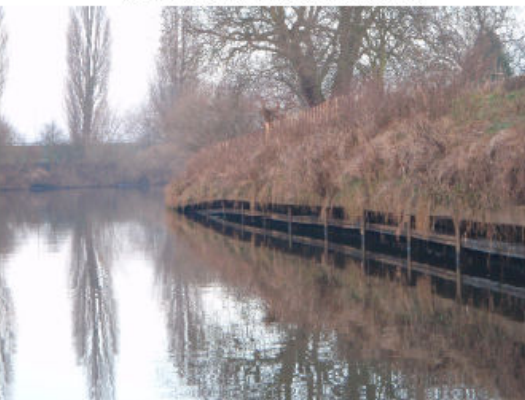
Upstream length: repairable length with failed length beyond
