FLOODING INVESTIGATION REPORT

BADGER HILL / HULL ROAD, YORK

Incident Date: 10 June, 2012

March 2013

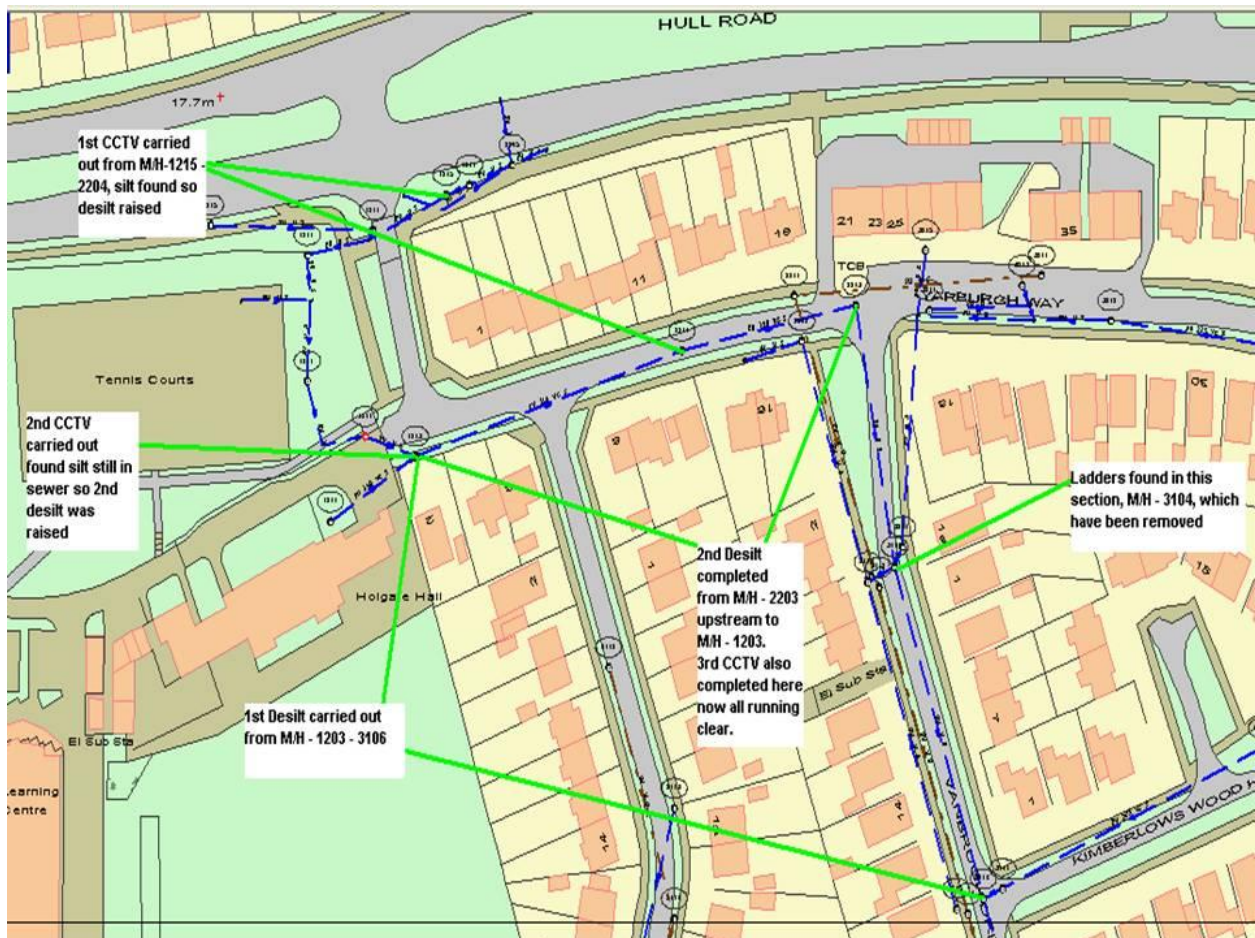
Although the tanks were cleared, constant high water level was still being experienced. YWS and CYC flood engineers met on site on 11 October, when YWS agreed to carry out further investigatory works. Additional desilting works were carried out on the public surface water sewer on Hull Road, between the head of the public sewer system and the storage tanks in the grounds of Archbishop Holgate School.

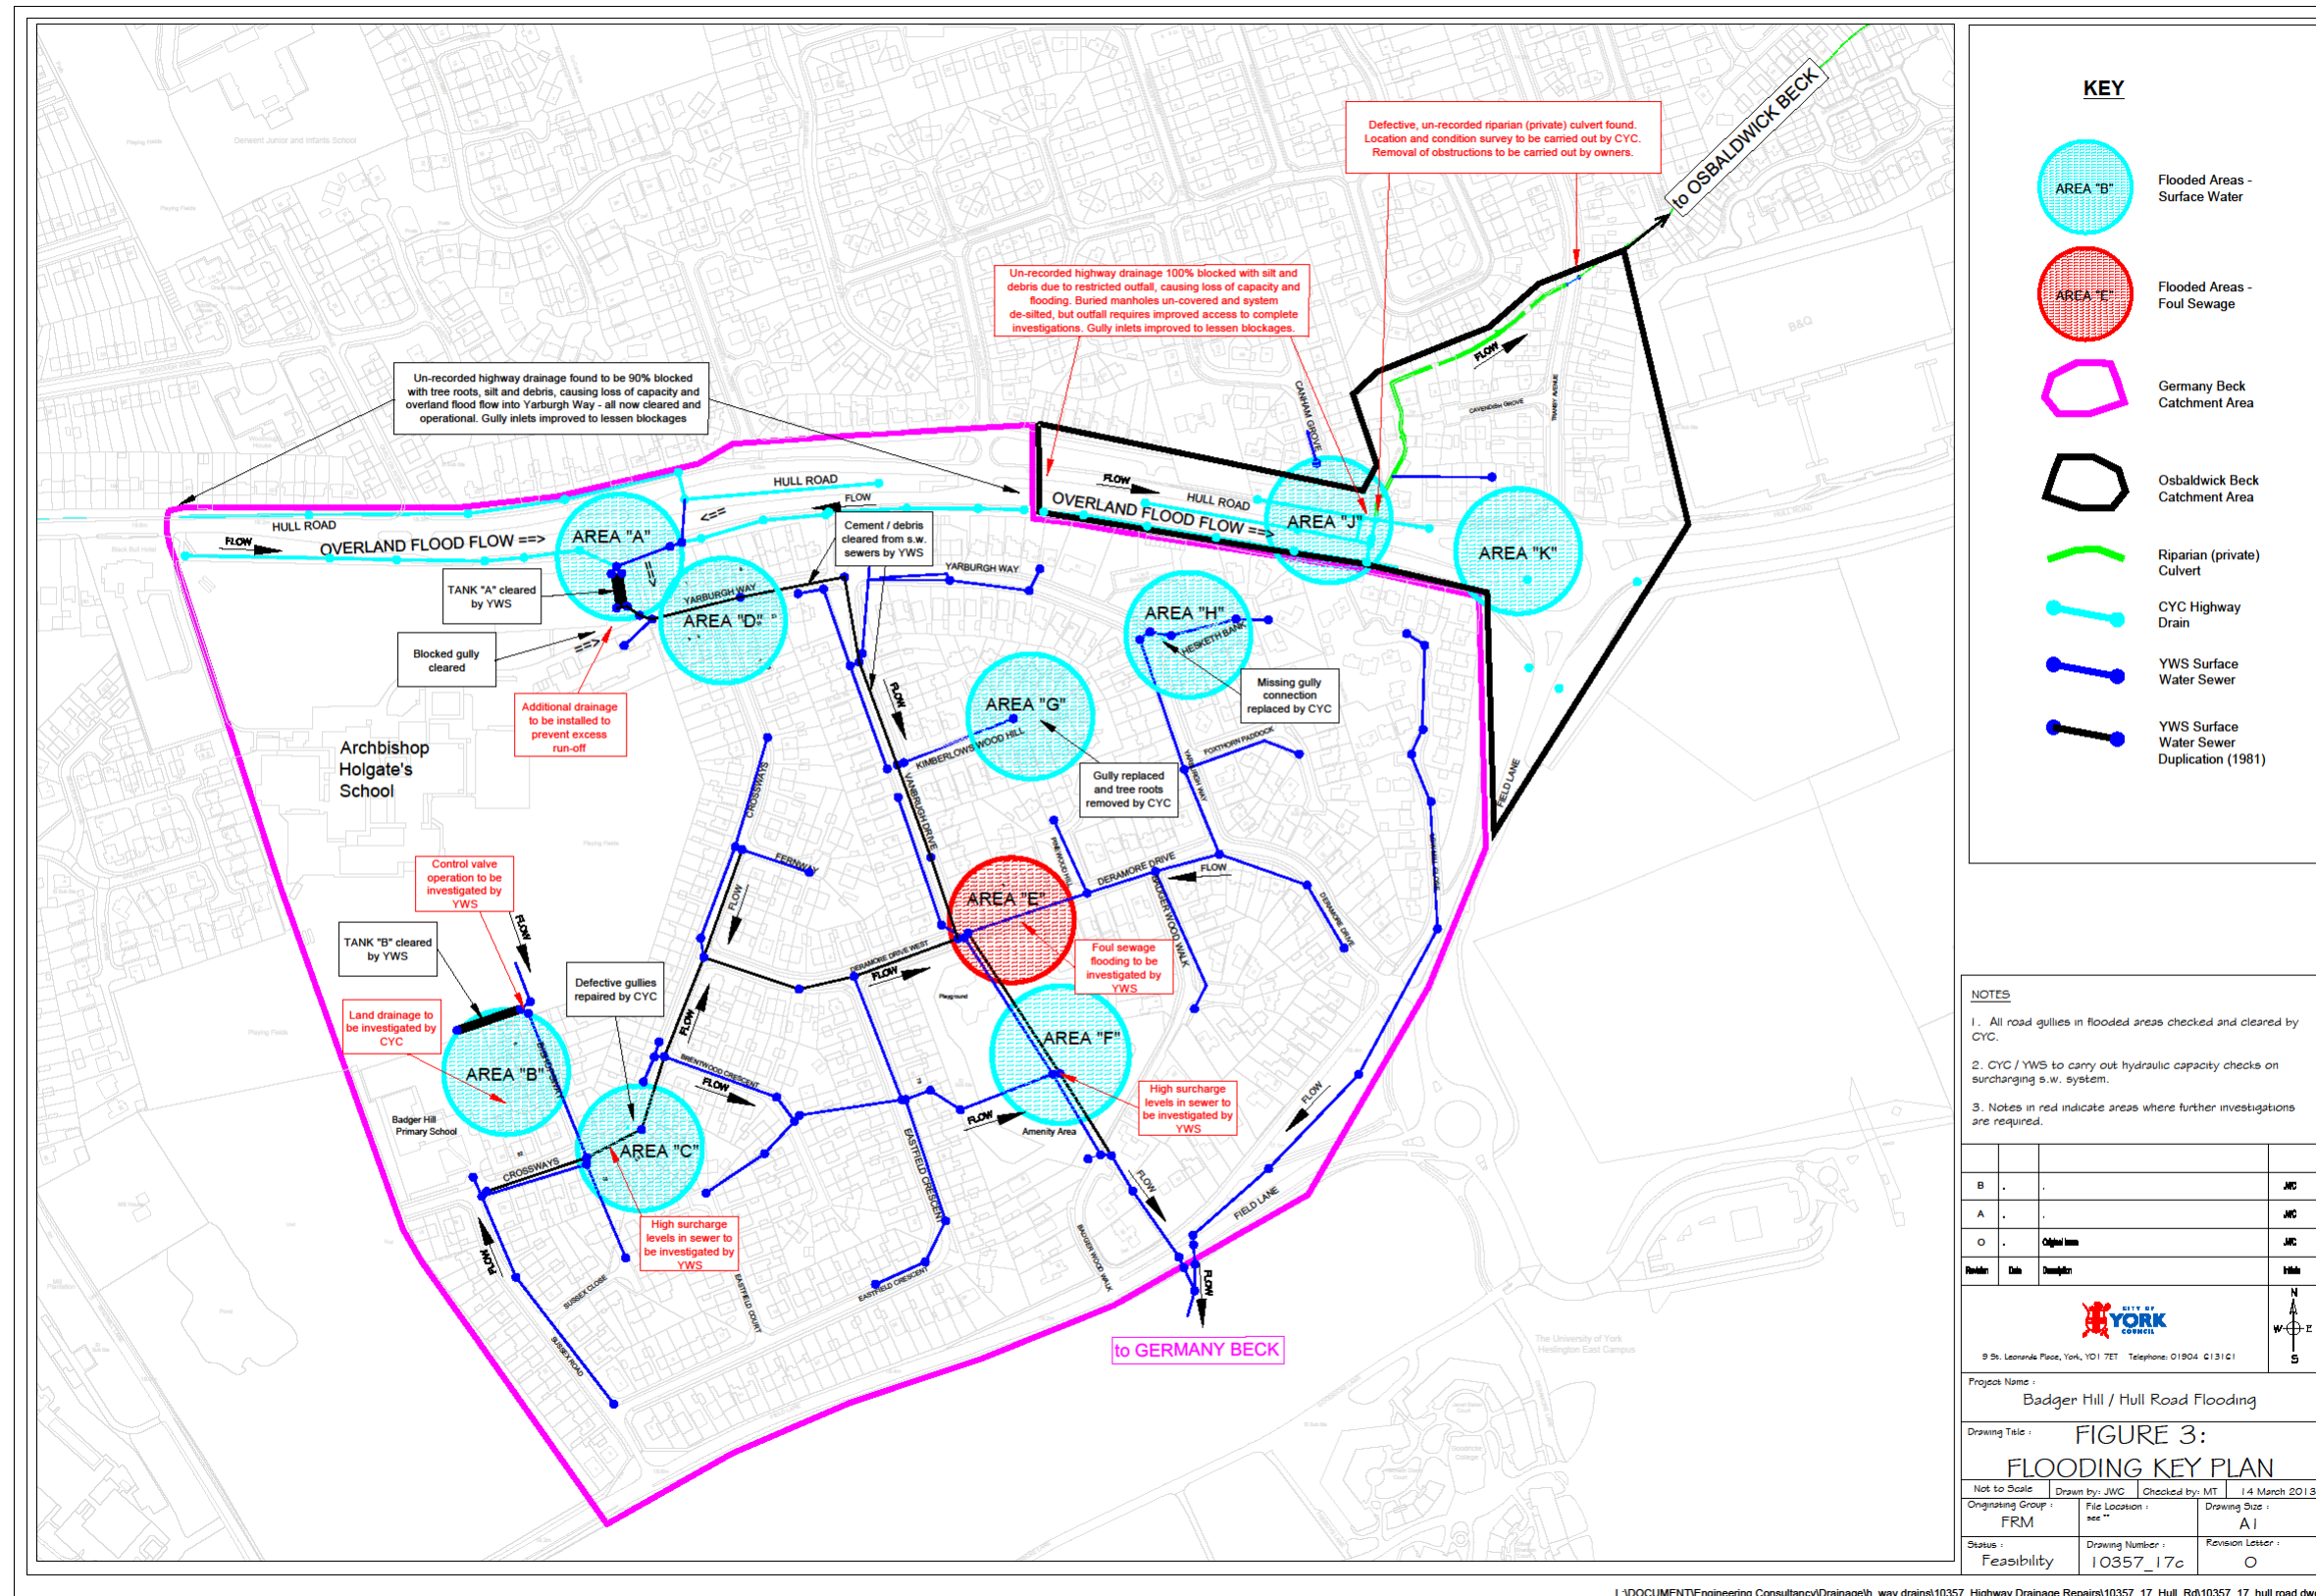
Figure 3: Flooding Key Plan

Figure 3 shows that there were ten areas affected by significant flooding (2 or more properties)

Flooding to Hull Road, opposite its junction with Canham Grove (Figure 3, Area "J"), had been noted by CYC in June 2007. However, as no properties were reported to have flooded at the time, further investigations were deemed to be low priority.

The first attendance at the site by members of CYC's Flood Risk Management team was on 14 June 2012, when high surcharge levels in the highway drainage system were still being experienced. From the initial flooding reports, investigations by CYC were focussed on areas "A" to "D", with results as follows:

There has been concerted action and co-operation by the relevant responsible bodies to ensure that the immediate flood risk was minimised, with remedial works as detailed in Table 1 in Appendix 1 and shown on Figure 3.

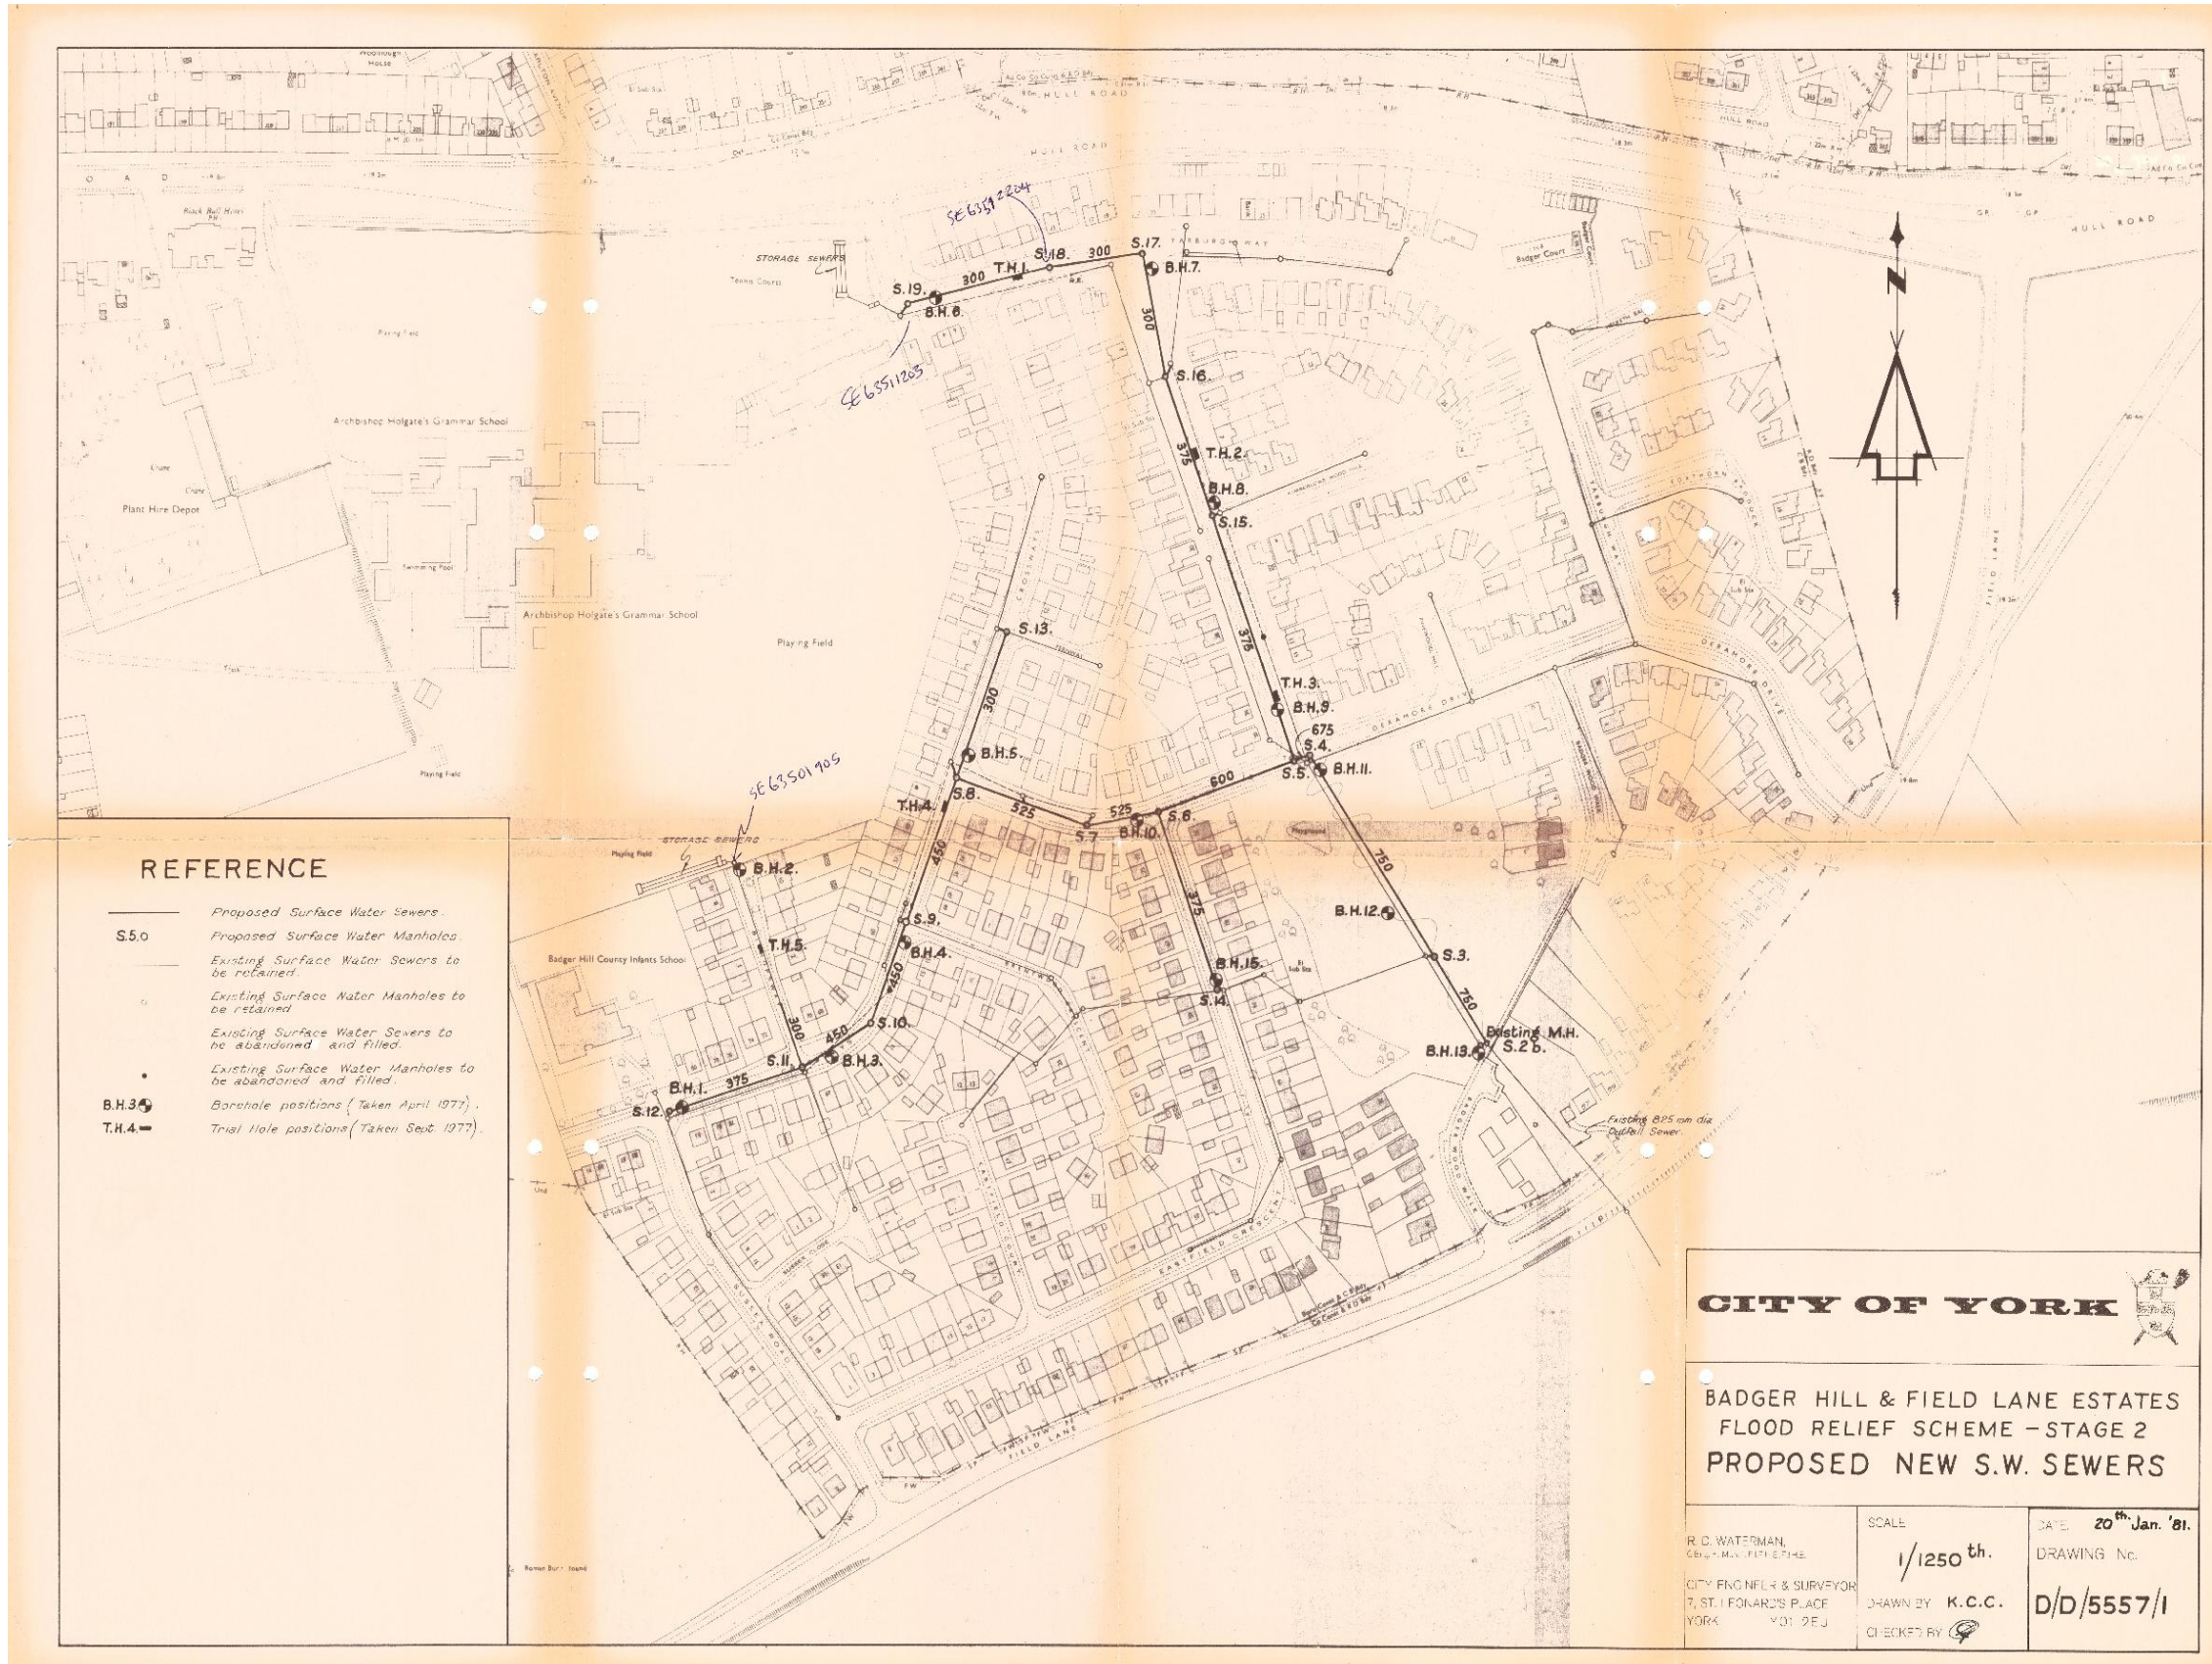
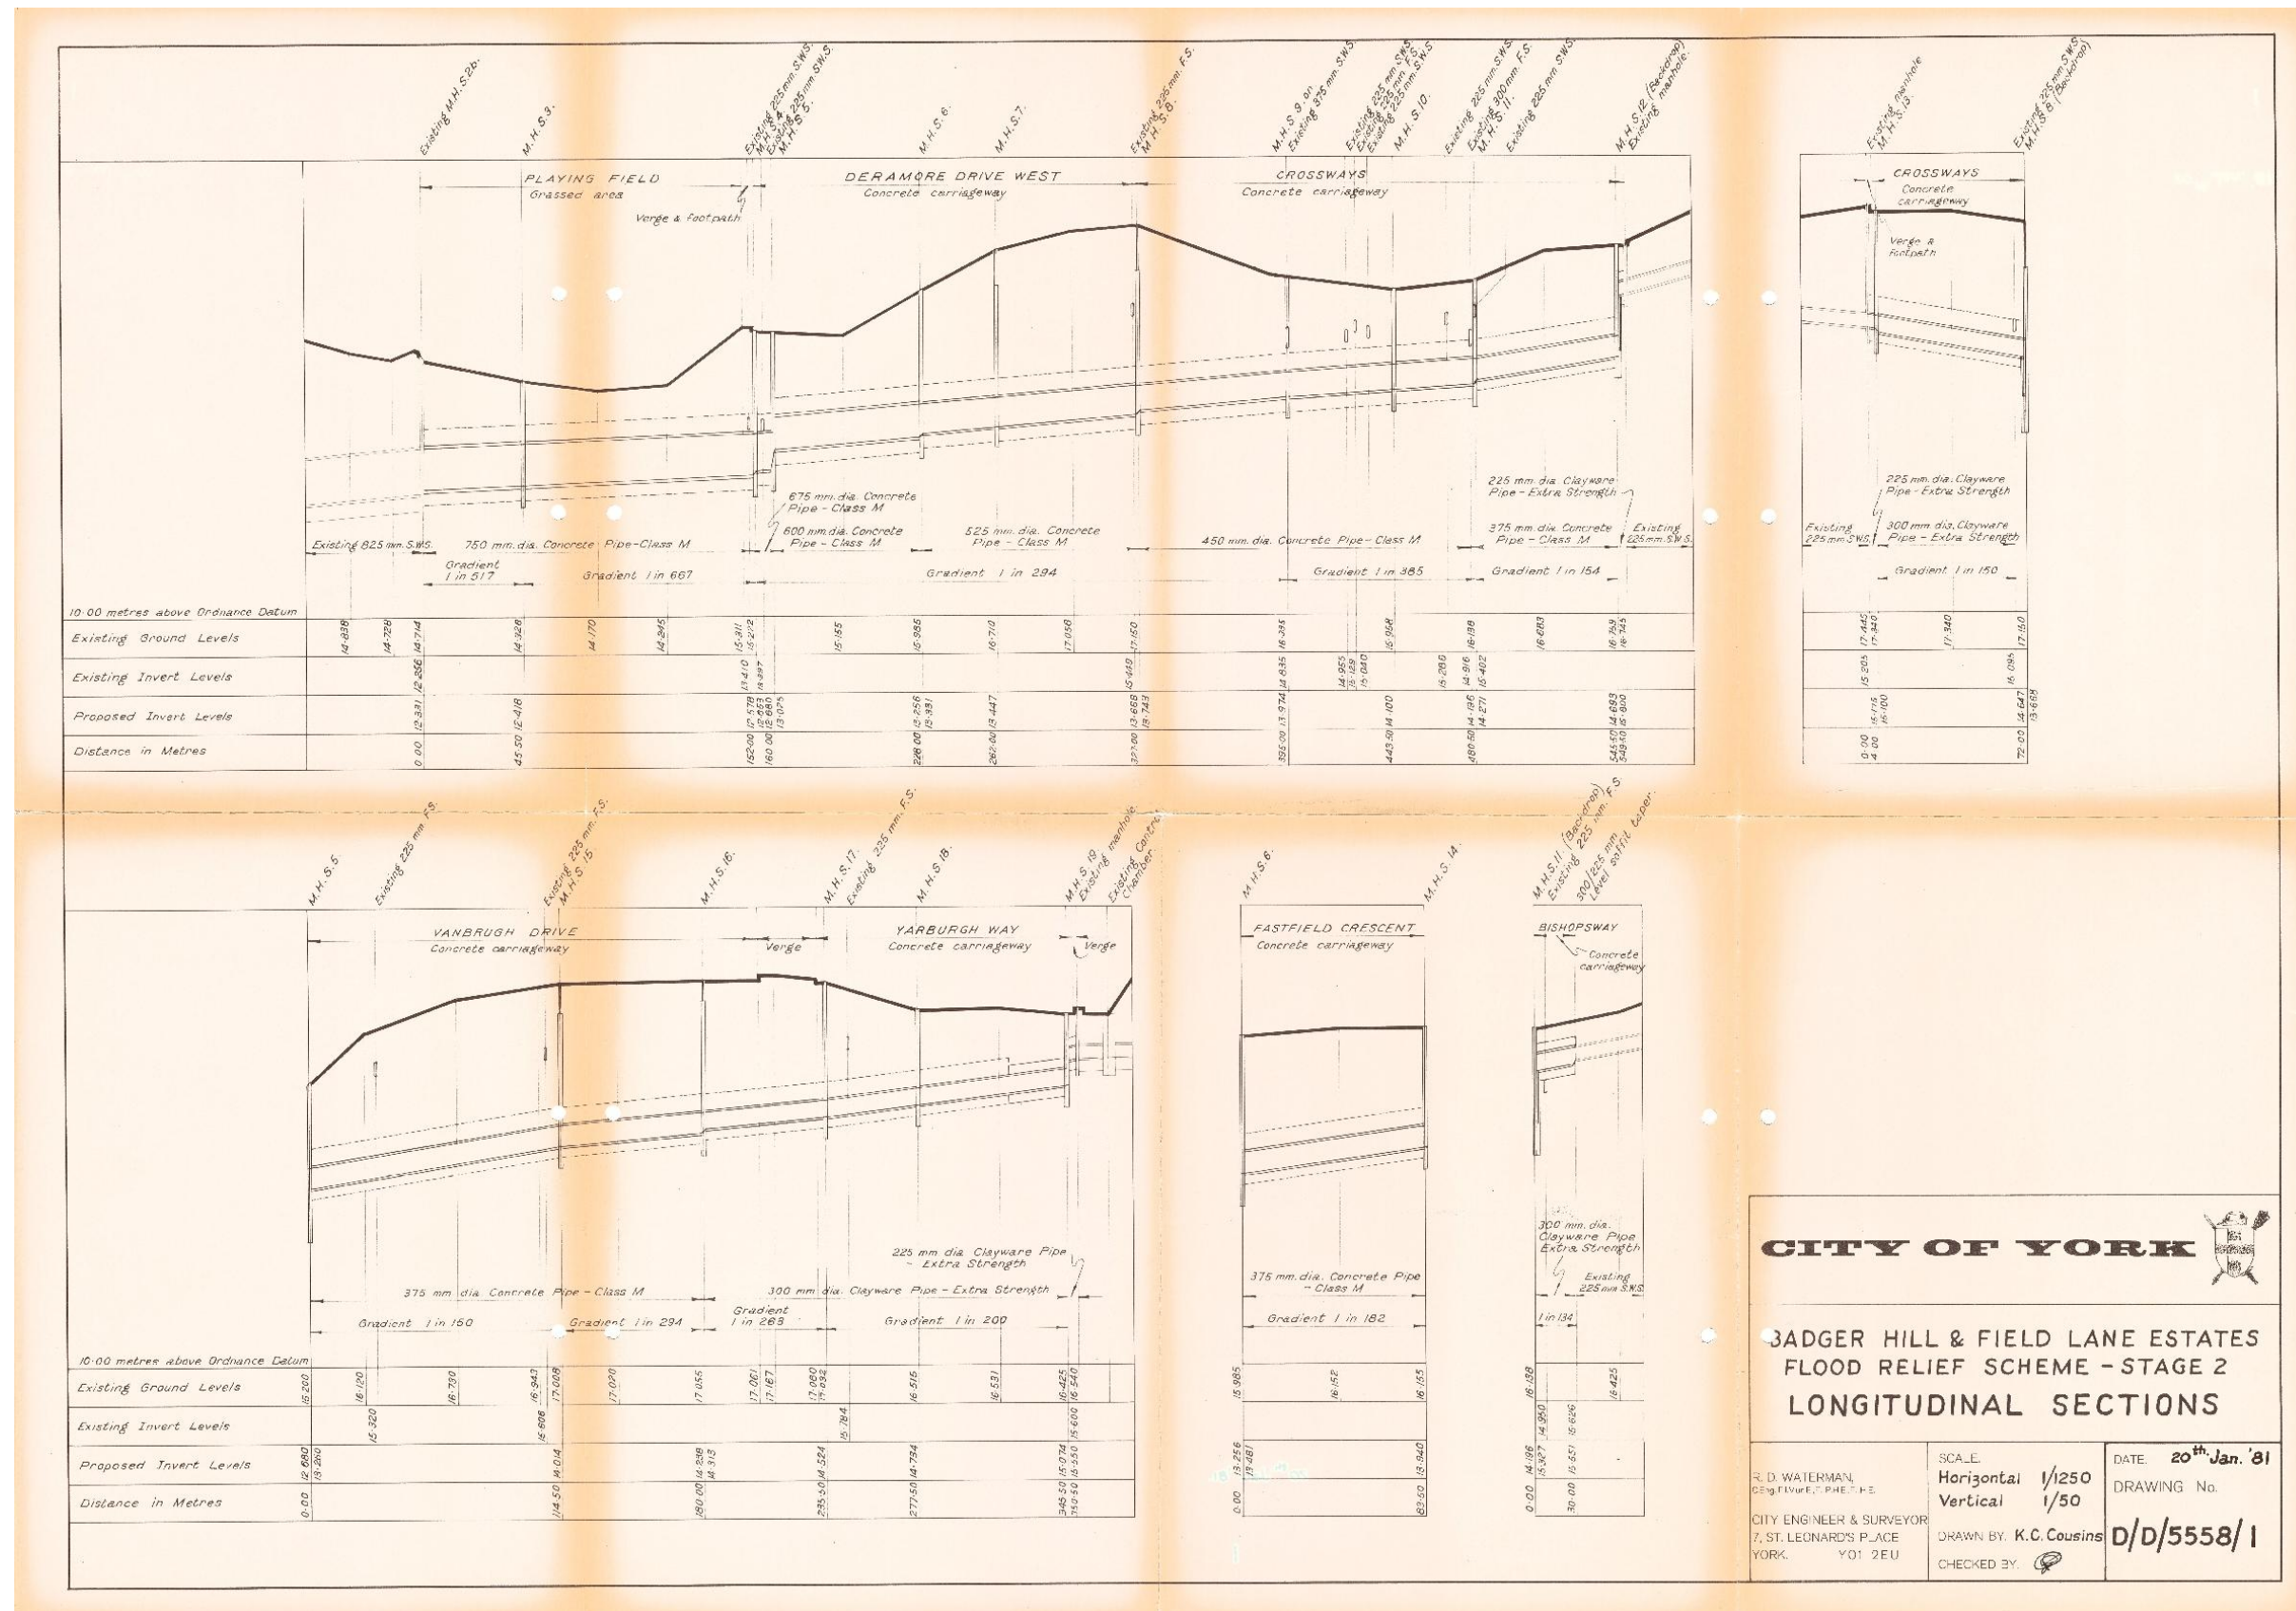
Figure 4: Badger Hill Flood Relief Scheme (1981) – Proposed Plan

The Stage 2 works, built in 1982, entailed the construction of a duplicate surface water sewerage system, serving the western half of the estate, to augment the overloaded original system (see **Figures 4 and 5**).

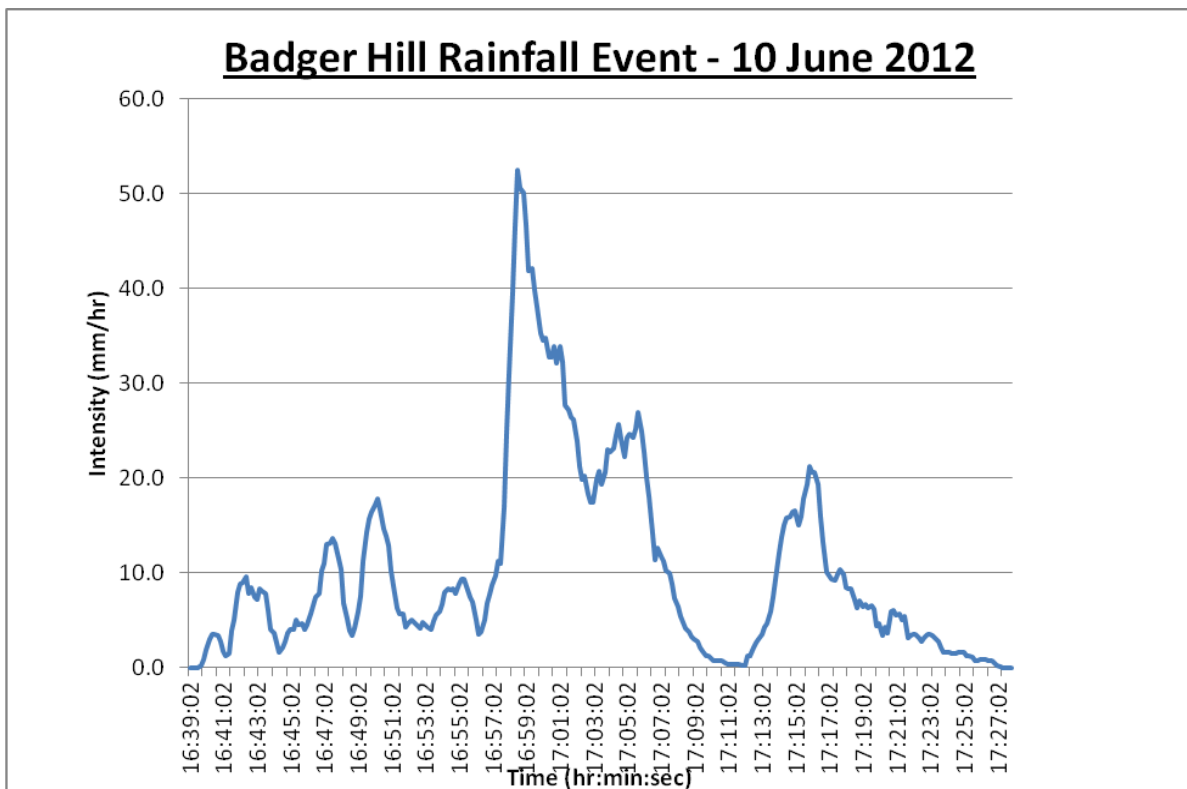
Figure 7: Badger Hill Rainfall Intensity - 10 June 2012

The rainfall on 10th June was preceded by three days of less intense rain, as shown on **Figure 6**. It can be seen that these events were each spread over 4-6 hours, which would have filled the drainage systems, but not caused extensive flooding. The 10th June storm was over a much shorter duration (51minutes), producing intense localised rainfall**, shown on **Figure 7**. Analysis by YWS calculated the return period to range from 1 in 7-years to 1 in 31-years, which they classed as exceptional. However, modern sewerage systems should have capacity for these storms, without causing flooding. This flood risk investigation shows that other factors had considerable influence on the extent of flooding.
