CITY OF YORK COUNCIL	Stage 1 Safety Audit	
	Safety Audit Ref (see form TP/SAR)	16/015

Scheme Title: A19 Pinchpoint – Phase 2

Site Location details: A19, Crockey Hill / Wheldrake Lane Junction

Safety Audit Team Statement**A19 Pinchpoint Scheme – Phase 2, Crockey Hill / Wheldrake Lane
junction
Stage 1 Safety Audit**

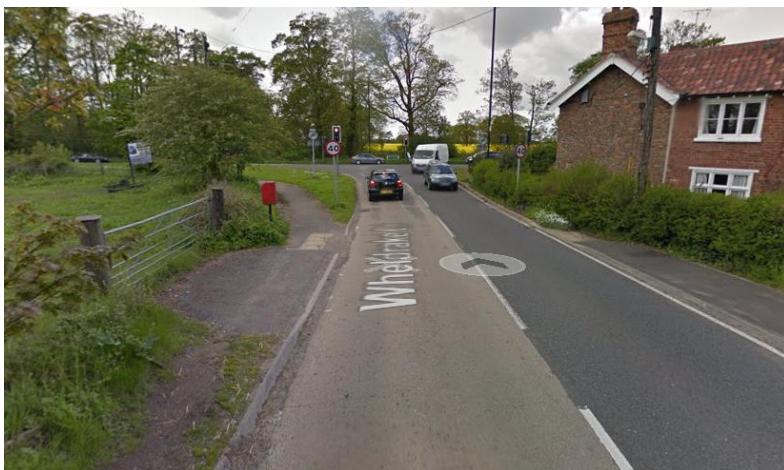
The proposals for the Wheldrake Lane arm of the junction make no reference to the existing uncontrolled crossing point pictured below. Whilst no pedestrian crossing data was provided the presence of the post box suggests that the residents and business owners at Crockey Hill regularly use this route.

The proposals appear to move the stop line further back from the junction increasing the chances of pedestrians trying to cross between queuing traffic. Additionally the visibility for pedestrians crossing from the north at this location is very poor due to vegetation along the property boundaries. This could increase the chance of a pedestrian / vehicle collision.

This crossing point should be reviewed during detailed design and improvements made to ensure pedestrians can use it safely.

Designer's Response: Agreed. The crossing point will be reviewed during detailed design stage.
