**STRUCTURAL INSPECTION AT
REYNARDS GARAGE, 17-21 PICCADILLY, YORK
FOR CITY OF YORK**

JOB NO: 10823/12.0

DATE: APRIL 2015

Document Title: Structural Inspection

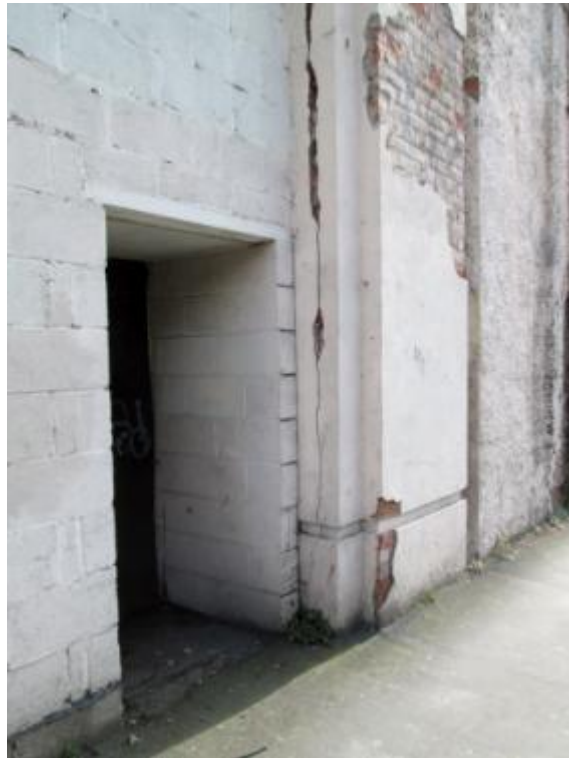
Photograph No. 11 – Old Piccadilly entrance

- 2.1 The building is as discussed in our previous report and from a brief inspection it appears that very little has changed over the last six years.
- 2.2 A close inspection of the external envelope was carried out. This revealed very little change from our previous inspection with only small pieces of render having fallen off. For example compare photographs 11 and 19 of this and the previous report.

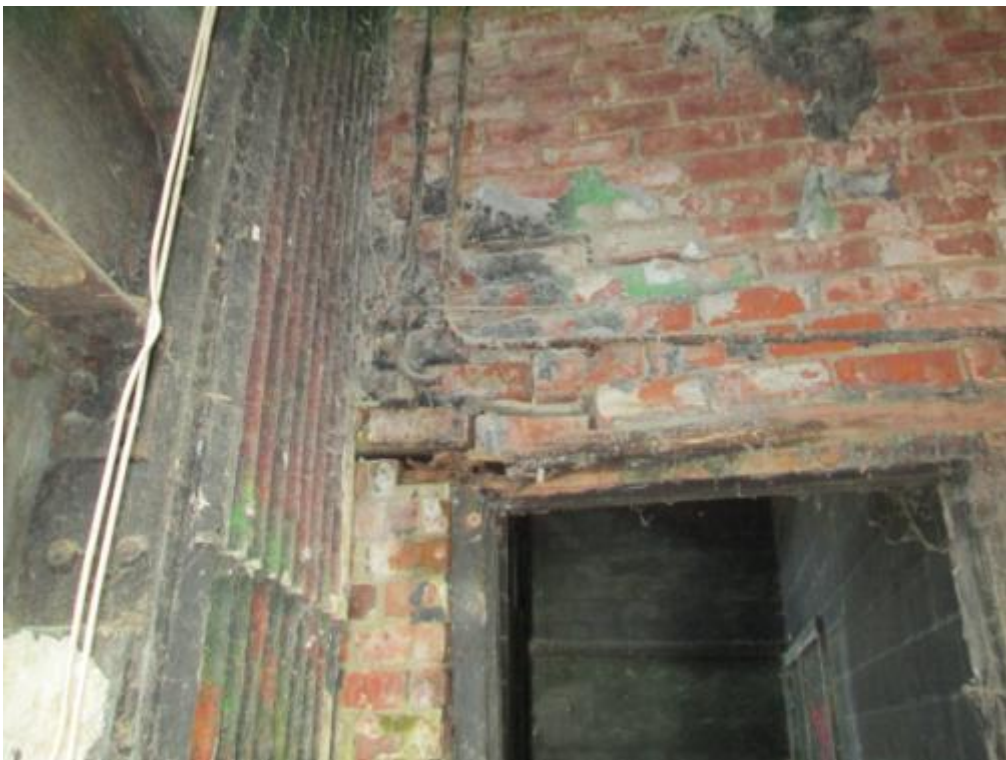
- a. A timber lintel over a door opening into the lean to at the rear of the building has failed.
 - b. Rusting of the columns at the junction with the ground slab. This was distinctly more apparent along the exposed rear elevation with one column flange severely corroded. This can be seen on photograph 68. A typical case can be seen on photograph 69.

Photograph 64 – Failed timber lintel above end door opening to lean-to

- 3.1 In addition to our previous recommendations we would advise that the wall over the door opening into the lean to at the rear of the building is propped as a matter of urgency. The gaps left by rotting timbers in the wall should also be packed tight with suitable materials.

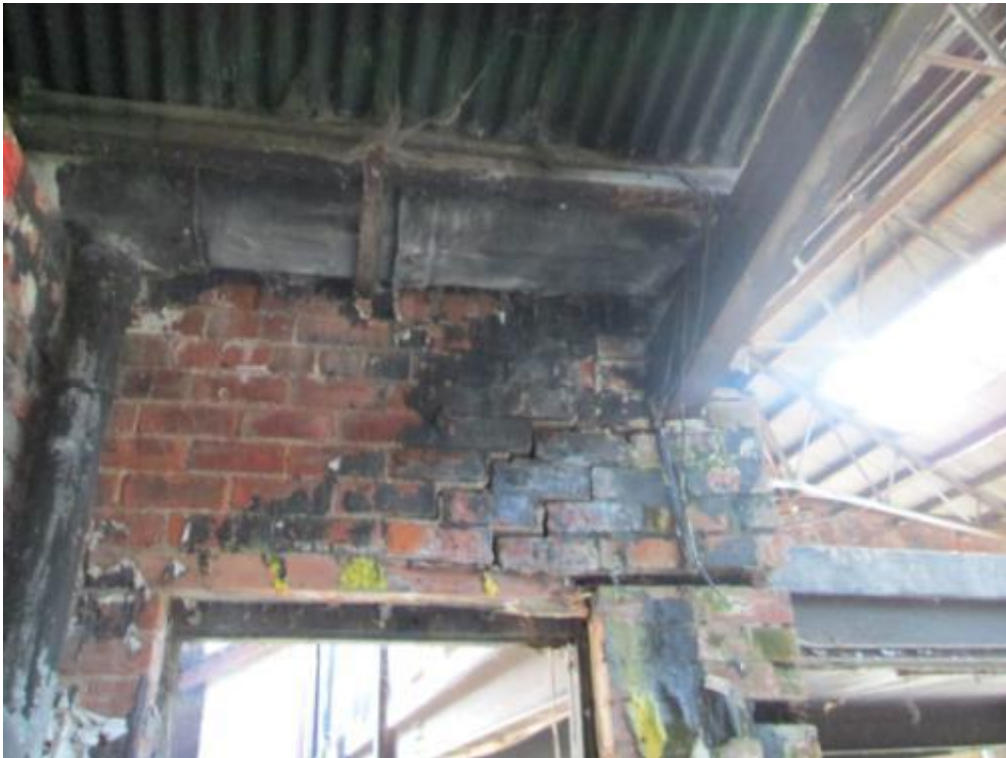
Photograph 65 – Failed timber lintel with steel rafter supported on wall

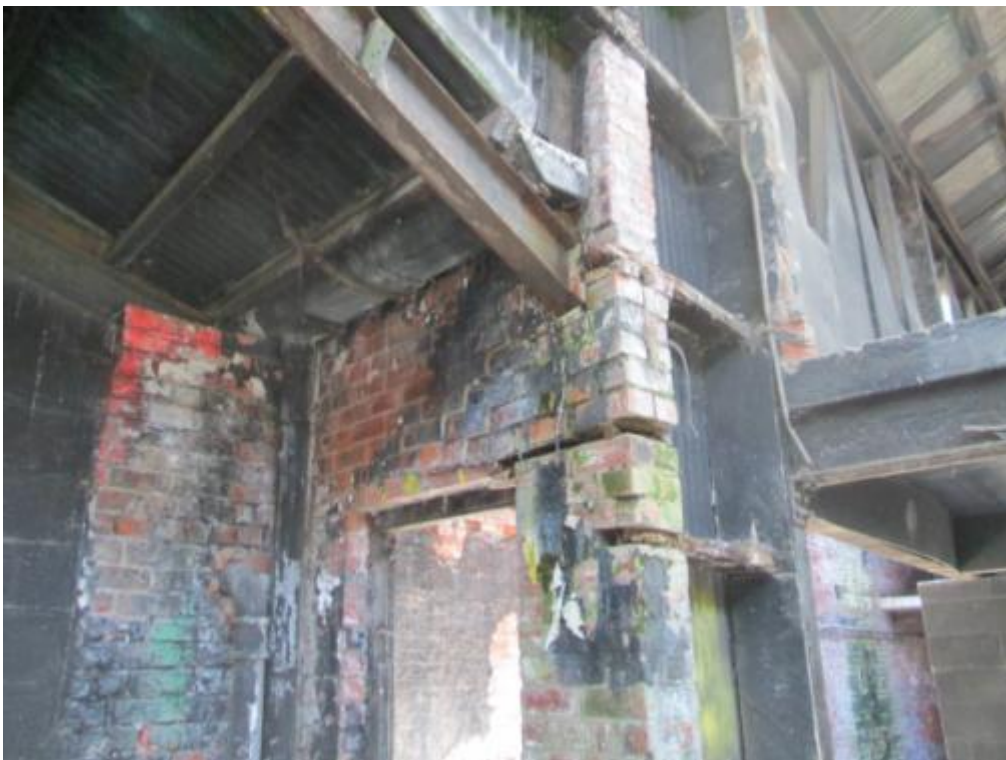
Photograph 66 – Rafter supported on wall above failed timber lintel

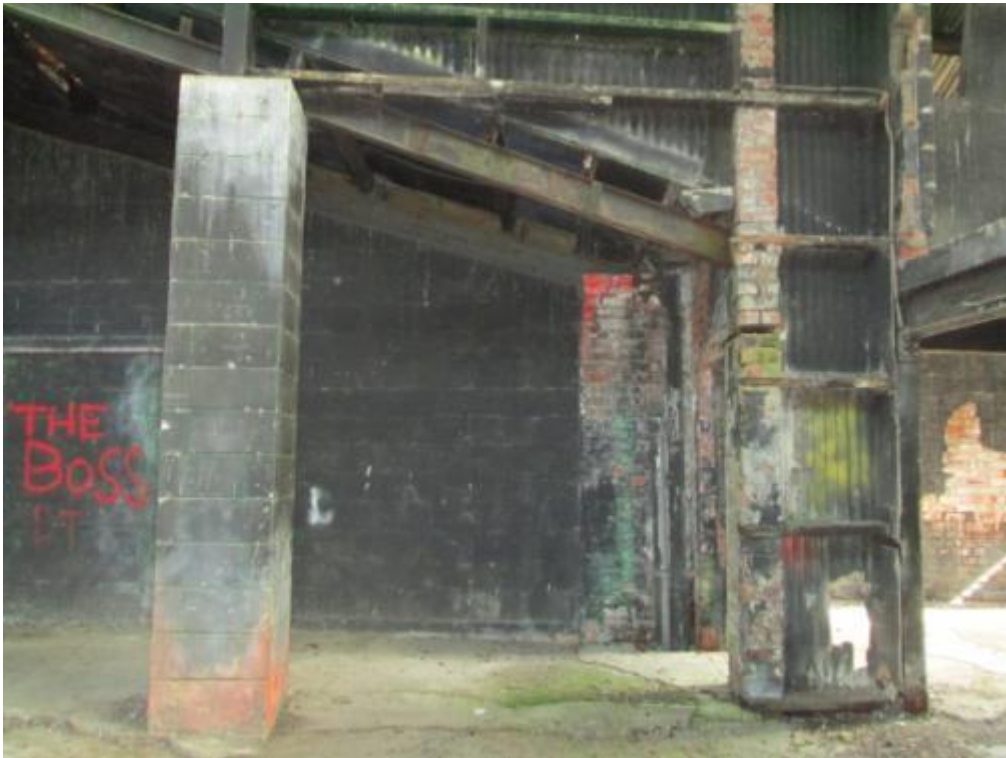
Photograph 66a – Rafter supported on wall above failed timber lintel

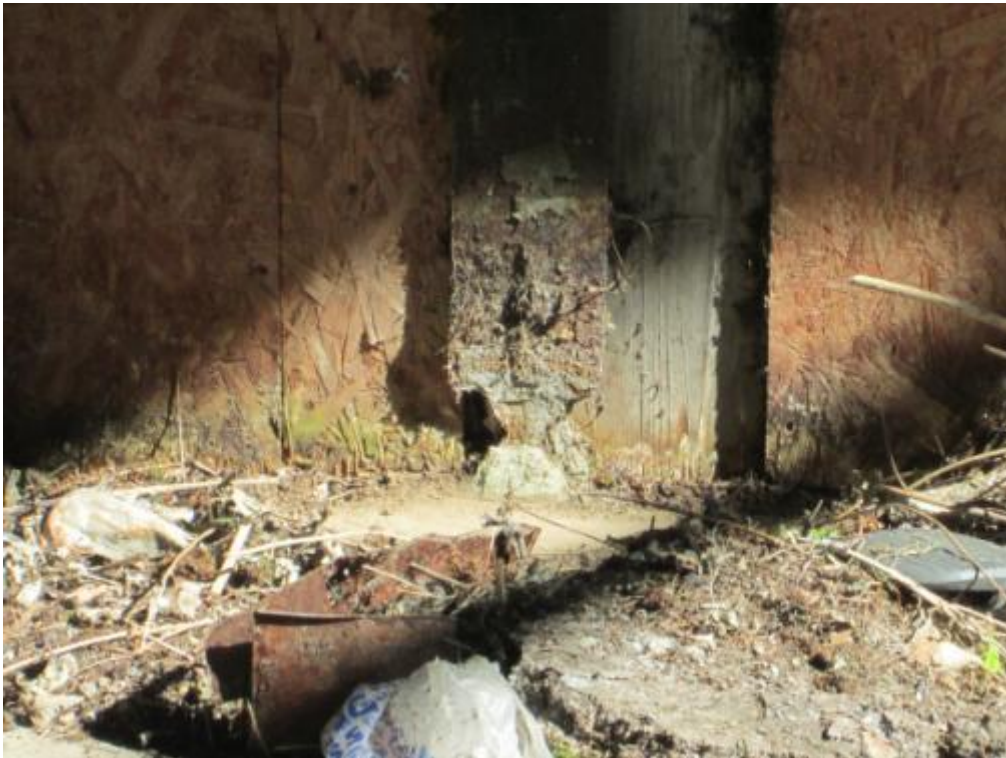
Photograph 68 – Rusting column to rear elevation (worst case)

- 3.2 With regards to the rusting columns we would recommend that the full extent of the corrosion is determined in order for a temporary strengthening detail to be produced. To do this the concrete slab around the columns need to be broken out. Firstly the column shown in photograph 68 should be exposed along with a more typical example. At this point a decision could be made to expose further columns if considered necessary.

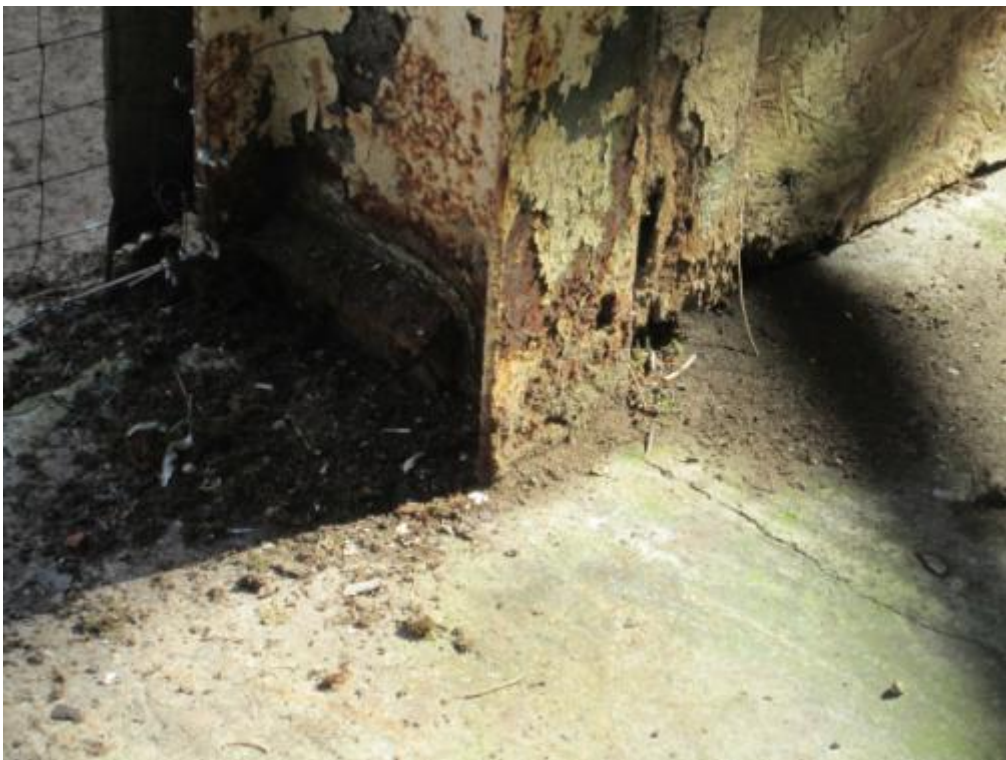
Photograph 69 – Typical view of rusting column to rear elevation

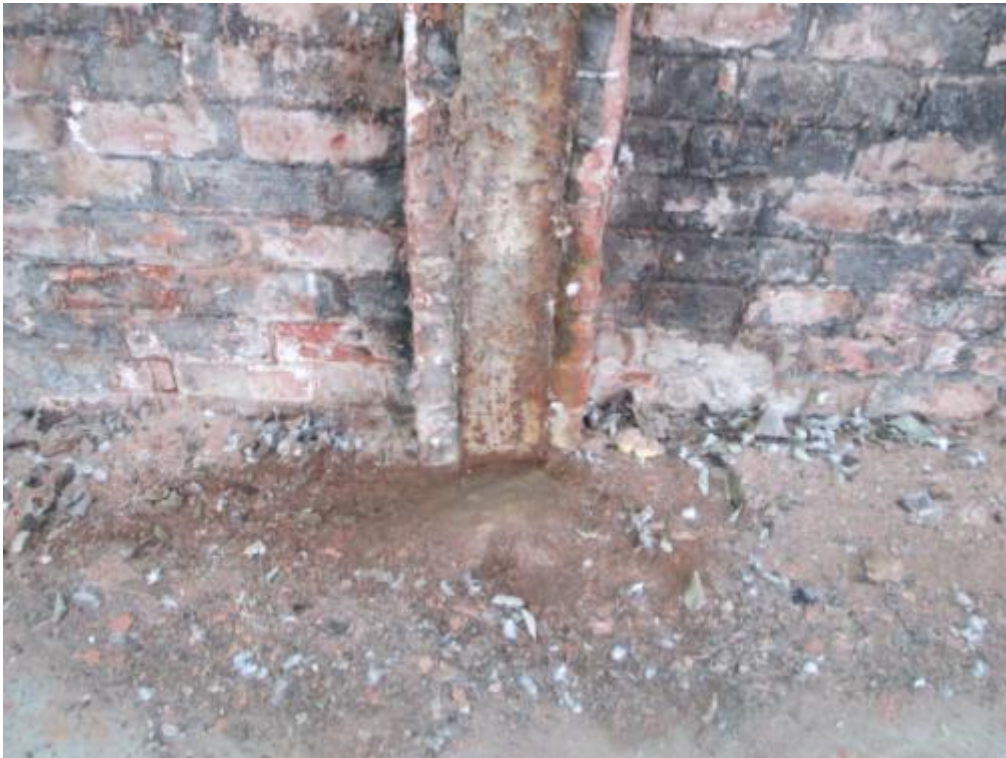
Photograph 70 – Typical view of rusting column to front elevation
