17 - 21 PICCADILLY, YORK

CITY OF YORK COUNCIL

STRUCTURAL INSPECTION

3 November 2009

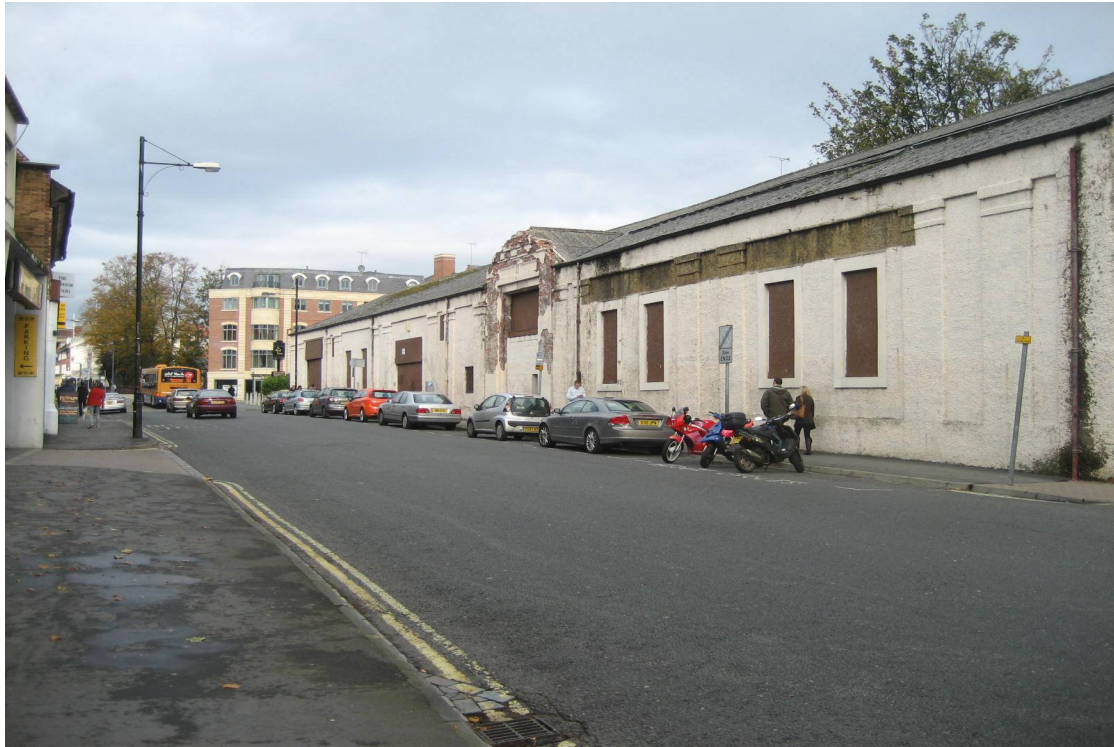
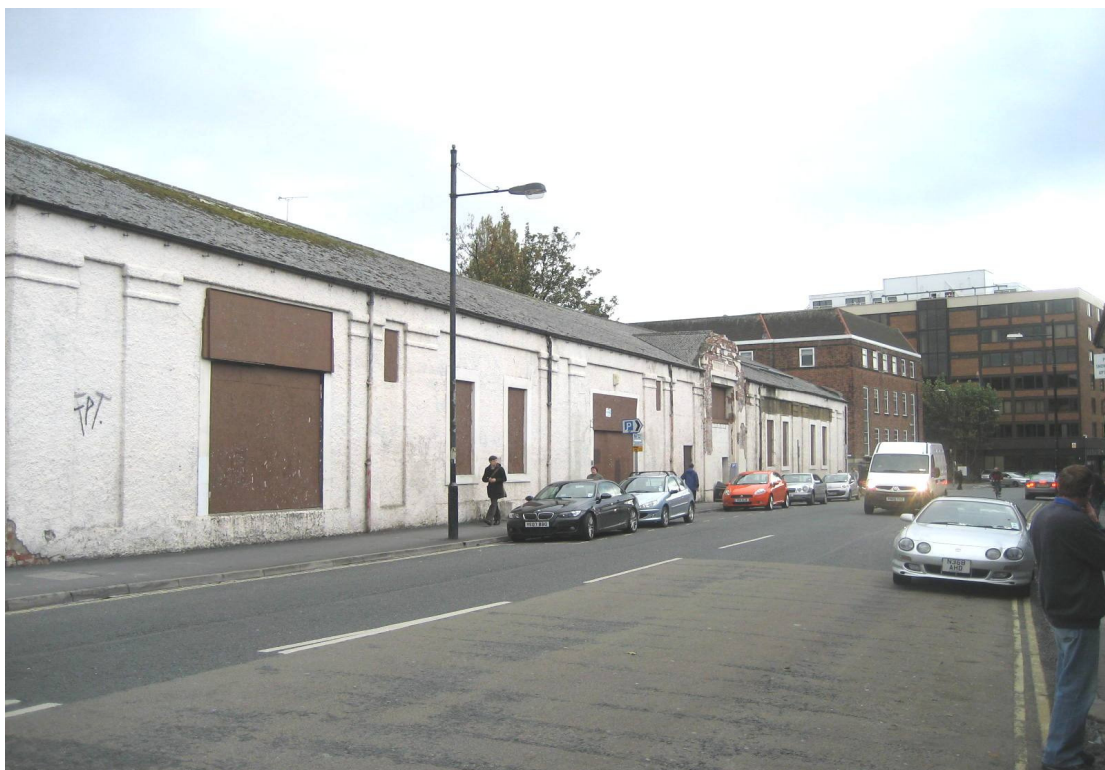
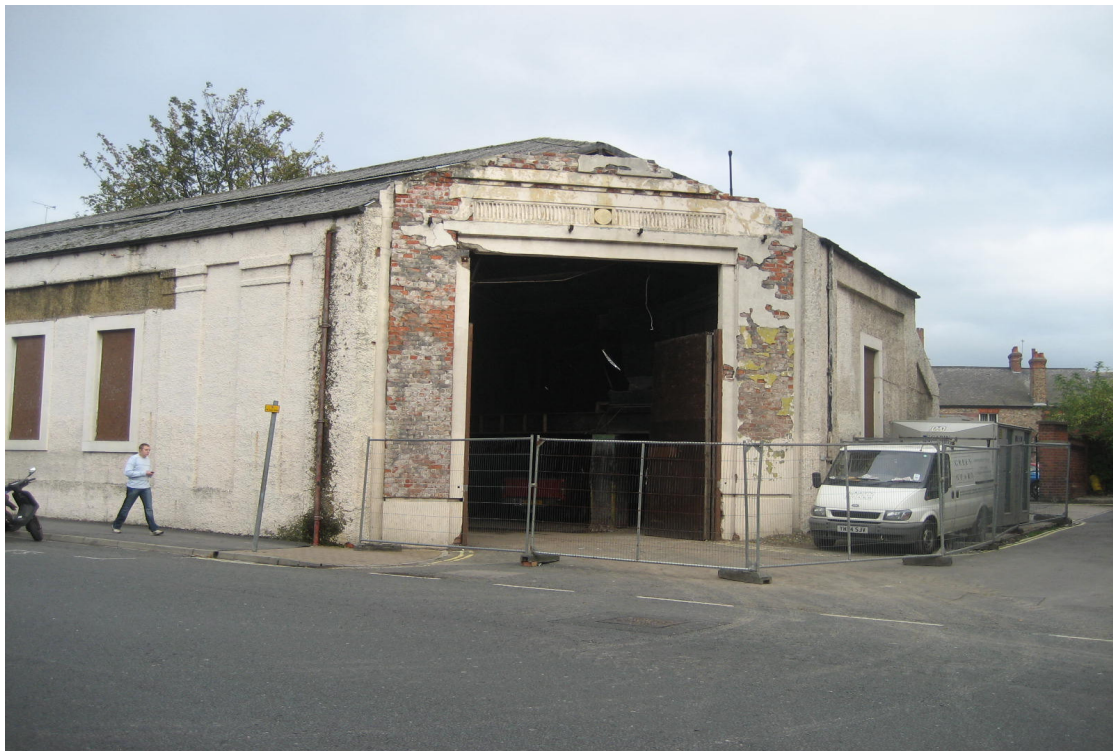
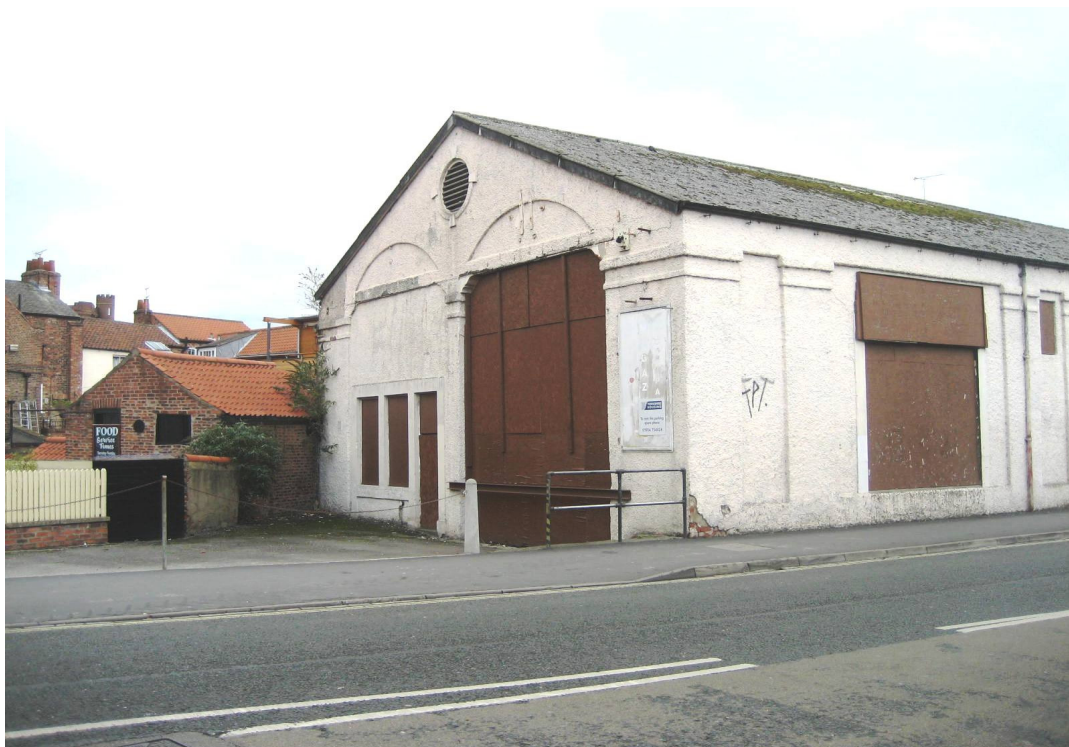
2.1 The building is a long steel framed single storey construction with columns at regular centres supporting steel trusses spanning the full width of the main building. Along the rear elevation there is a lean-to section of the building for approximately one quarter of the length of the main building. The roof consists of asbestos cement sheeting on timber purlins directly supported on the steel trusses. Except for the most of the rear elevation the walls are brickwork for the full height. Timber rails support asbestos cement sheeting to form the rear elevation but a significant proportion has been removed. (see photographs 1 to 4, 32, 33, and 37 to 41)

Photograph 1 Piccadilly Elevation

Photograph 2 Dennis Street Elevation

Photograph 3 Dennis Street Elevation

Photograph 4 North West Elevation

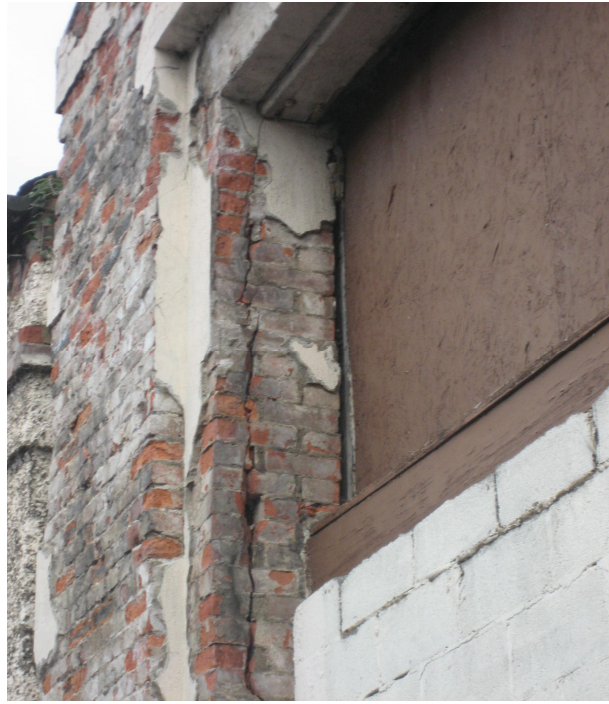
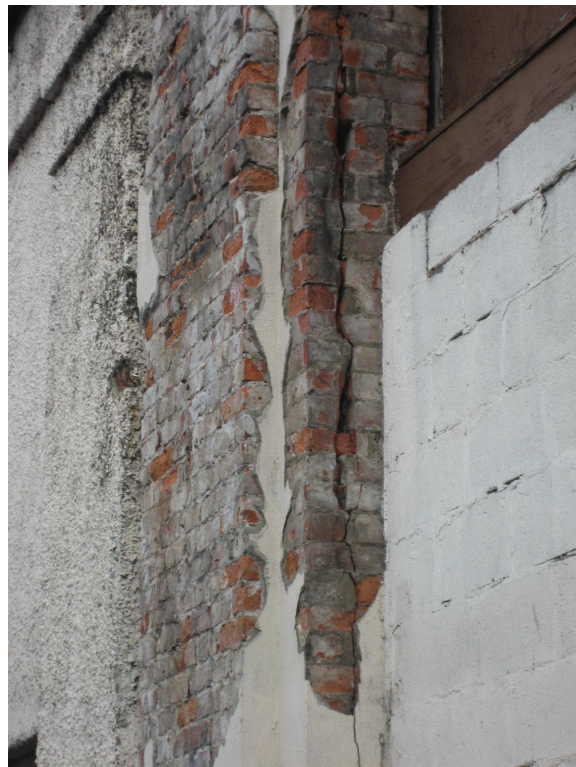
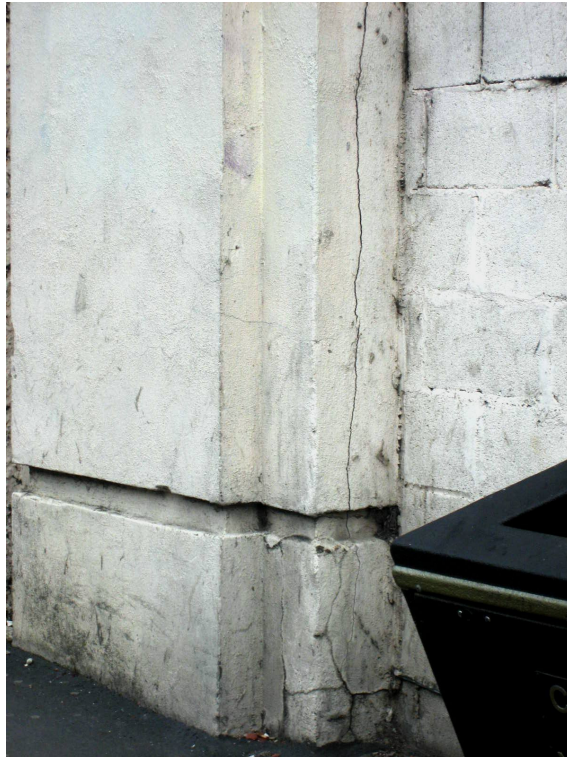
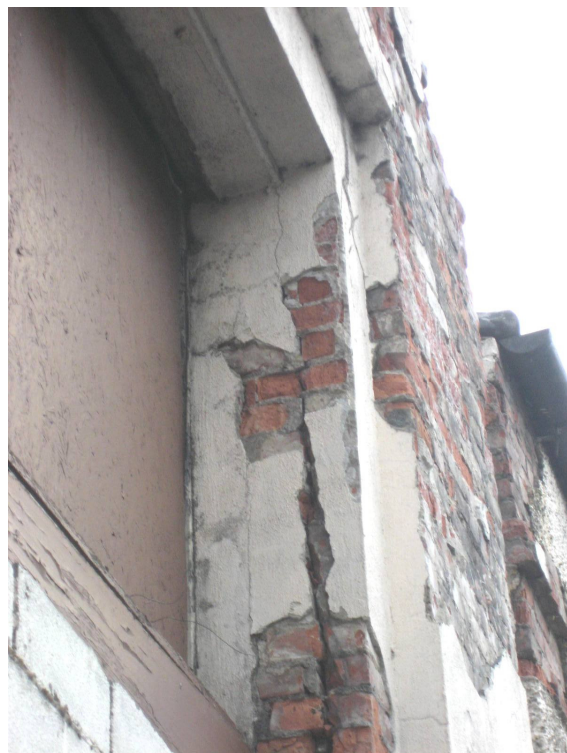
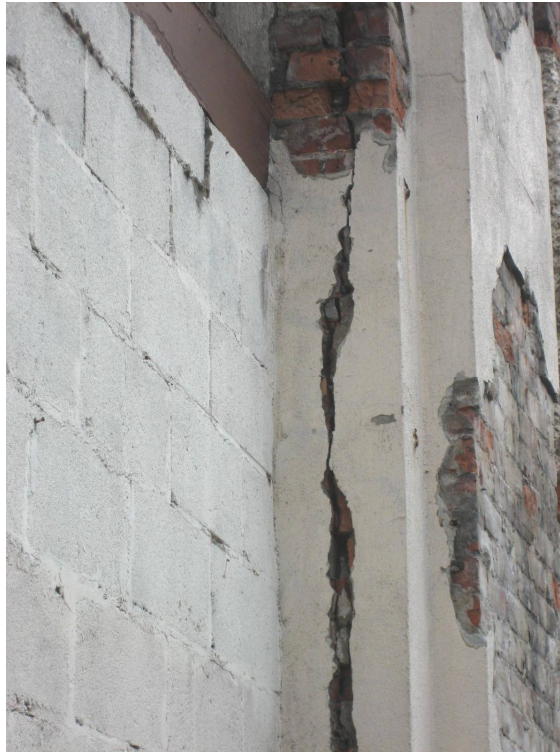
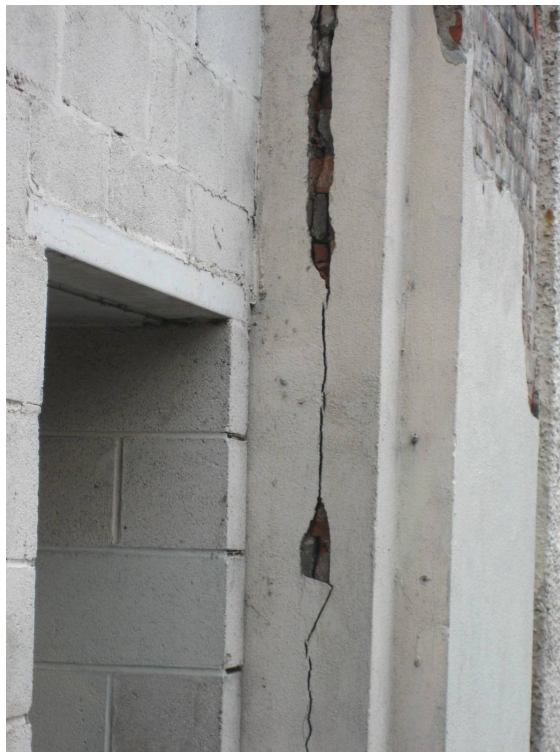
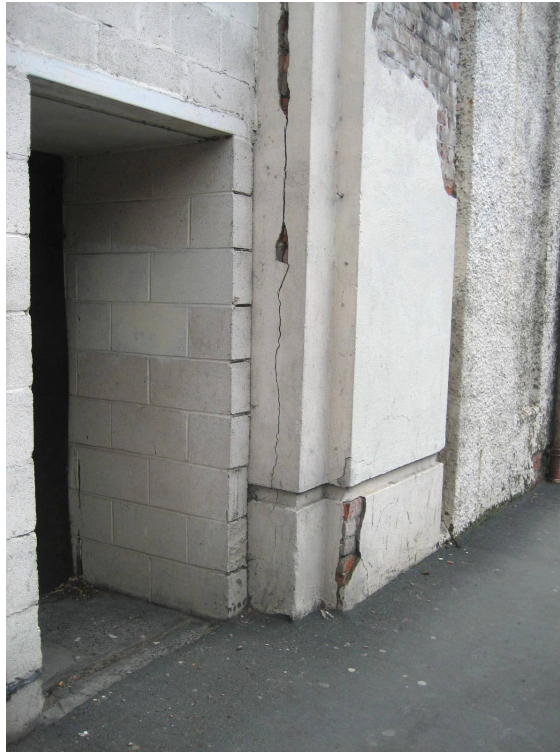
- 2.8 All the masonry elevations are rendered and there are indications that some of this render may be loose or may become loose.
- 2.9 Reveals to the old Piccadilly entrance have cracked for the full height of the original opening. (see photographs 5 to 11)

Photograph 5 Old Piccadilly Entrance

Photograph 6 Old Piccadilly Entrance

Photograph 7 Old Piccadilly Entrance

Photograph 8 Old Piccadilly Entrance

Photograph 9 Old Piccadilly Entrance

Photograph 10 Old Piccadilly Entrance

Photograph 11 Old Piccadilly Entrance

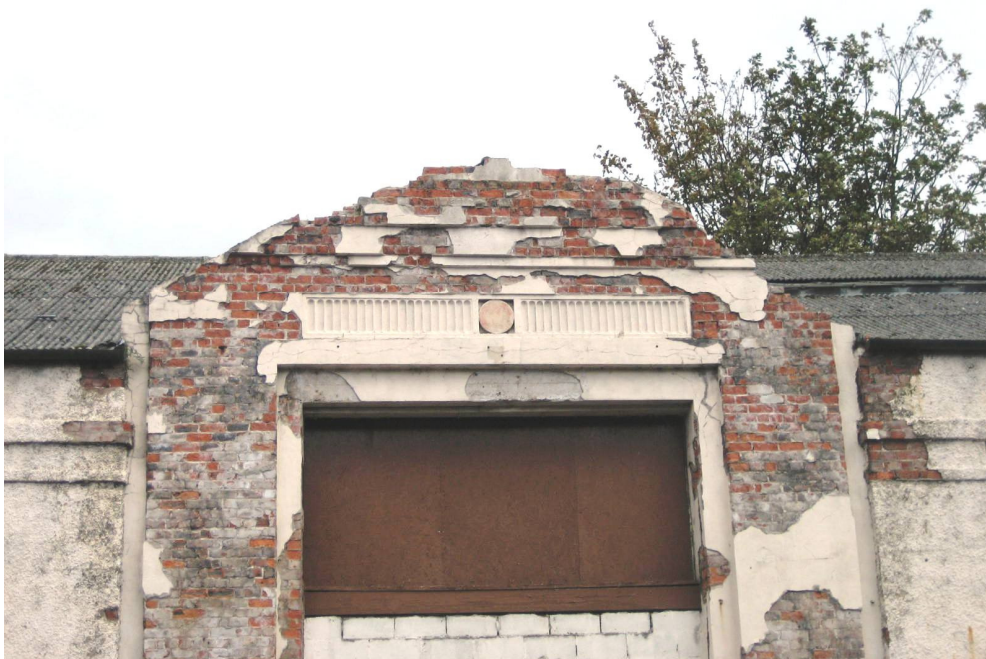
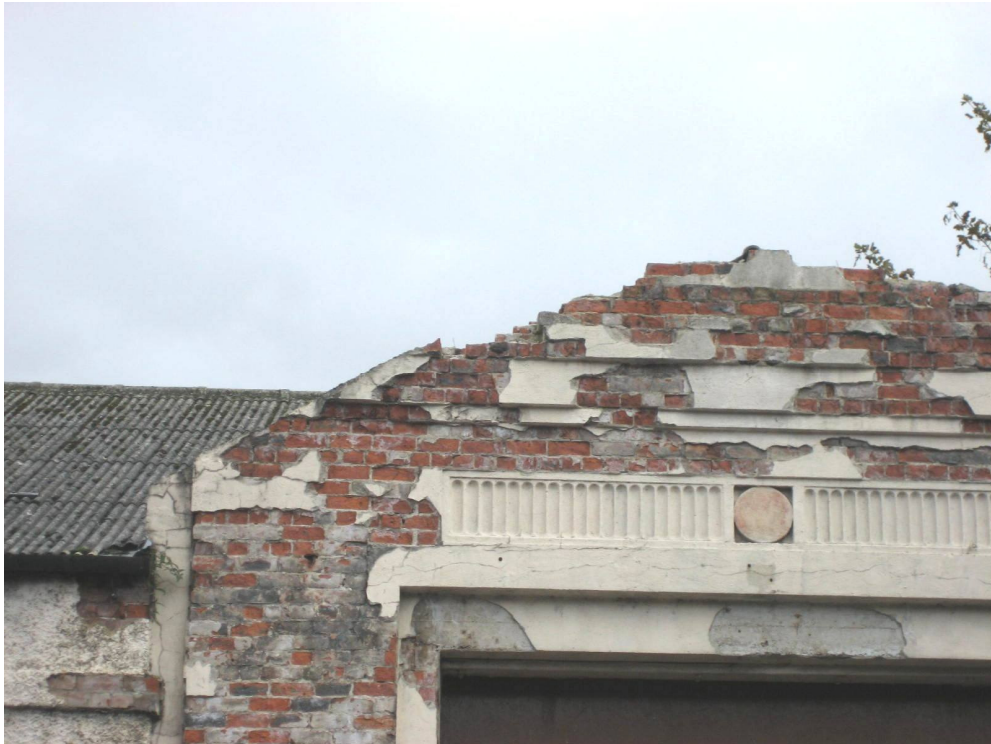
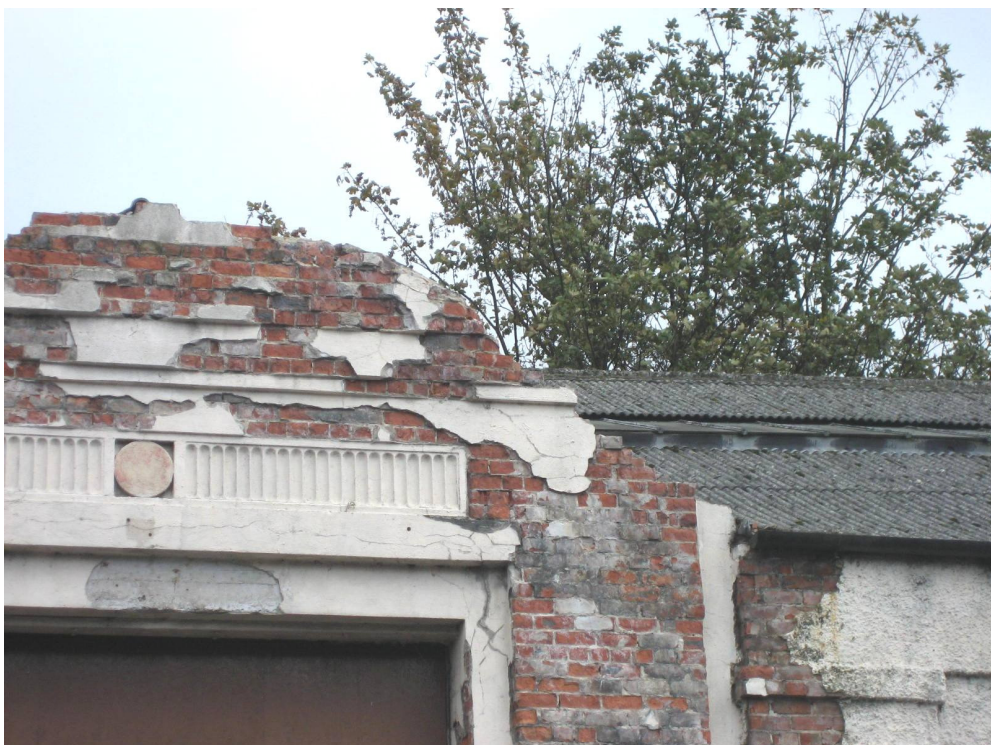
- 2.7 From ground level it appears that there may be some loose masonry at the top of the Piccadilly and Dennis Street gables although it is understood that this was checked recently. (see photographs 12 to 14 and 30)

Photograph 12 Old Piccadilly Entrance

Photograph 13 Old Piccadilly Entrance

Photograph 14 Old Piccadilly Entrance

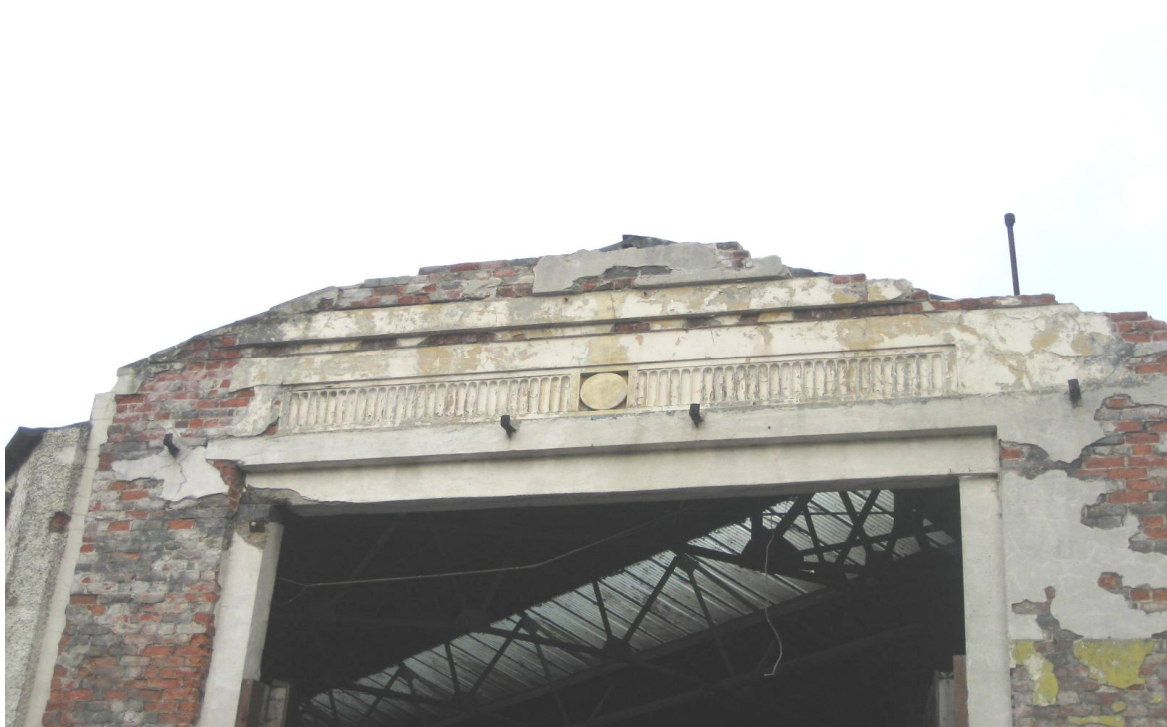
Photograph 30 Dennis Street Entrance Elevation

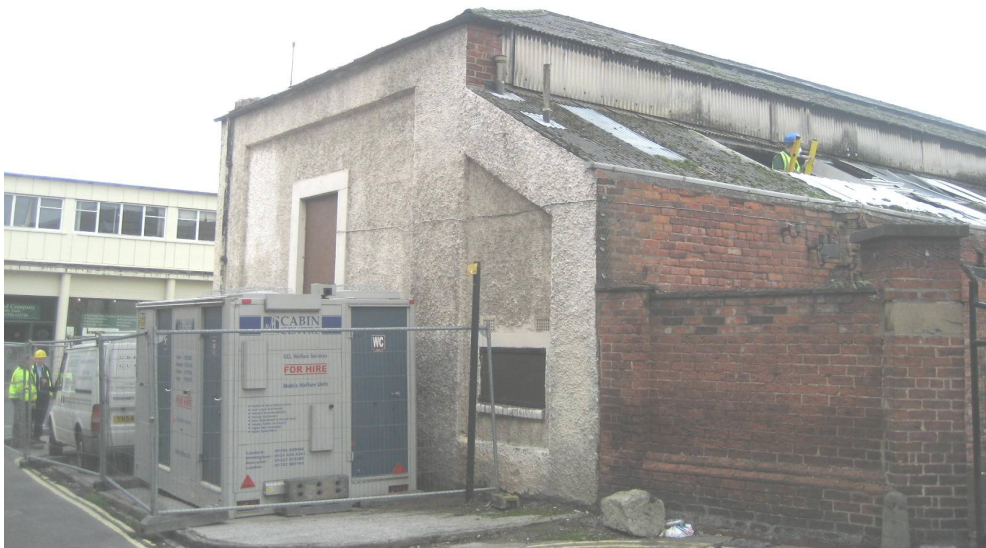
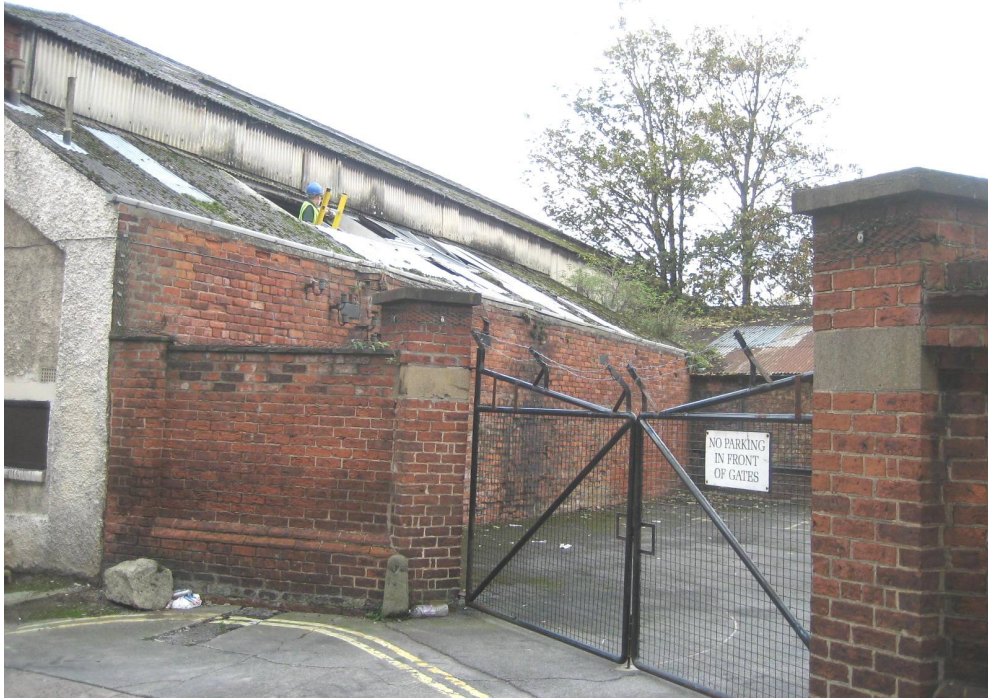
Photograph 32 Dennis Street Entrance Elevation

Photograph 33 Rear Elevation

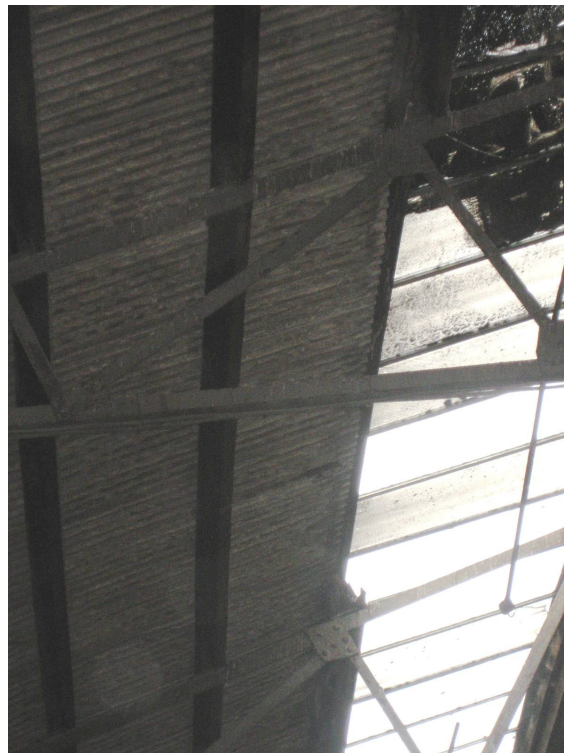
- 2.6 Towards the Dennis Street end of the building there is a missing purlin at the bottom edge of the roof light. This has allowed the roof light to drop and is in danger of falling into the building. (see photograph 34) Photographs 43 and 44 show a typical purlin connection to the truss. Our observations indicate that there may be some incomplete connections which need to be reinstated. (see photograph 46)

Photograph 34 Missing Purlin in Roof

3.5 The missing timber purlin must be replaced with a C24 timber of the same size and fixed similar to the existing purlins. To achieve this it may be necessary to remove some of the existing roof lights and sheeting. During this operation and whilst the scaffolding is still in place we would recommend that the condition of the existing fixings are checked to determine if further fixing are required.

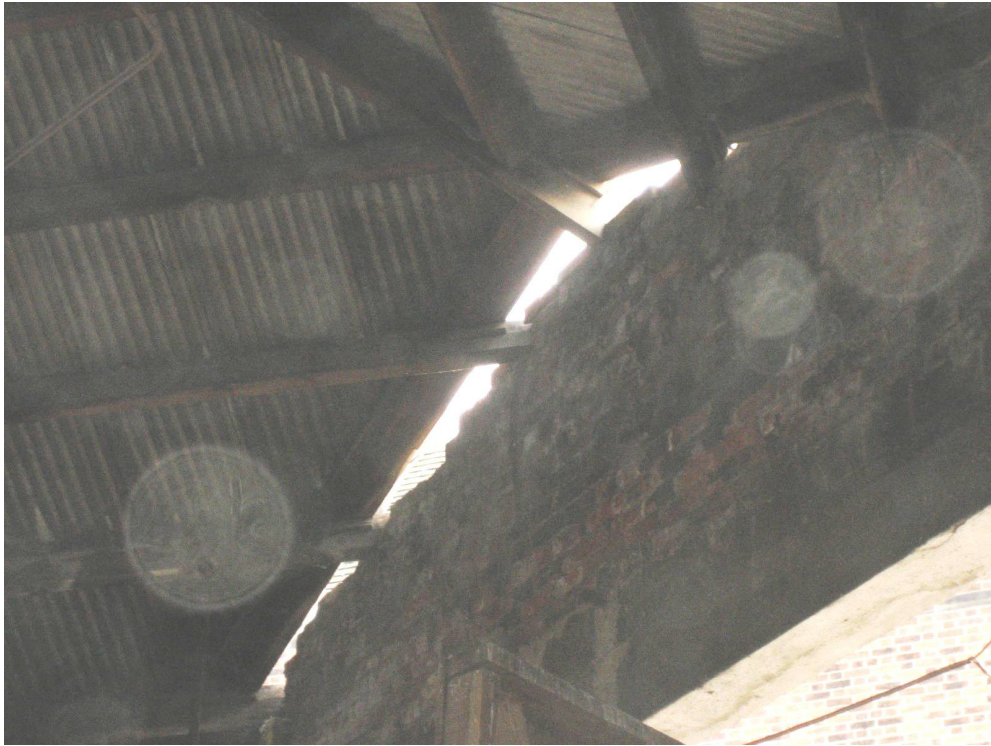
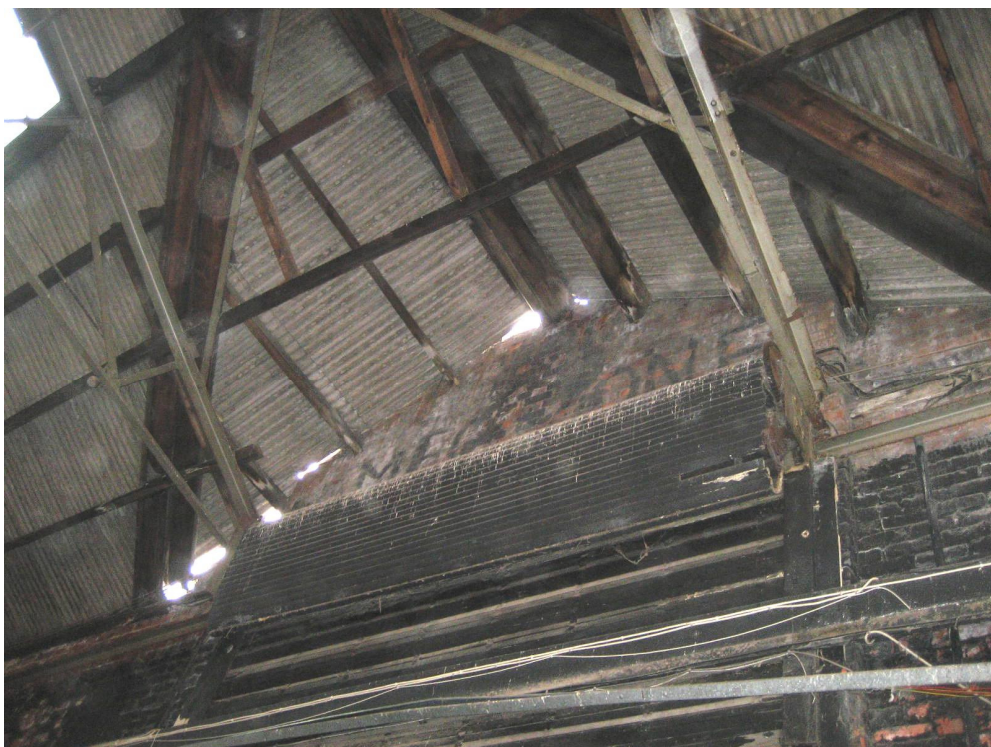
- 2.5 The gables at each end of the building along with the closed off Piccadilly entrance are not adequately tied in at purlin level. (see photographs 35, 36, 47 to 51, and 54 to 58)

Photograph 35 Internal view above Dennis St. Entrance

Photograph 36 Internal view above Piccadilly Entrance

- 3.8 Wall bearing timber purlins to be strapped down to the wall in all locations and the top of the wall to be restrained with straps along the purlin and fixed to the wall. (see detail sheets)
- 3.9 Render to the masonry elevations need to be checked to eliminate any loose areas by removing.
- 3.10 The top of the brickwork walls forming gables to Dennis Street and Piccadilly also need to be checked for any loose bricks.
- 3.11 Cracking within the masonry elevations has been caused by thermal movement most of which should not cause any problems except for the cracked reveals to the old Piccadilly entrance. The external leaf needs to be tied back to prevent any further damage. (see detail sheets)
- 3.12 Finally we would recommend that the unstable partially demolished mezzanine wall is taken down back to a suitable safe location.

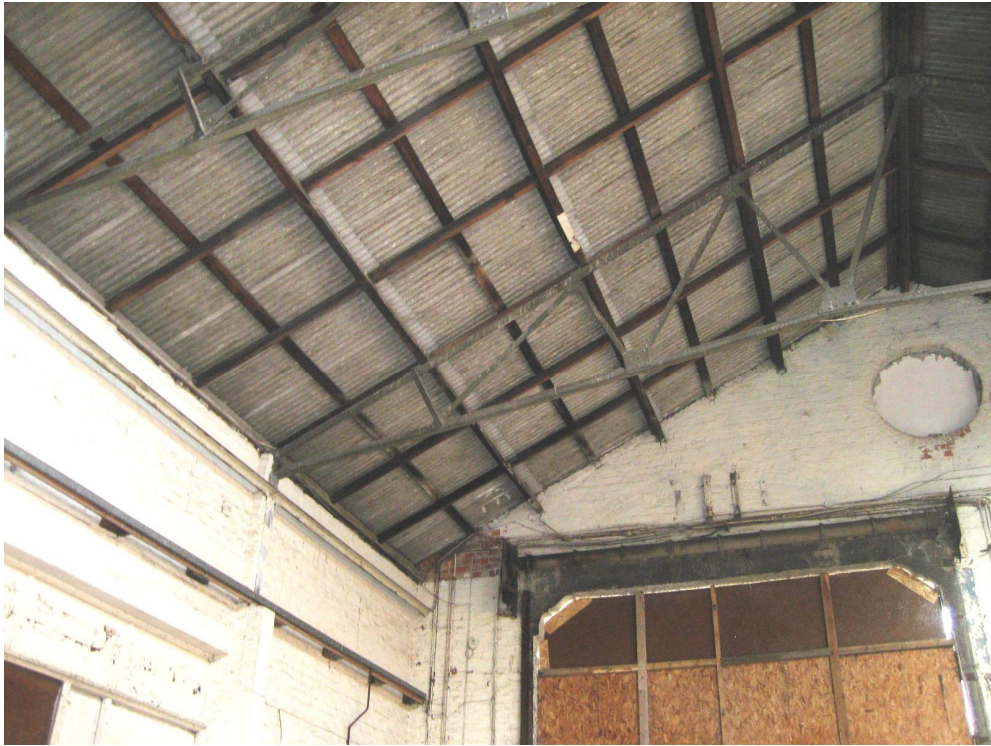
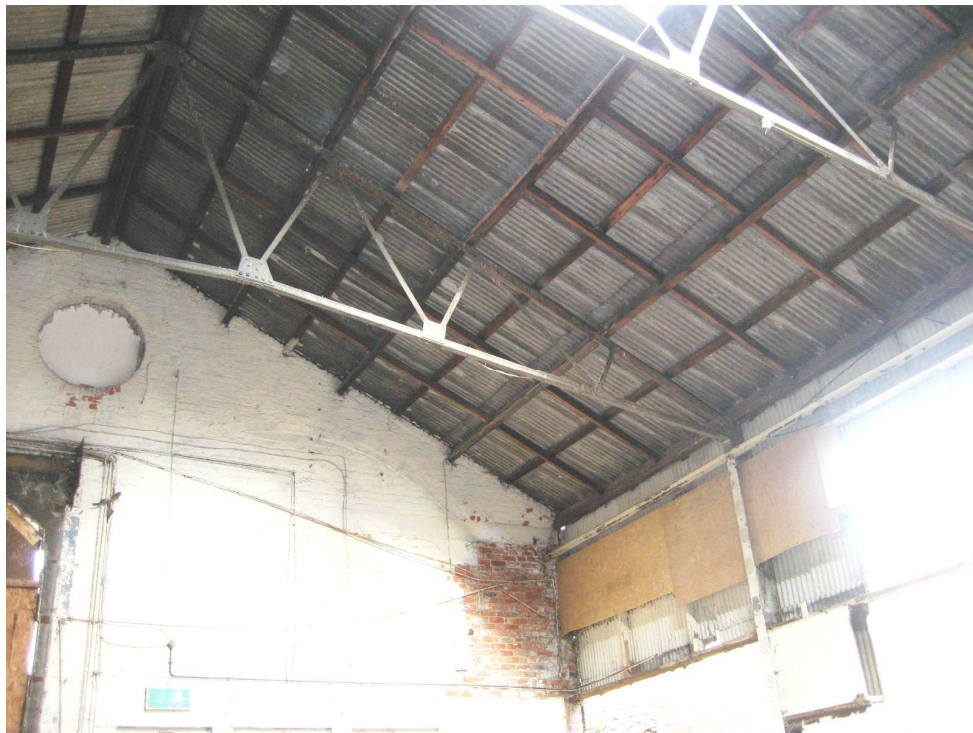
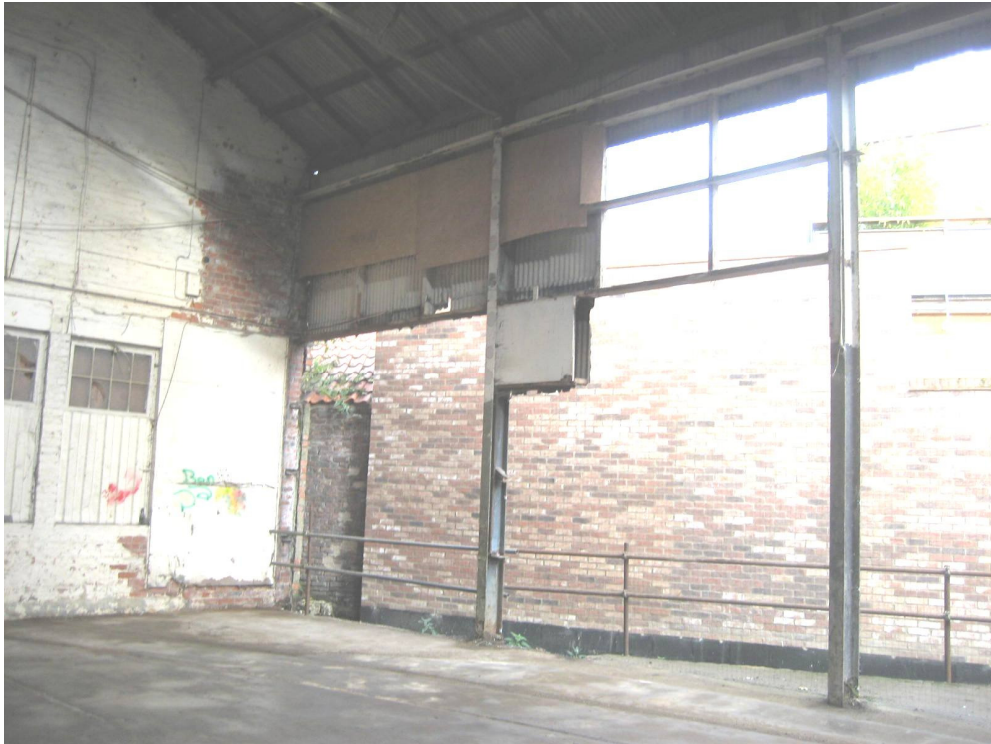
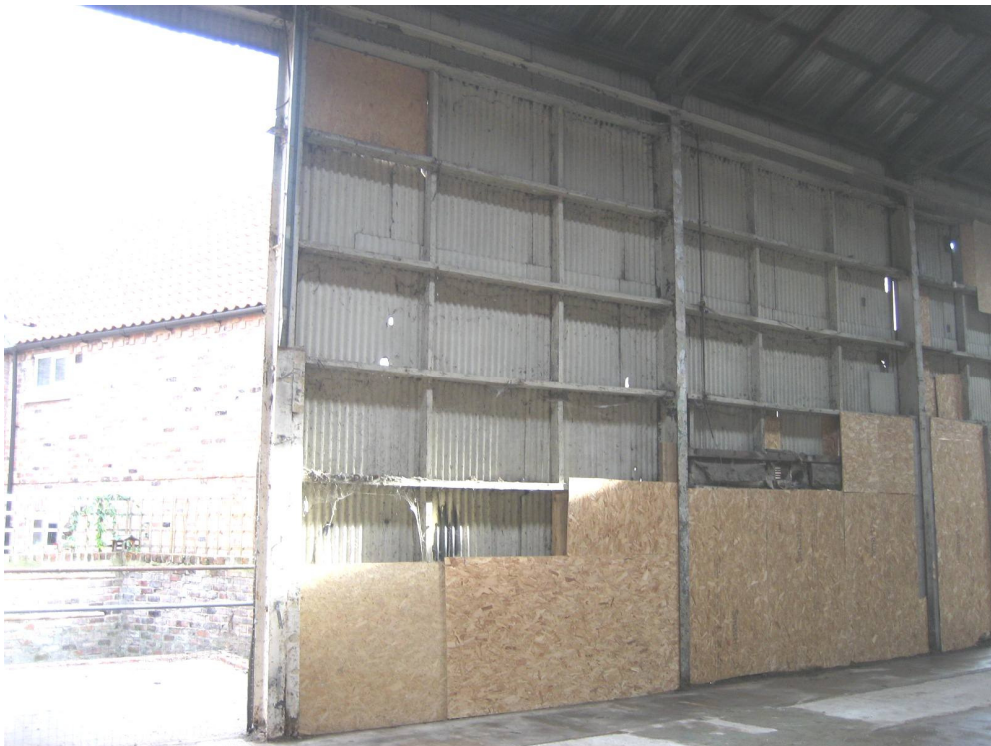
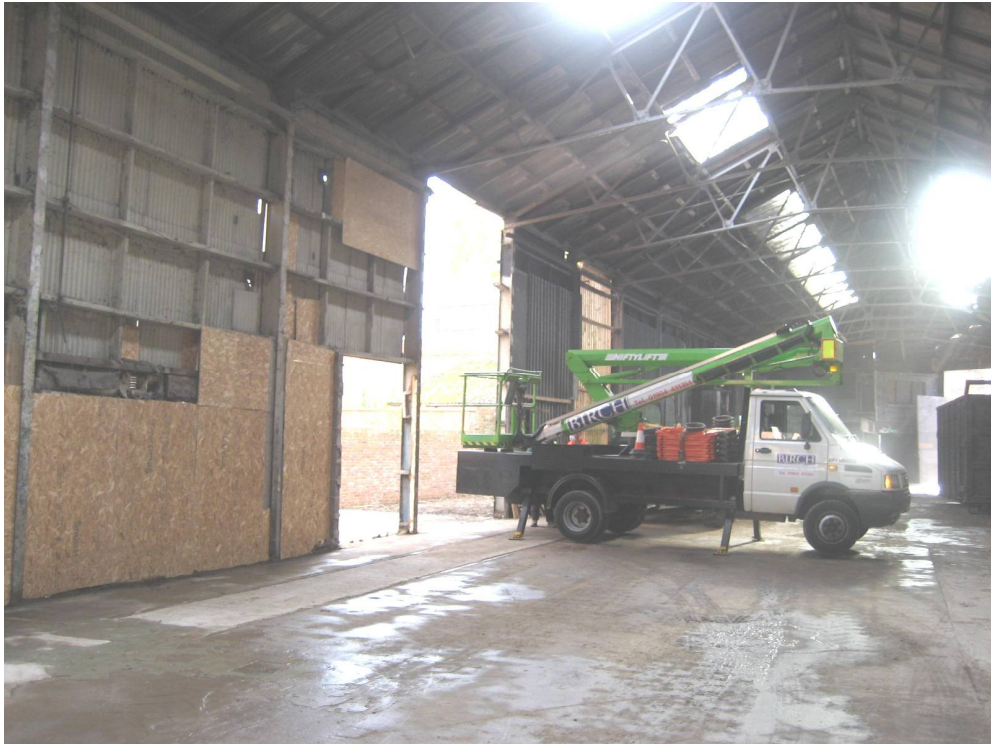
Photograph 37 Internal view towards North West Entrance

Photograph 38 Internal view towards North West Entrance

Photograph 39 Part view on rear elevation

Photograph 40 Part view on rear elevation

Photograph 41 Part view on rear elevation

3.2 To regain longitudinal stability along the rear elevation it will be necessary to provide bracing in one of the bays. We would recommend that this is fixed in the open bay formed during the clean up works. (see detail sheets 3 & 4)

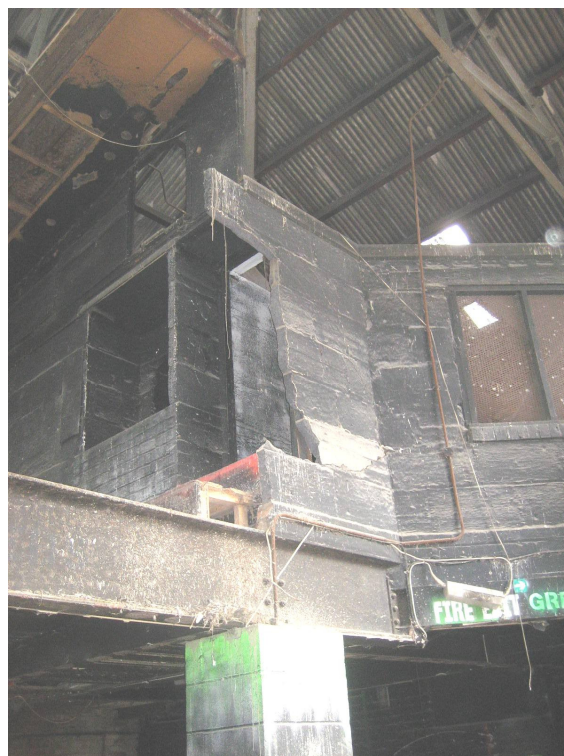
- 2.11 At the time of this inspection some demolition of internal partitions had taken place but this has left a wall at mezzanine level unstable. (see photograph 42)

Photograph 42 partially demolished wall at Dennis St. end

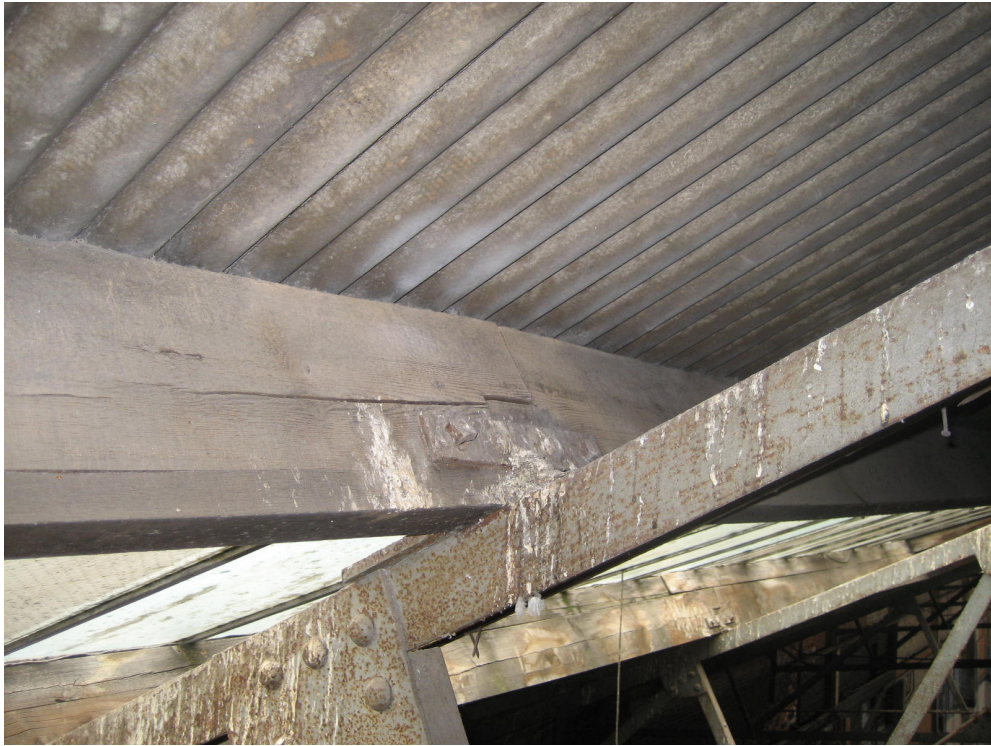
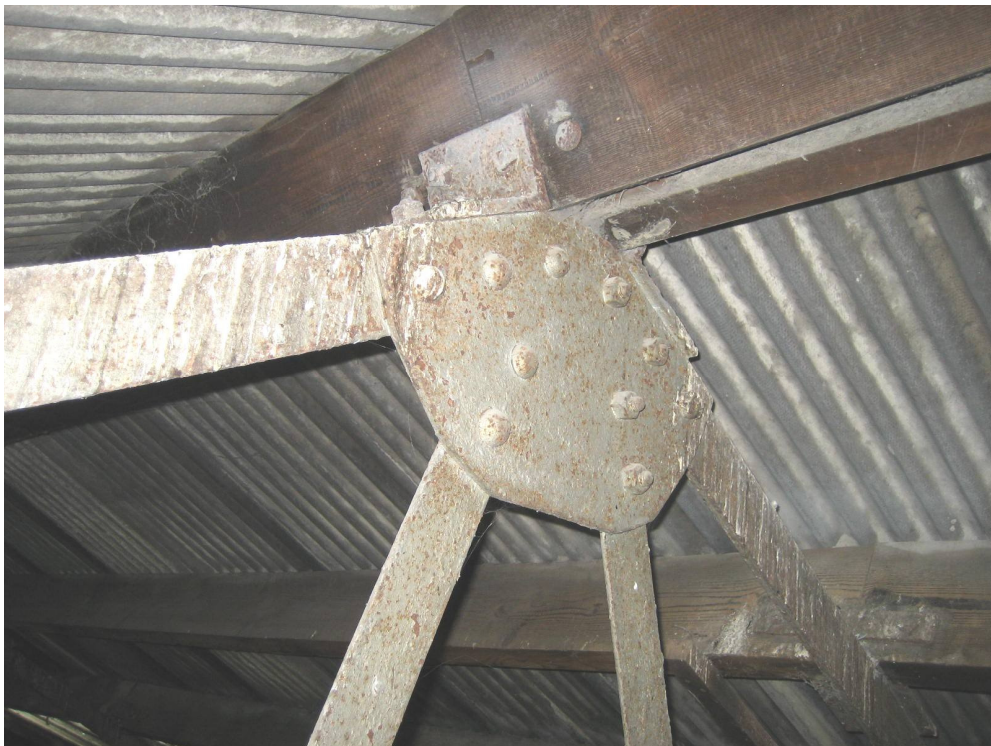
Photograph 43 Typical purlin connection

Photograph 44 Typical purlin connection

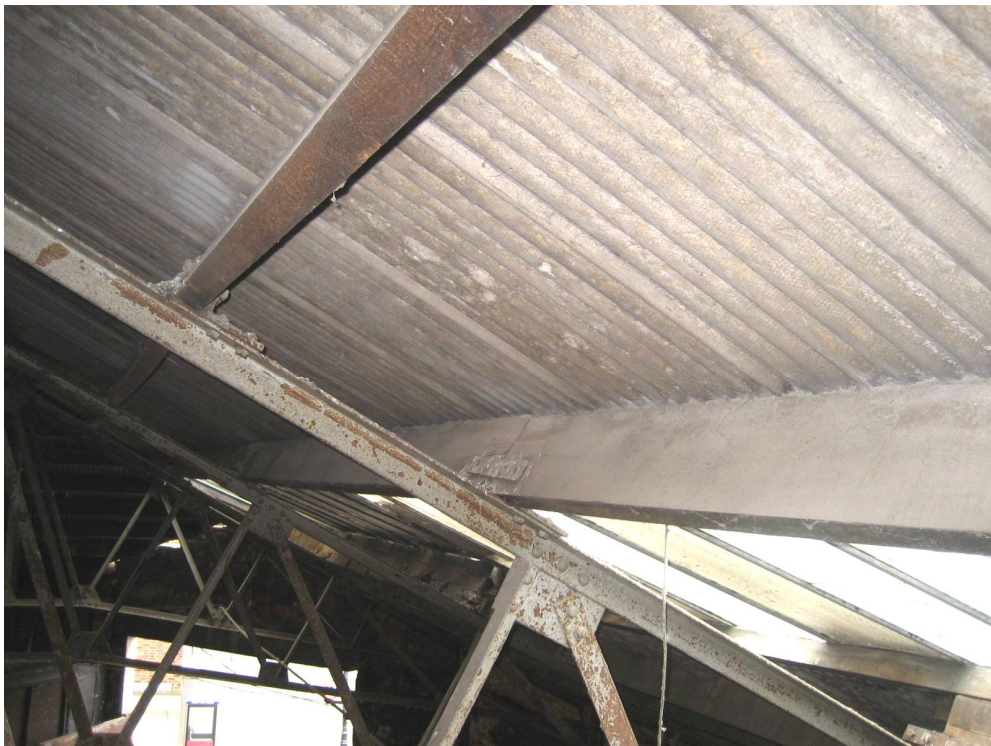
Photograph 46 Purlin connection indicating missing bolts

3.6 All purlin connections to be checked and any missing bolts etc. to be replaced.
