17 - 21 PICCADILLY, YORK

CITY OF YORK COUNCIL

STRUCTURAL INSPECTION

3 November 2009

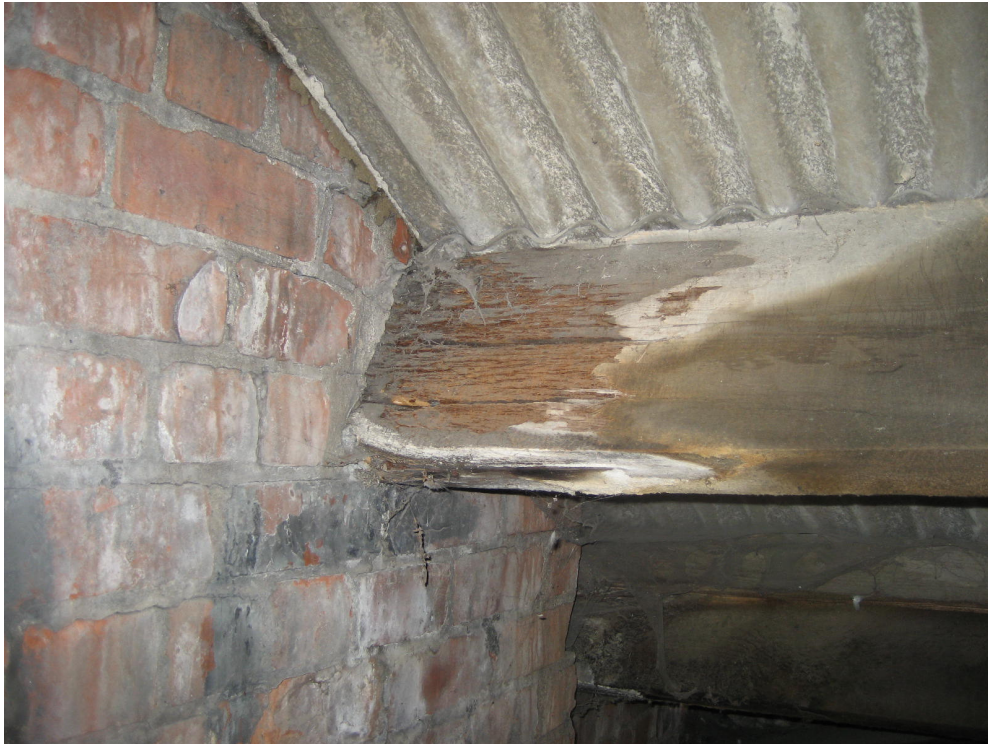
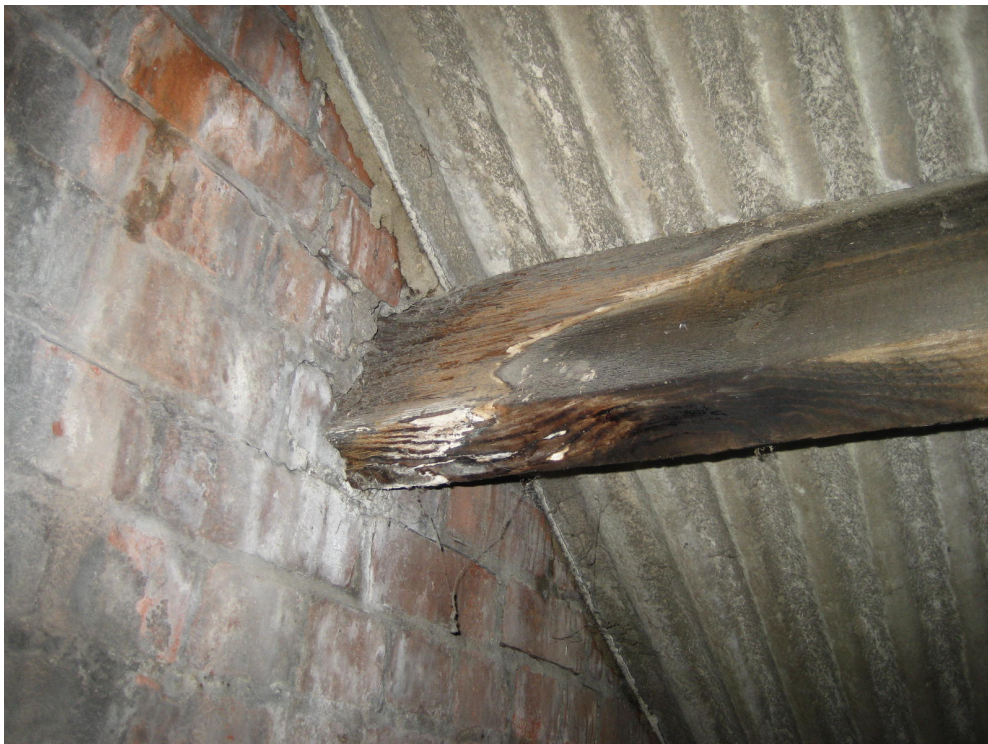
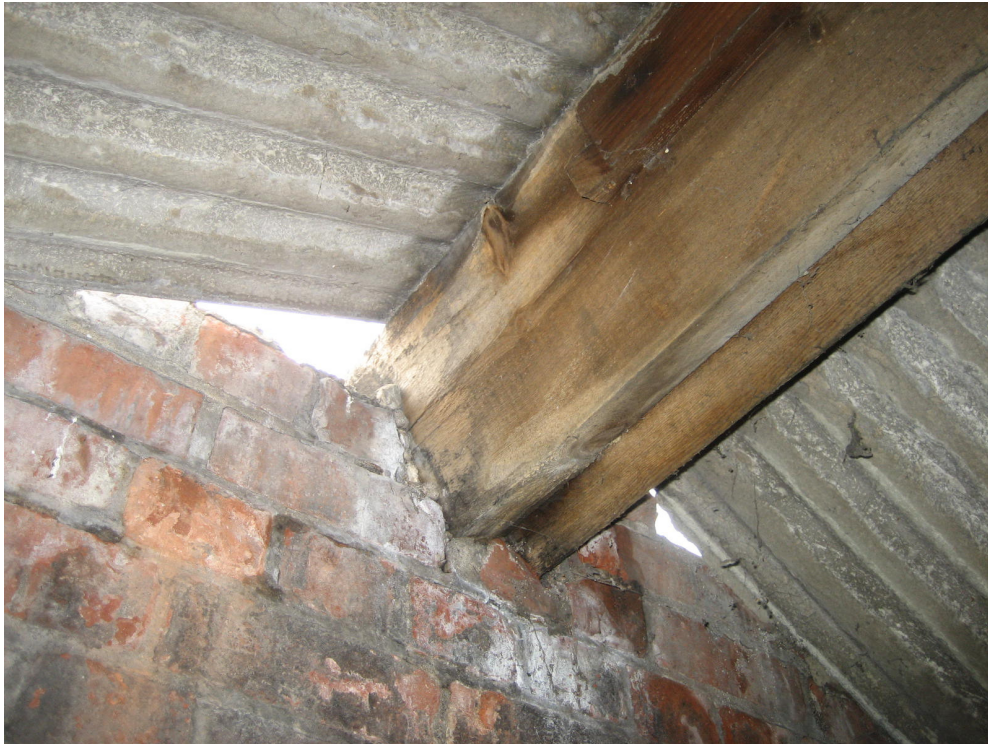
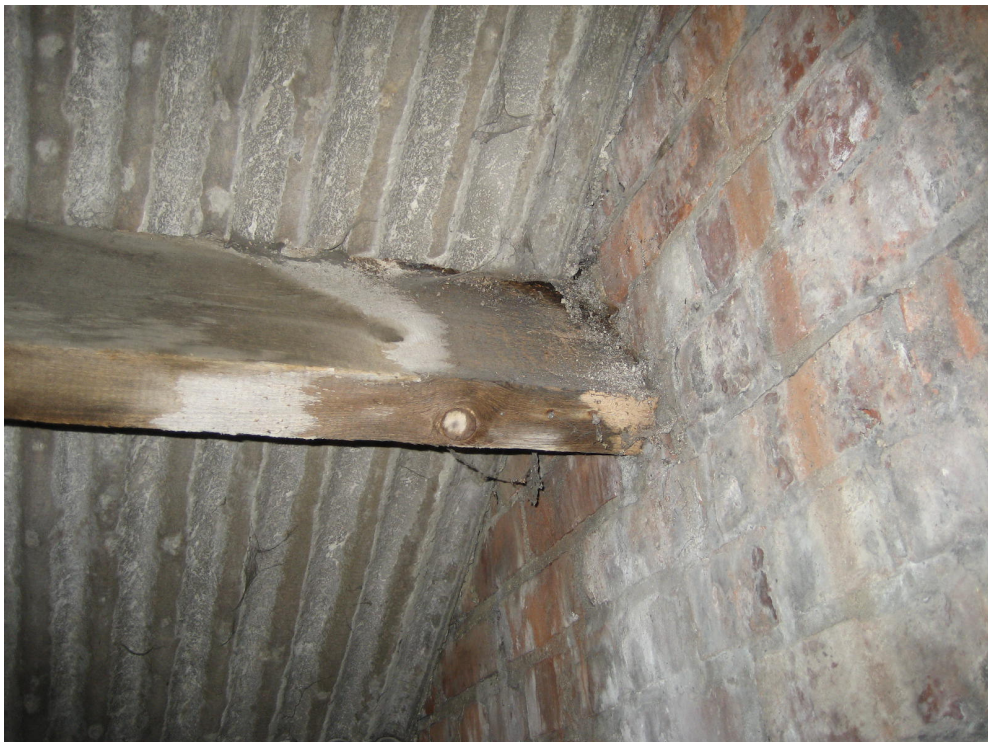
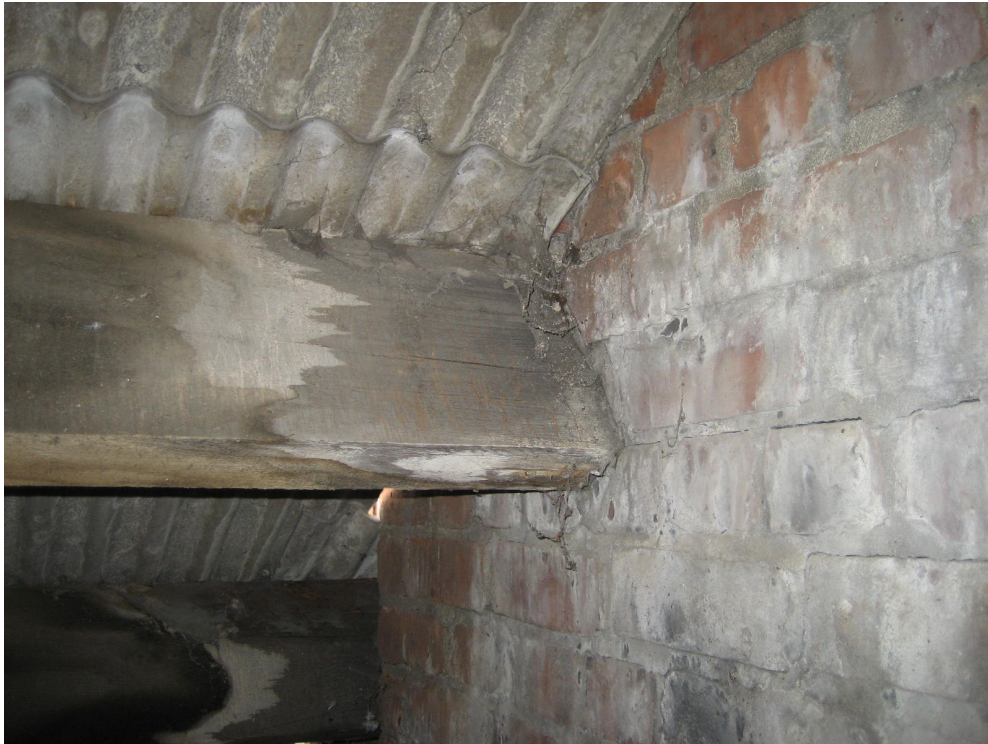
- 2.5 The gables at each end of the building along with the closed off Piccadilly entrance are not adequately tied in at purlin level. (see photographs 35, 36, 47 to 51, and 54 to 58)

- 2.10 Where the timber purlins are built into or on to walls there is evidence that these may have been affected by water. (see photographs 47 to 51 and 54 to 58)

Photograph 47 Purlin bearing into wall above Piccadilly Entrance

Photograph 48 Purlin bearing into wall above Piccadilly Entrance

Photograph 49 Purlin bearing into wall above Piccadilly Entrance

Photograph 50 Purlin bearing into wall above Piccadilly Entrance

Photograph 51 Purlin bearing into wall above Piccadilly Entrance

3.7 We would recommend that a timber specialist is employed to check the ends of the purlins where these bear into or on the external walls to comment on their structural integrity. Should any of these be deemed to not to be adequate they should be replace with the same size timber in class C24.

- 3.8 Wall bearing timber purlins to be strapped down to the wall in all locations and the top of the wall to be restrained with straps along the purlin and fixed to the wall. (see detail sheets)
- 3.9 Render to the masonry elevations need to be checked to eliminate any loose areas by removing.
- 3.10 The top of the brickwork walls forming gables to Dennis Street and Piccadilly also need to be checked for any loose bricks.
- 3.11 Cracking within the masonry elevations has been caused by thermal movement most of which should not cause any problems except for the cracked reveals to the old Piccadilly entrance. The external leaf needs to be tied back to prevent any further damage. (see detail sheets)
- 3.12 Finally we would recommend that the unstable partially demolished mezzanine wall is taken down back to a suitable safe location.

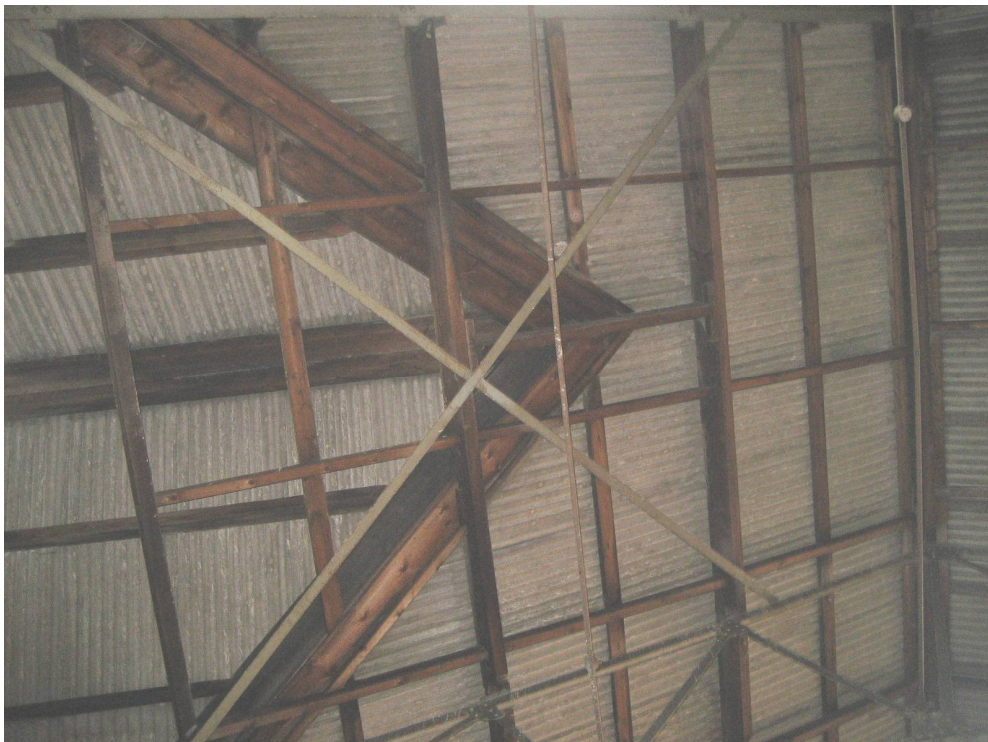
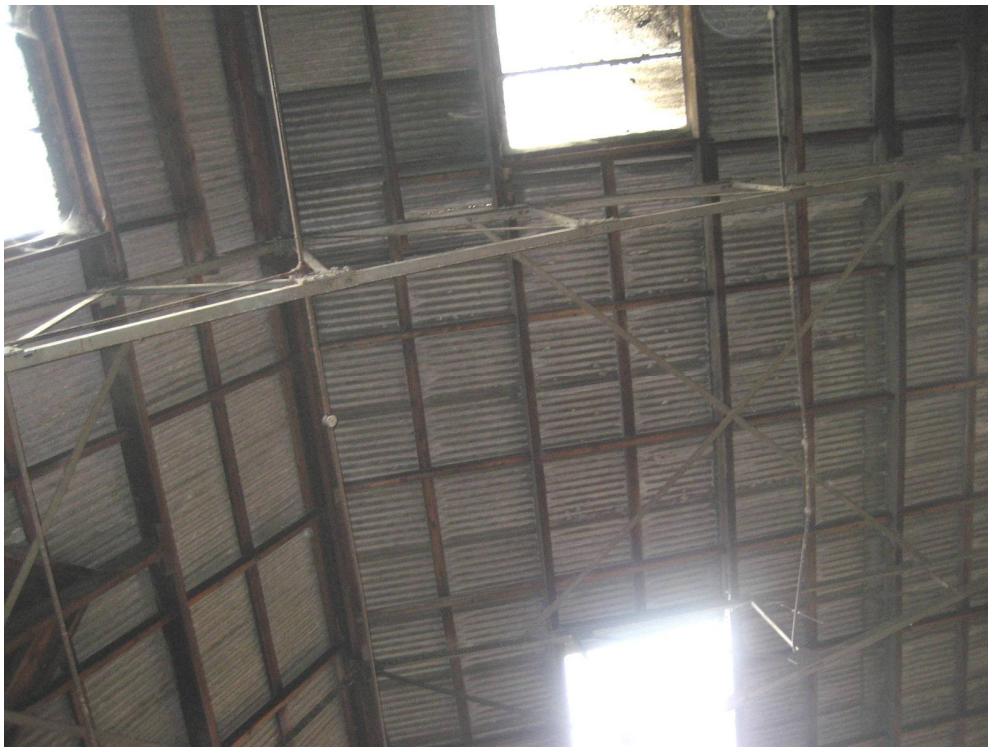
- 2.4 Approximately half way down the building there is cross bracing at top boom level of the truss. Although this does not completely extend down to the eaves or up to the apex but it is considered to be sufficient to transfer longitudinal wind loading to the side walls. (see photographs 52 and 53)

Photograph 52 Cross bracing in roof

Photograph 53 Cross bracing in roof

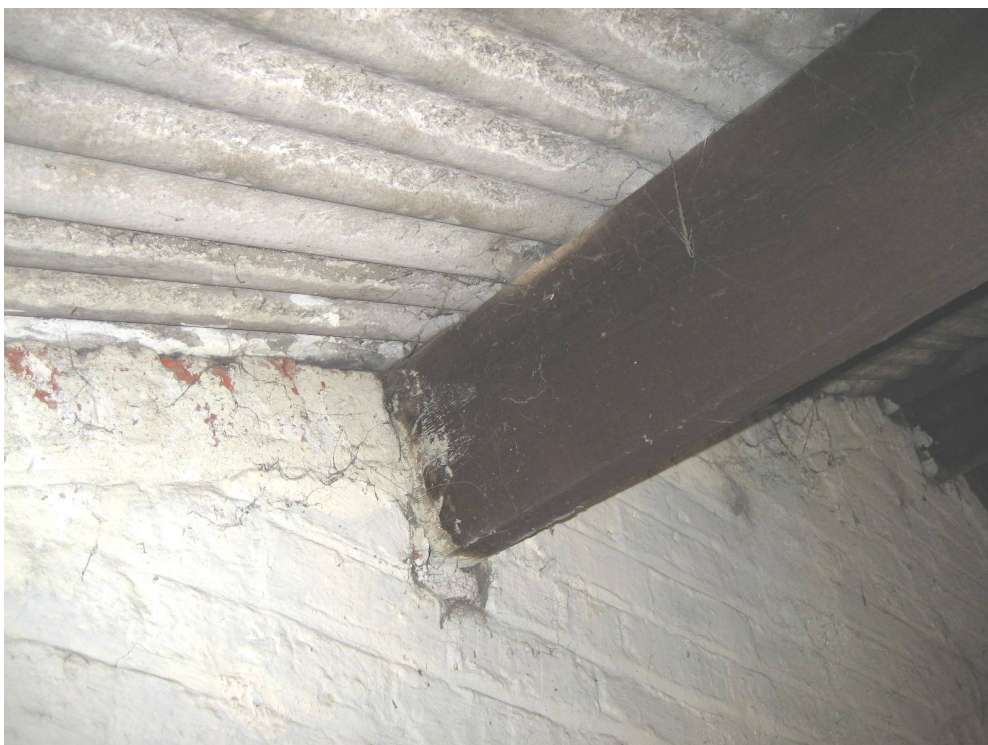
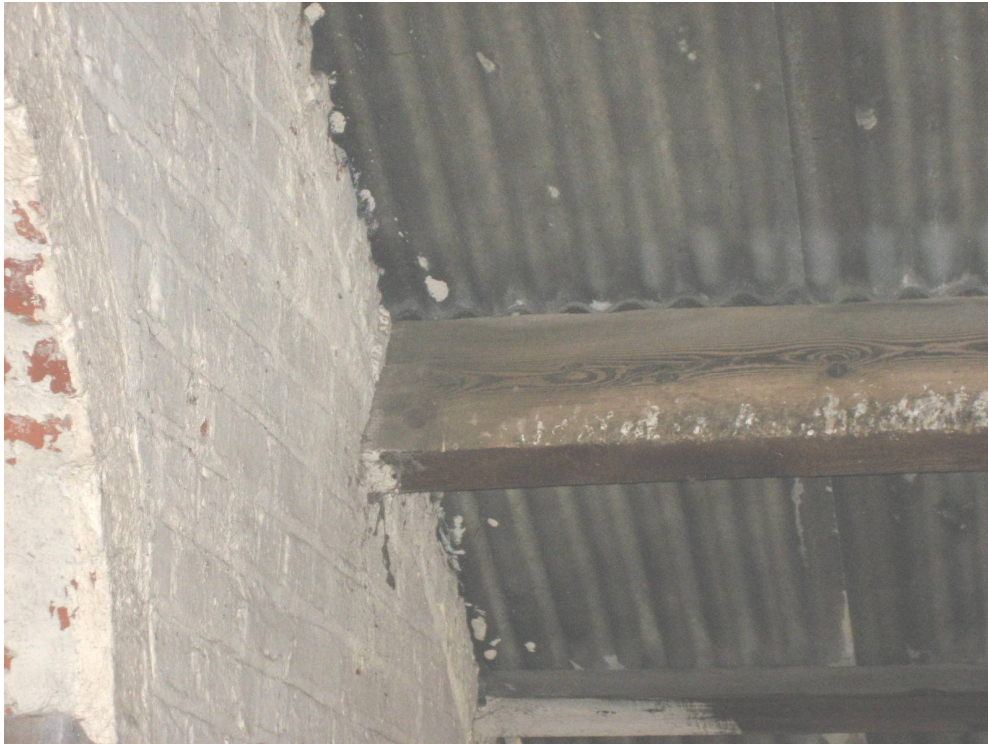
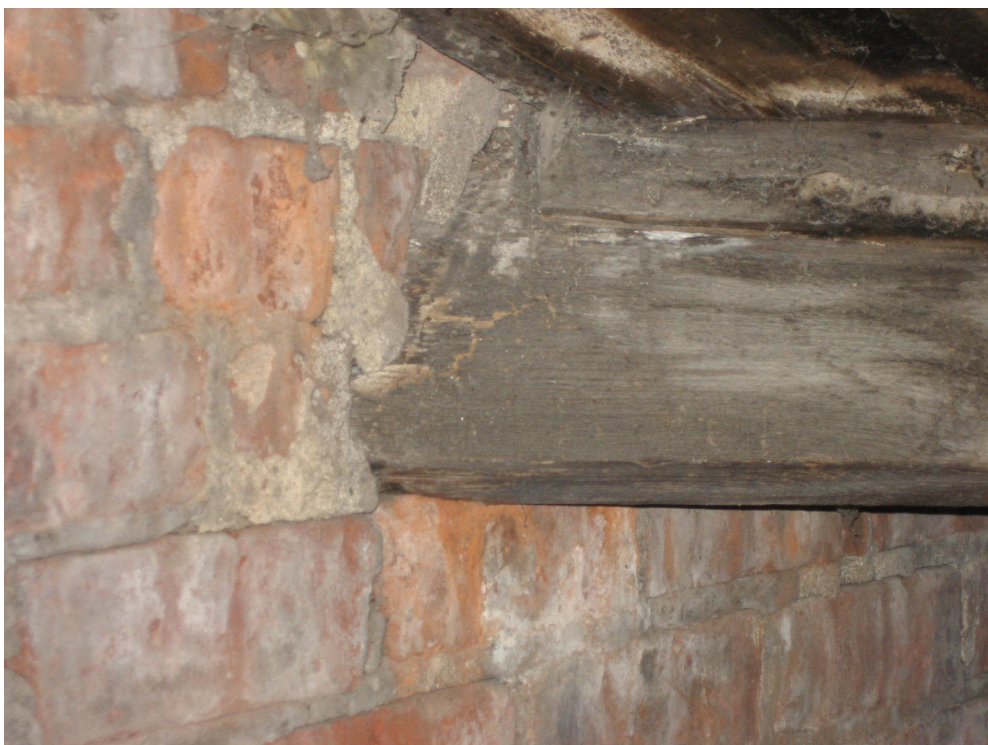
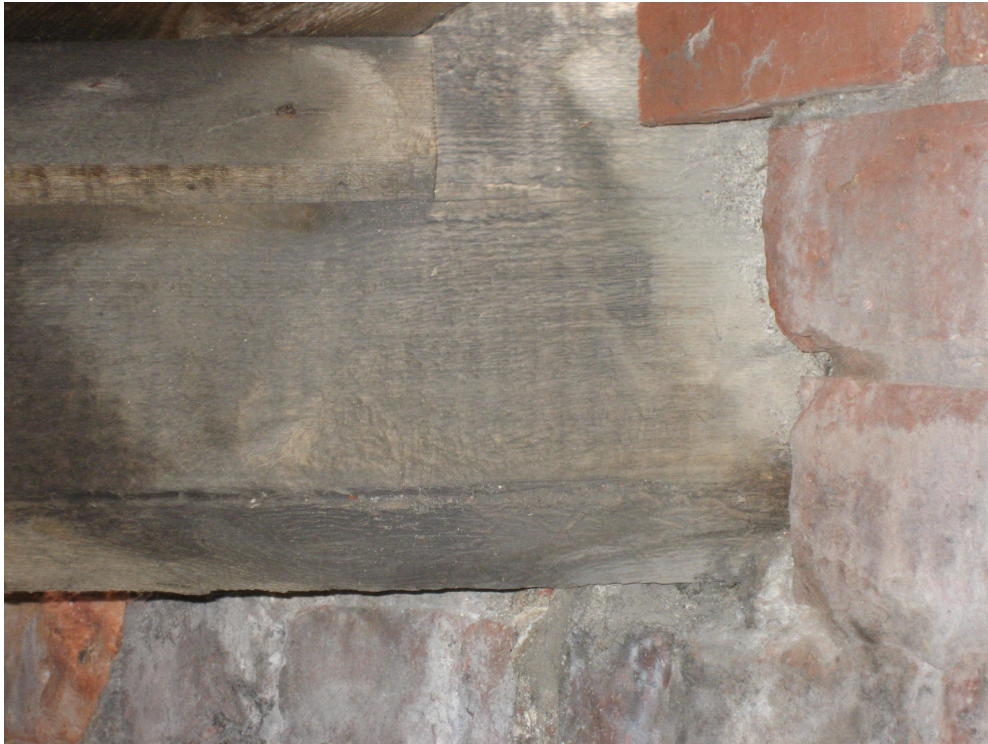
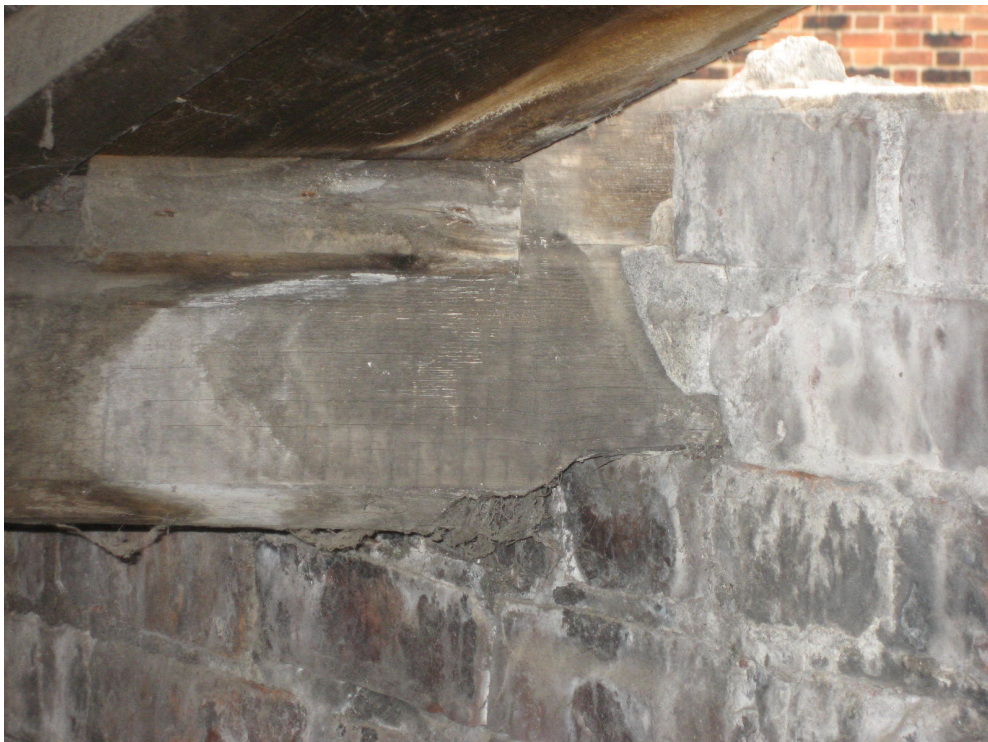
Photograph 54 Purlin bearing North West Entrance

Photograph 55 Purlin bearing North West Entrance

Photograph 56 Purlin bearing above Dennis St. Entrance

Photograph 57 Purlin bearing above Dennis St. Entrance

Photograph 58 Purlin bearing above Dennis St. Entrance
