York 13th August 2018 Section 19 Surface Water Flood Investigation

Revision Schedule
City of York Council

Executive Summary

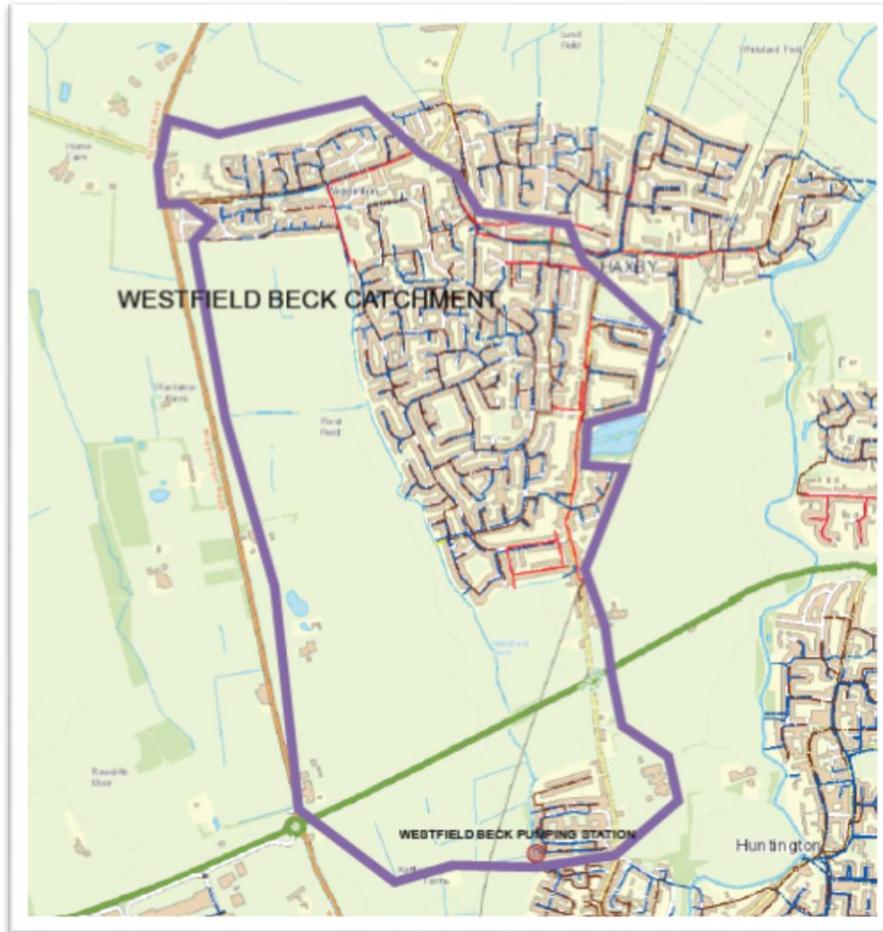
Figure 5 – Indicative illustration of area draining to Westfield Beck

Surface water drainage in Haxby & Wigginton effectively drains in two separate directions, the majority of flows drain south and west to Westfield Beck and are pumped by the Westfield Beck pumping station in times of flood, flows in the north east of the ward drain towards the Strensall system, Figure 5 below gives an indicative illustration of the area that drains to the Westfield Beck Pumping Station.

The pumping station is essential to ensure that the surface drainage system can discharge effectively and levels within the highway and surface water sewerage system that discharge to it are as low as possible. However, a range of investigations identified issues that were affecting the efficient drainage of the immediate highway or sewerage connections irrespective of the influence of the pumping station.

Westfield Beck pumping station is located to the north west of New Earswick, see location on Figure 5. In normal flow conditions river flow on Westfield Beck passes through the station and continues along the beck which ultimately joins the River Foss just upstream of the New Earswick and Huntington Link Road bridge.

In flood conditions a flow control penstock closes to restrict flows in the downstream section of Westfield Beck to 1 cumec (1 cubic metre of water per second) and all other flows are diverted in culvert to the River Foss in the east. This operation provides protection to communities in New Earswick.

Investigations have found that the automated penstock was not opening sufficiently, this will elevate levels upstream in normal flows as more flow is sent to the pumps, in addition to this one of the pumps was found to be not working, the IDB confirmed both issues were observed on the day.

Recommendation 13 - Westfield Beck, Yorkshire Water to ensure all aspects of the pumping station are included in their customer centre records to enable effective response when contacted by the public and partners.

Recommendation 14 - Westfield Beck, Yorkshire Water to ensure a full review of pump and penstock condition is completed and all necessary works are completed. Operational and control specifications for the station to be confirmed with City of York Council, IDB and Environment Agency.

Recommendation 15 - Westfield Beck, Foss (2008) IDB to work with Yorkshire Water to ensure a safe and sustainable approach to screen clearance is in place at the asset.

Recommendation 16 - Westfield Beck, Environment Agency and City of York Council to consider future improvement needs for the pumping station to deliver the benefits required as part of the York Flood Alleviation Scheme.
