## Annex A

### Case studies

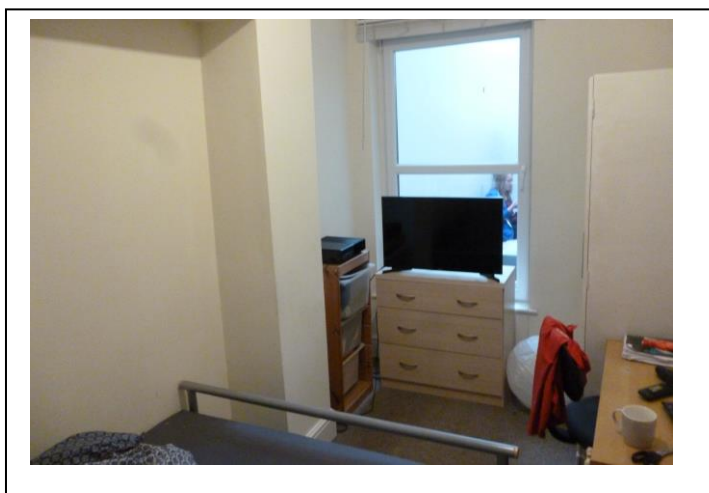
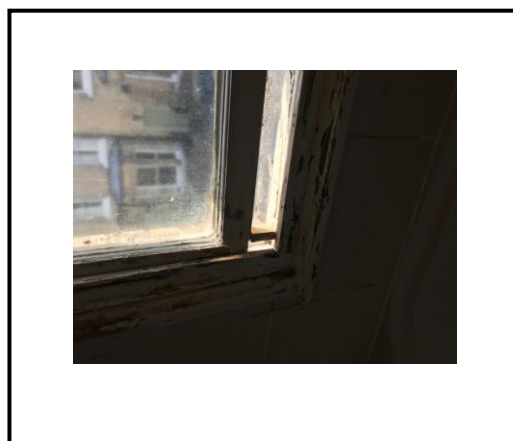
Bedroom 2 is in the middle of the house and sandwiched between bedroom 1, the communal kitchen / lounge area and the hallway. As a result of this, the bedroom has no outside window and no natural light or fresh ventilation. It does have a UPVC internal window which opens into the communal kitchen / lounge area, giving no privacy or any fresh air. In addition this window is also a fire hazard as it does not give a 30 minute fire resistance and is adjacent and looks into a communal kitchen.

The above hazards were scored under the HHSRS system for lighting and fire hazards, lighting scored a band C Cat 1 hazard, fire scored band F, Cat 2 hazard.

A suspended prohibition notice has been served

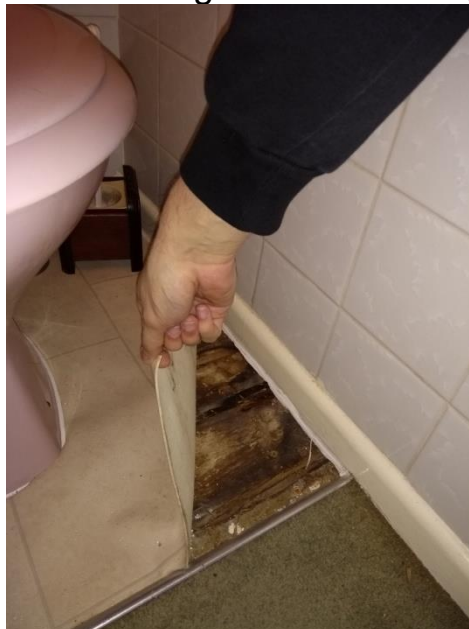
- Lack of fire detection and fire doors
- Built in appliances damaged and broken but not replaced by Agent
- Furniture in poor condition and not compliance with The Furniture and Furnishings (Fire Safety) Regulations 1988.
- External communal area (rear garden) overgrown and poorly maintained
- Lack of refuse receptacles – Agent advising tenants it's their responsibility to supply
- Leak to WC and bath (two separate rooms) which had cause water ingress to floor boards and damages floor covering (ongoing and not

addressed by Agent)

Conservatory to the rear had rotten windows causing water seepage and infestation of wood lice (potential Excess cold) unable to heat due to drafts around windows

Hazard awareness notice served for fire safety and management regulations breaches served for failure to maintain property.
