| <b>CITY OF<br/>YORK<br/>COUNCIL</b> | <b>Stage 1/2</b><br><b>Road Safety Audit Report</b> |

| Safety Audit Ref | 25/016 | Version no. | 01 |
| Scheme Title: | Outgang Lane to G&T site – Road Safety Improvements | | |
| Site Location details: | Outgang Lane, Osbaldwick | | |

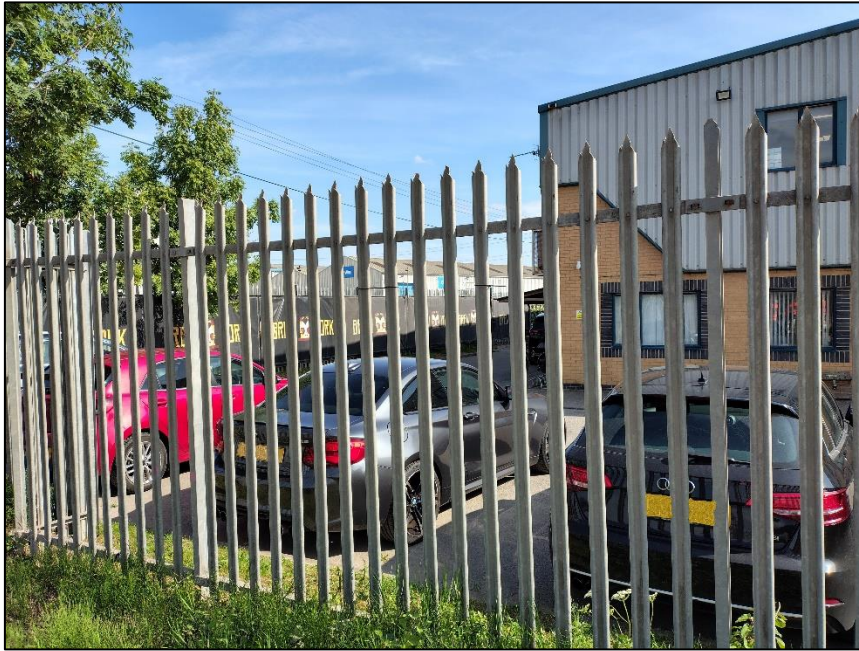
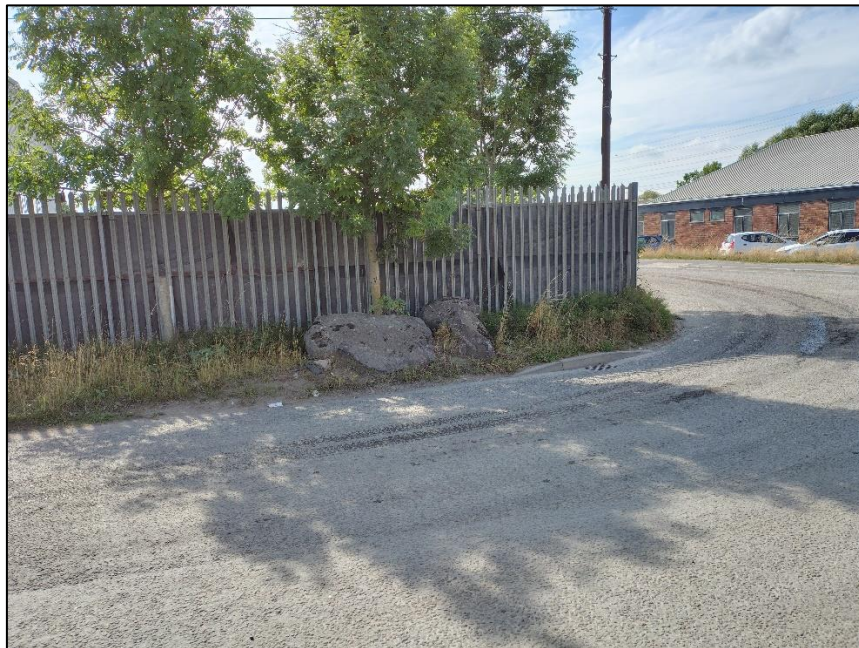
| PROBLEM – Ref: 5.1.2 | |

| PROBLEM – Ref: 5.1.2 | |
|---|---|
| <b>Summary:</b> | <b>Head on collision risk</b> |
| The tighter bend created by the new footway forces left turning vehicles across to the offside to negotiate the bend. This introduces a risk of head on collisions. | |
| This issue is exacerbated by the hoarding on the fence at Brew York which removes visibility between vehicles at the critical point (see photos). | |

A bend warning sign to Diag no. 512 with supplementary plate "Oncoming vehicles in middle of road" should be provided on the approach to the bend.

Discussions should be held with Brew York to explore removal of the hoarding to assist with visibility.

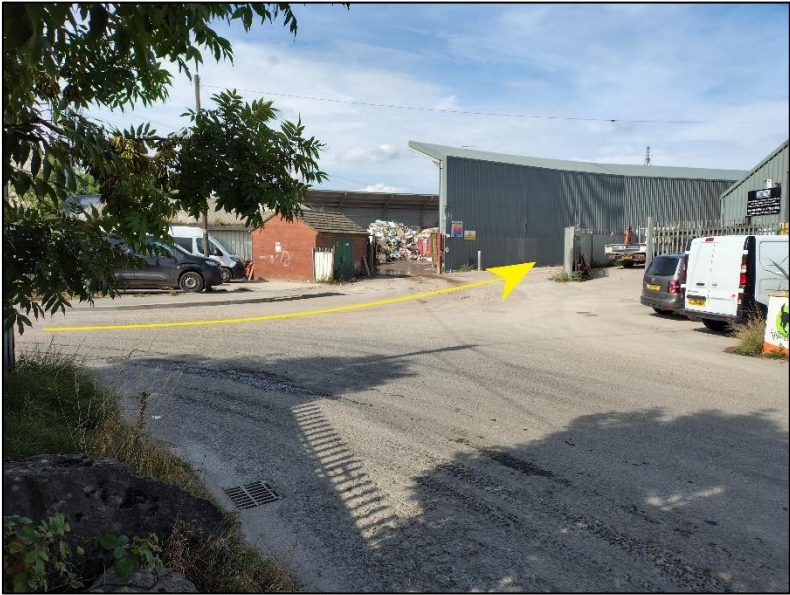
| PROBLEM – Ref: 5.1.3 | |
|---|---|
| <b>Summary:</b> | <b>Speed of entry in conflict with vehicles from the right</b> |
| <p>The current access to Blacker Steel Fabrications doesn't slow traffic as they enter or promote vehicles to slow as they approach the bend. This is in an area of direct conflict with vehicles negotiating the left-hand bend as they approach from the east. This could result in serious collisions or loss of control if fast approaching vehicles try to brake heavily and steer on the dusty access road.</p> | |

| PROBLEM – Ref: 5.1.3 | |
|---|---|
| <p>The alignment of the entrance should be amended to slow traffic into the site. Additionally the signs recommended in problem 5.1.2 should help to reduce traffic speeds into the bend.</p> | |

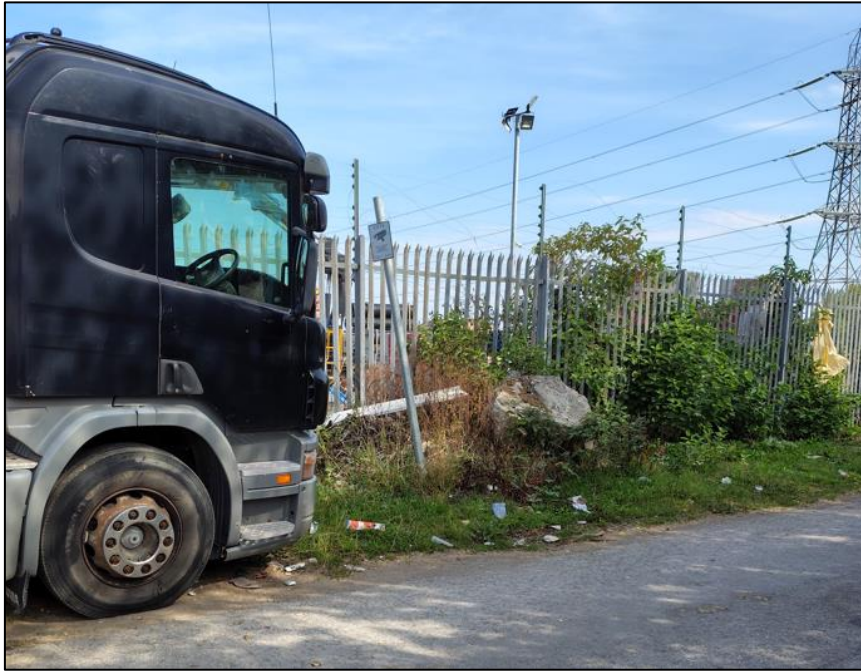
| <b>PROBLEM – Ref: 5.1.6</b> | |

| <b>Summary:</b> | <b>Risk of vehicles striking a rock</b> |
| There is a rock in the verge opposite Waggy Dog (pictured below) which could pose a risk to vehicles mounting the verge if it is overgrown with vegetation. | |

The rock should be removed from site.

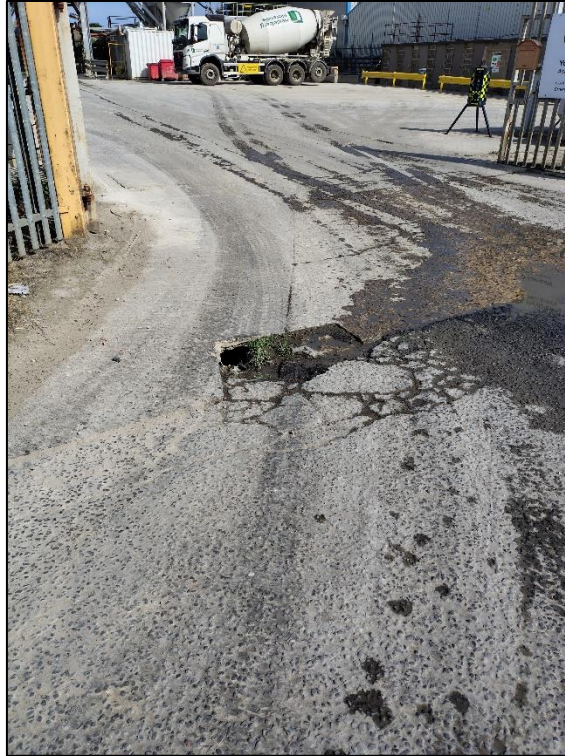
7.1 – There is evidence of a void below the carriageway at an existing carriageway failure in the Heidelberg access. Additionally, a water leak from Keyline was flowing west along the carriageway to this point (see photo below). This may need further investigation before any construction works take place.
