**The Royal Society for the Prevention
of Accidents**

Water Safety Review for:
City of York Council

04 September 2014

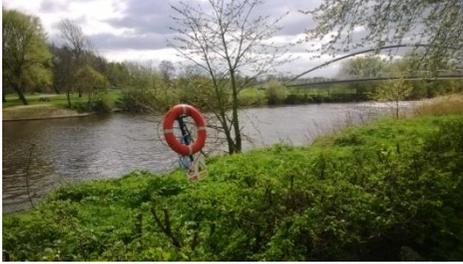
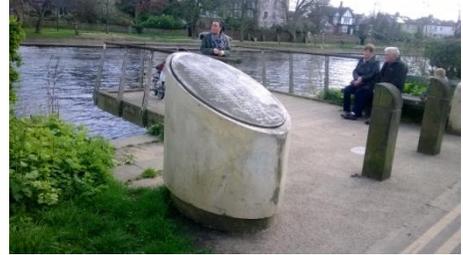
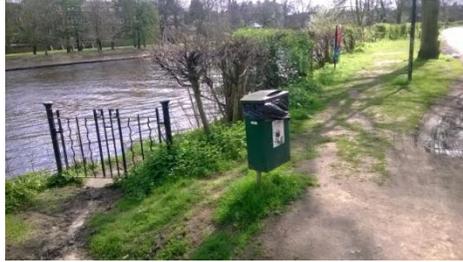
# 1	West bank from Millennium Bridge to Rowntree Park	45
<p><u>Description:</u></p> <ul style="list-style-type: none"> Well made pathway/ roadway well away from the river. Viewing platforms provided. Viewing platforms steps have no handrails. Life rings are provided at regular spacing's along the bank as with other locations recovery lines were in a tangled condition. One unit was not easy to reach as its location has become very overgrown; this was the only unit with safety signage provided. The post and wire fence has become damaged over time but the hedging has failed to become fully established. <p><u>Incident history:</u></p> <p><u>Mitigation options:</u></p> <ul style="list-style-type: none"> Wire horizontal bars need to be repaired to maintain integrity/ strength as these have become unacceptably slack. The post and wire fence should be re-established in areas where the hedge does not provide a full barrier Handrails should be provided if people are invited down to the water's edge at this location. The unit should be moved and signage provided on all housings <p><u>Other comments:</u></p>

<p>Principle hazards observed</p> <p><u>Water</u></p> <ul style="list-style-type: none"> Viewing structure - fall/height Deeper cold water. 	<p><u>Other</u></p> <ul style="list-style-type: none"> See comments relating to the Bridge

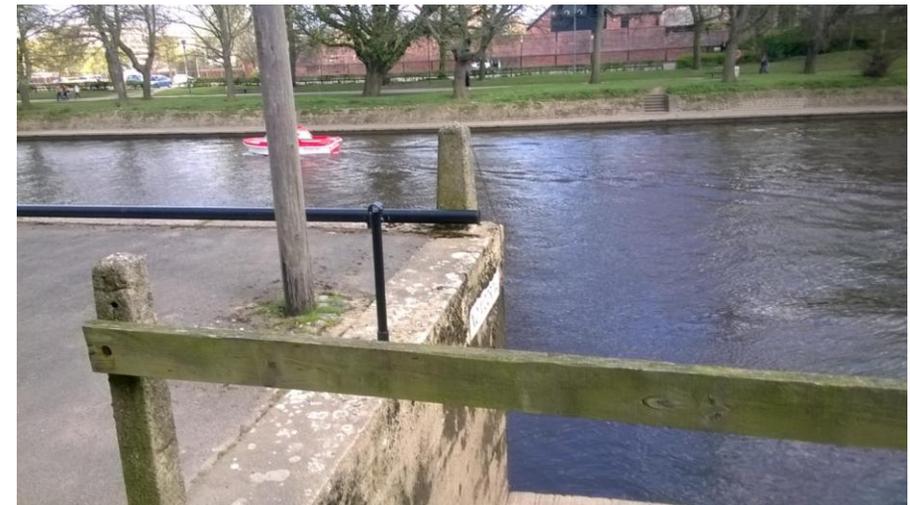
2 West Bank(riverside pathway) from Rowntree park along Terry Avenue to Skeldergate Bridge along Skeldergate with access checked towards Ouse Bridge

<p>Principle hazards observed</p> <p><u>Water</u></p> <ul style="list-style-type: none"> • Vehicle access/ Turning Circle on Queens Staith • Access to moorings • Access to boats moored by riparian owners • Moorings. 	<p><u>Other</u></p> <ul style="list-style-type: none"> • Riparian ownership restricts access 	
<p><u>Access:</u> Skeldergate.</p> <p><u>Site reviewed:</u> 10/04/14</p>

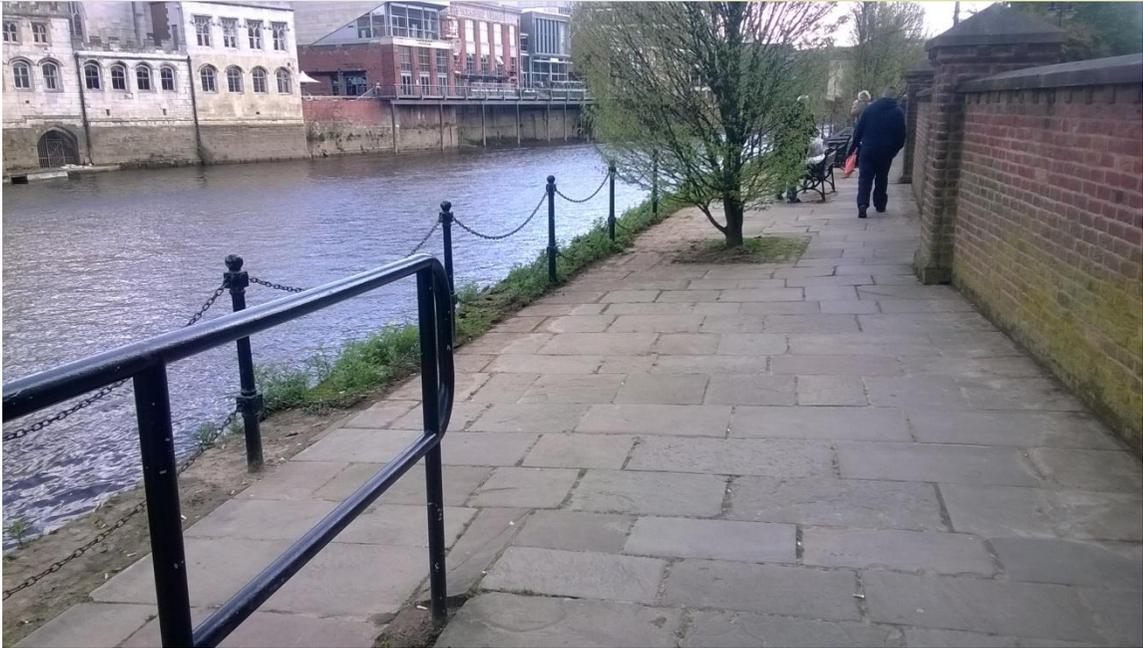
- Post and chain fence offers little pedestrian protection and would not necessarily provide adequate protection from a slip or trip on the footpath, e.g. from the slope from the bridge.
- Trees and the setting provide an obstacle and obscure the footpath, but do encourage people to walk landside.
- Steps down to the lower level are very steep and no handrails are provided. The opening is not gated or chained which is an inconsistent approach
- Life ring provided on wall, no other signage noted in this location.
- Improved fencing and walls here, but handrail in poor condition and missing in some points on steps to bridge – to be repaired.

- Repair and improve edge protection

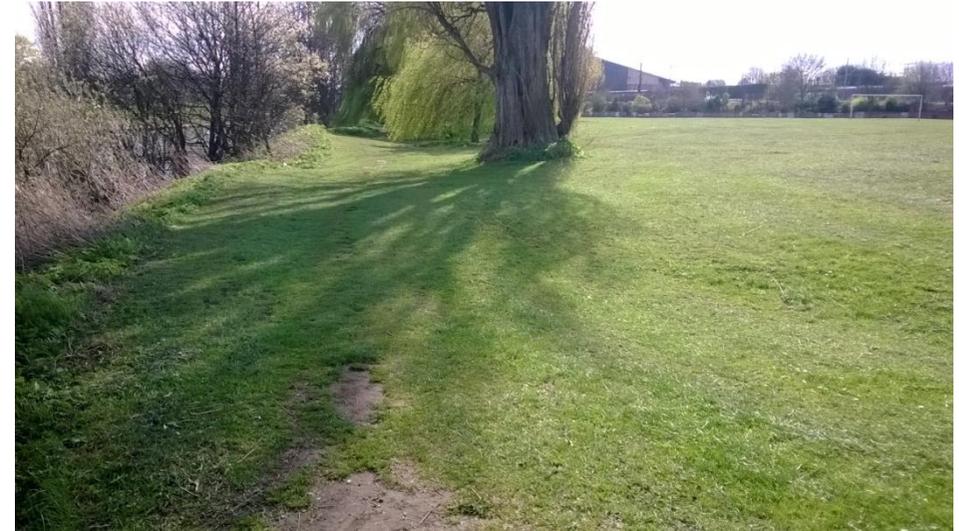
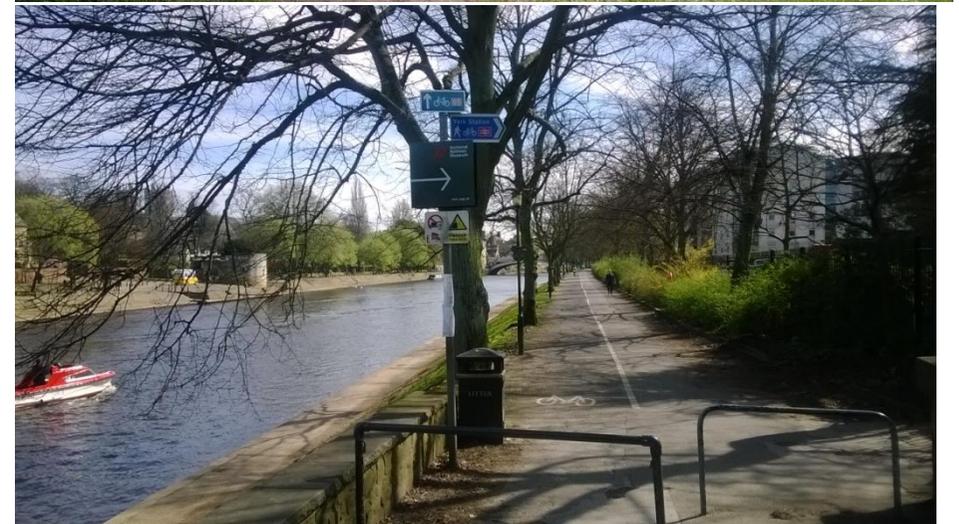
4 West bank, from Lendal Bridge to Clifton Bridge, Water End Road

<p>Principle hazards observed</p> <p><u>Water</u></p> <ul style="list-style-type: none"> • Lack of pathway • Popular walking route • Steep slope to water 	<p><u>Other</u></p> <ul style="list-style-type: none"> • Hire boats causing disruption for rowers due to not following speed limit, wearing PRE or following the river code of conduct 	
<p><u>Access:</u> Jubilee Terrace or opposite bank</p> <p><u>Site reviewed:</u> 10/04/14</p>

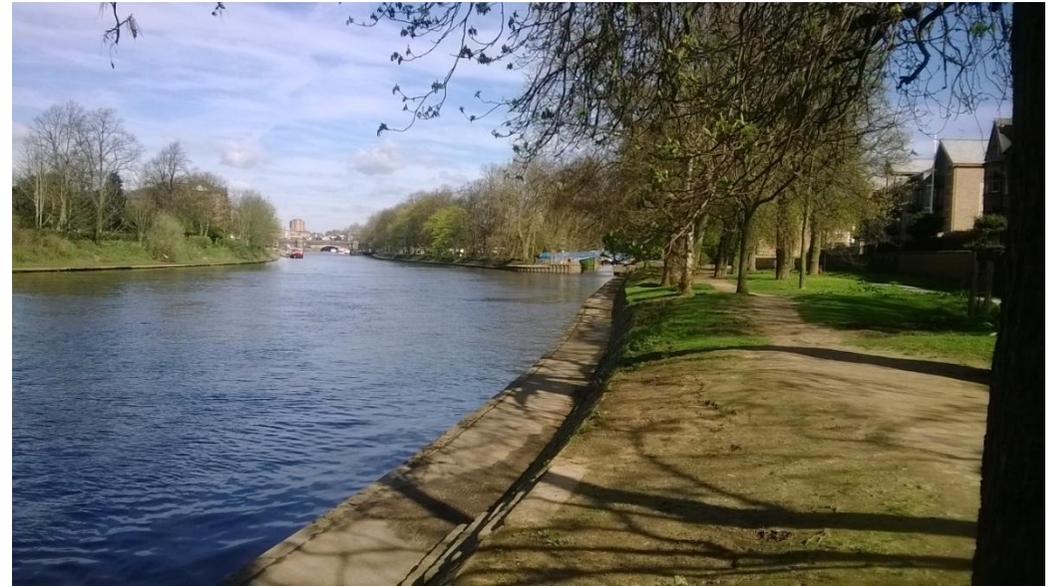
- Car park has bollards, knee rails and hedging provided to delineate the car park area from the riverside walkway. No signage is provided at entry points to the riverside walkway, but no swimming and danger deep water signage provided on other side of bridge – this signage would be better placed at the entry point and lower to be more visible

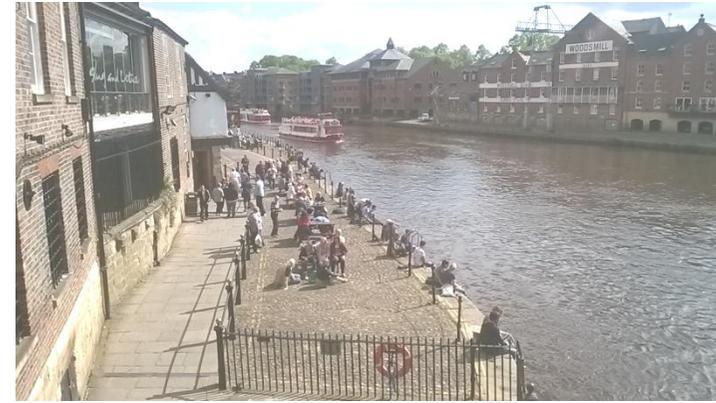
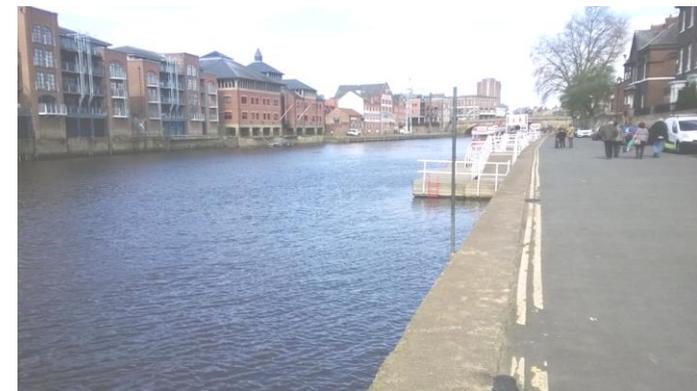
- This is a very popular area with high footfall and bars close by.
- The coping stones/edge and drains are indistinct and could lead to a trip into the water.

- There is a pronounced ledge parapet on the Ouse Bridge which people could use to jump into the river.

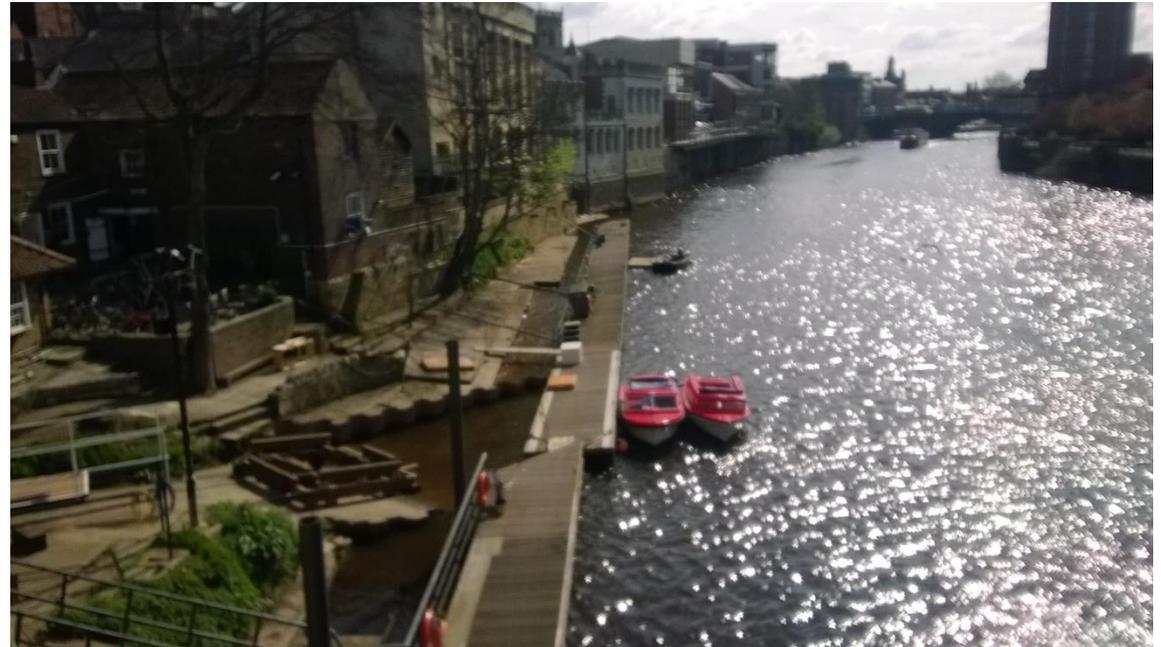
- Access to the water is protected by suitable railings.
- Terrace to rear of bars shows memorial to Anthony Horrocks who died in 2011. In need of renovation. No swimming or diving signage provided under the memorial, and along the fencing at other locations.

<p>Principle hazards observed</p> <p><u>Water</u></p> <ul style="list-style-type: none"> • Fall • Alcohol related incidents 	<p><u>Other</u></p> <ul style="list-style-type: none"> • Lack of familiarity with floating pontoons by public 	
<p><u>Access:</u> Via Ouse or Lendal Bridges</p> <p><u>Site reviewed:</u> 10/04/14</p>

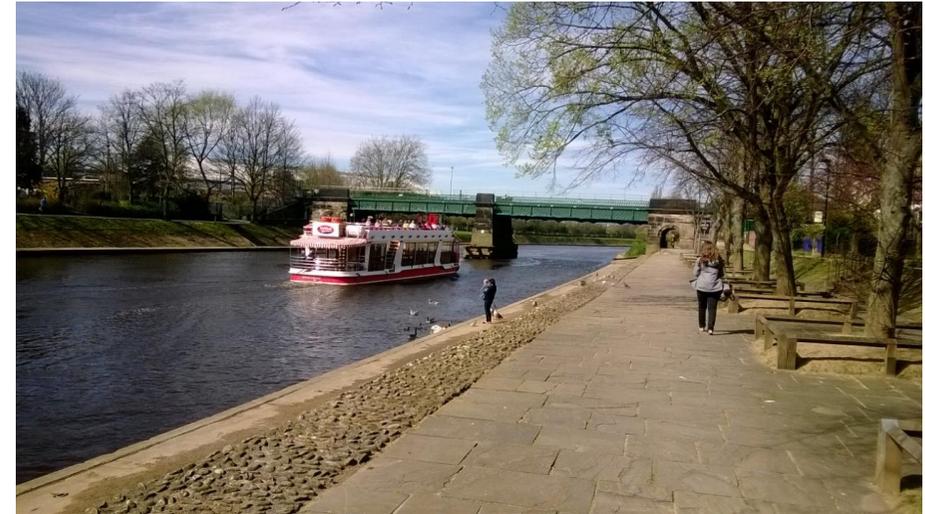
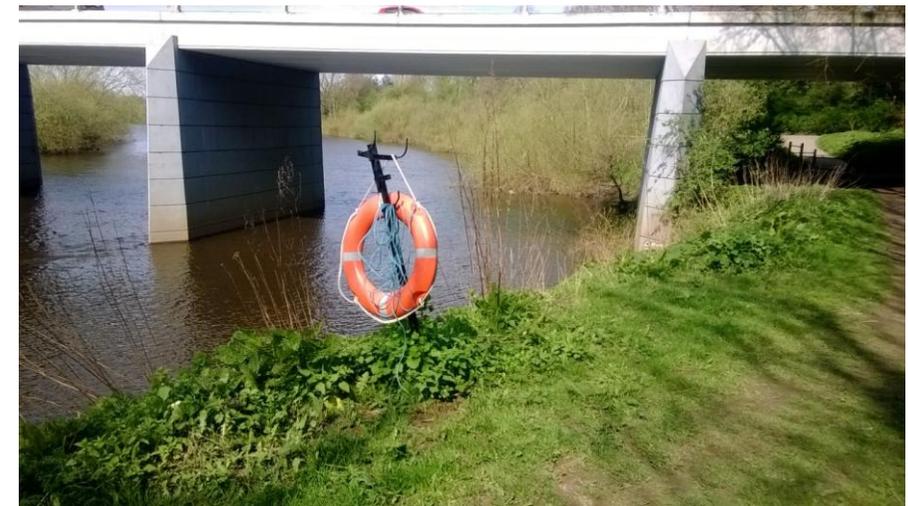
- Narrow walkway has edge protection provided, the opening out to riverside walk with no edge protection. The embankment is visually distinguishable by cobbles, there are steps down to the lower tier, and a small number of these steps have handrails down to the water's edge.

- Evidence of dog and pedestrian access near to bridge, steps on southern side have no handrail but appear to be well maintained and vegetation has been cleared to maintain visibility of edge.

<ul style="list-style-type: none"> No safety signage on post at junction of esplanade, No swimming signage should be provided. <p><u>Incident history:</u></p> <p><u>Mitigation options:</u></p> <ul style="list-style-type: none"> Repair edges and coping stones Indicate separate pedestrian/ cycle routes Improve life rings along stretch Improve signage at entry points <p><u>Other comments:</u></p>	
<p>Principle hazards observed</p> <p><u>Water:</u></p> <ul style="list-style-type: none"> Edge profile Collisions Use of lower mooring areas by very young children and vulnerable adults 	<p><u>Other</u></p>
<p><u>Access:</u> Foot via Dame Judy Dench Walk</p> <p><u>Site reviewed:</u> 10/04/14.</p>

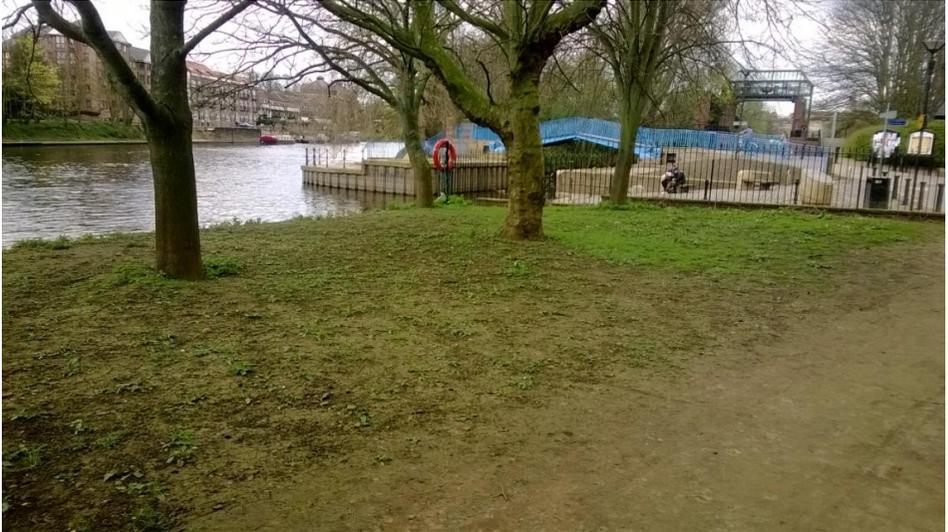
# 9	Blue Bridge and confluence with Ouse	58
<p><u>Description:</u></p> <ul style="list-style-type: none"> • Very popular route • The edge protection for the bridge (Blue railings) does not return around the corner, where the ground falls away quickly, therefore there is a lip on the edge of the bridge. As this bridge is used by a high number of cyclists, pedestrians, and (on the day of the visit) nursing mothers. There is a risk of a collision or slip, resulting in a fall down the bank and into the water. Consideration should be given to extending the fencing around the corner to prevent this. • There was evidence of the slipway here being used for street drinkers to congregate. • There is a slightly increased risk of drowning in this spot. The operation of the lock will produce underwater currents which may not be obvious from the surface. • The nearest life ring was in poor condition and should be repaired and replaced. • There was also no signage provided on the life ring post <p><u>Incident history:</u></p> <p><u>Mitigation options:</u></p> <ul style="list-style-type: none"> • Fencing • Signage and life ring improvements <p><u>Other comments:</u></p>

<p>Principle hazards observed</p> <p><u>Water</u></p> <ul style="list-style-type: none"> • Lock • Slipway • Collisions 	<p><u>Other</u></p>

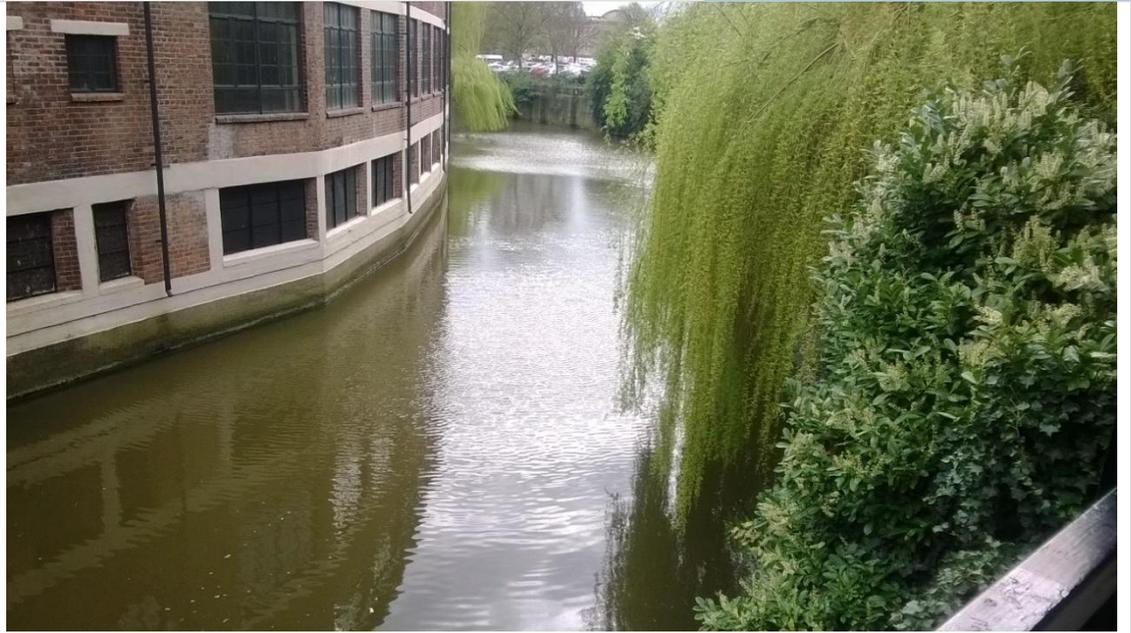
11 Castle Mills Bridge along Piccadilly bridge (both sides)

Water
Falls from sitting on railings

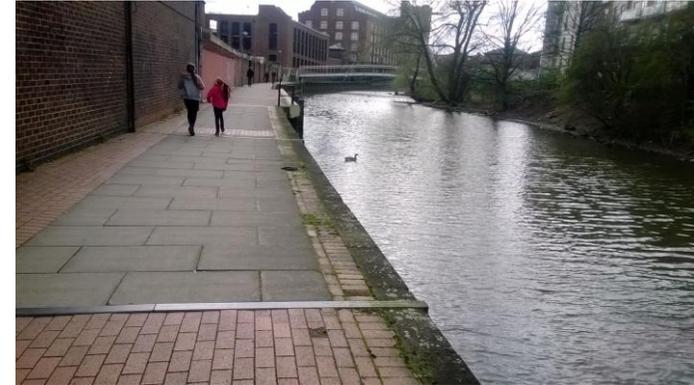
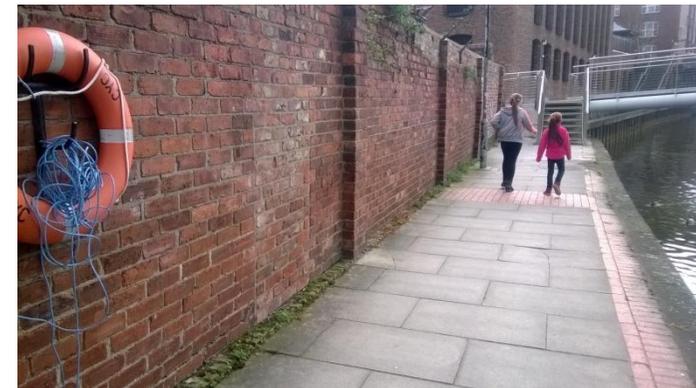
- No edge protection and high freeboard into water.
- No grab chain along lower part of pathway – exit would require swimming along/ across the river to the opposite bank.
- Both life rings are in a poor condition
- Many changes in surface materials indicating a high risk of trip hazards over time as materials move.
- Old wharf features which are attractive as play features to children (children overheard suggesting they had played a game of leaping between them)
- Old pedestrian bridge has been closed
- Fencing older style metal 4 rail fence, old but serviceable condition, flat wide pavement
- Life rings provided on private properties on far bank – appear to be inaccessible
- It was unclear why the balcony feature had exclusion fencing provided.
- Handrail and textured surface applied to old boardwalk to reduce slipping – good feature

- Steps slip/trip/fall on river left
- Height and remains of sluice structure.
- Signs of alcohol use adjacent to sluice.

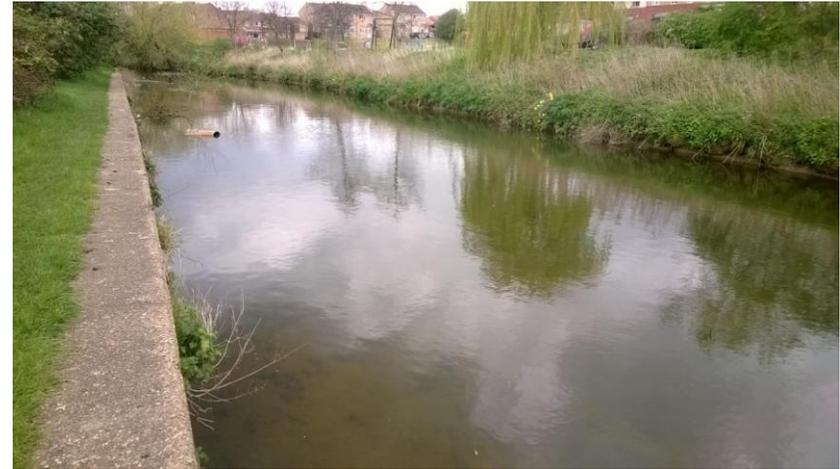
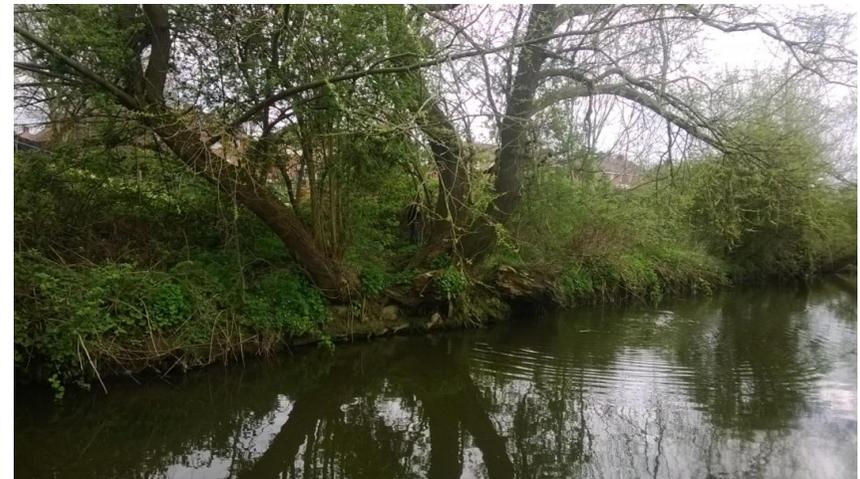
- Life rings provided in park in visible locations. No signage provided, many opportunities for children to feed the water birds. Many birds indicating a popular feeding spot. Tactile paving to parts of the edge.

<p>Principle hazards observed</p> <p><u>Water</u></p> <ul style="list-style-type: none"> • Freeboard • Trips and unclear walking routes. 	<p><u>Other</u></p> <ul style="list-style-type: none"> • Playing near to water • Underwater debris and planting 	
-------------------------------------------------------------------------------------------------------------------------------------------------------------------------	-----------------------------------------------------------------------------------------------------------------------------------------	--

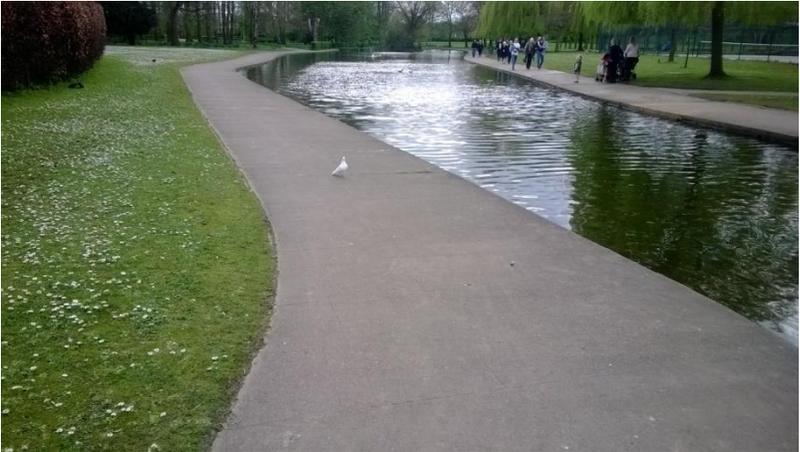
# 16	Rowntree Park	24
<p><u>Description:</u></p> <ul style="list-style-type: none"> • Two joined ornamental ponds provided. Both ponds are shallow. The main risk is for slipping and for unattended small children. • No fishing signs are provided, the pathways are in generally very good condition with some areas beginning to break up, particularly around the bridge area. <p><u>Incident history:</u></p> <p><u>Mitigation options:</u></p> <ul style="list-style-type: none"> • A regular inspection should be conducted to ensure that repairs are made before the surface crumbles and becomes a trip hazard close to the water • A regular programme of cleaning the pathways of bird mess and clearing the water of litter and detritus should be continued to ensure that high levels do not build up and cause physical and biological issues <p><u>Other comments:</u> No significant or unusual hazards noted</p>

<p>Principle hazards observed</p> <ul style="list-style-type: none"> • Shallow water for unsupervised young children 	<p><u>Other</u></p>

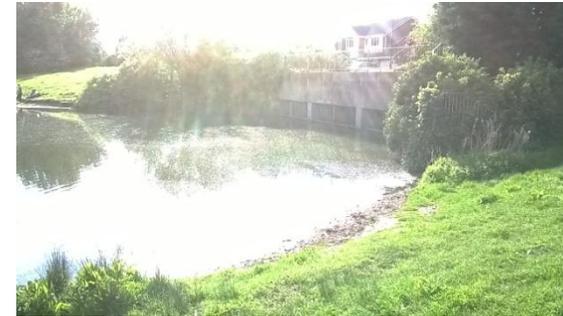
- Medium sized attenuation reservoir linked to Dale Dyke, adjacent to Rawcliffe Infant and Junior school.
- Two sluice structures at either end of lake, along with overflow channel form Dyke.
- The majority of lake hinterland is open grass with a shallow aspect.
- Path set back between 3-5metres.
- A number of small floating (bird) islands sit some 70metres out.
- Signage notes 'no boating' and 'alcohol' and 'deep water'.
- Perry Buoy PRE used at several points around lake, with buoys in housing.

Other comments: Signs of teenagers fishing and numerous dog walkers (at c.7pm). Verbal reports of swimming at location. School routes are nearby.
