ANNEX E

This annex contains the reports from Engineering Consultants on the locations that were put forward for Engineering consideration in the Decision Session in December 2009.

Speed Management Scheme
B1228 Elvington Lane, Elvington

B1228 Elvington Lane (ref SM02/09) – Investigation Report

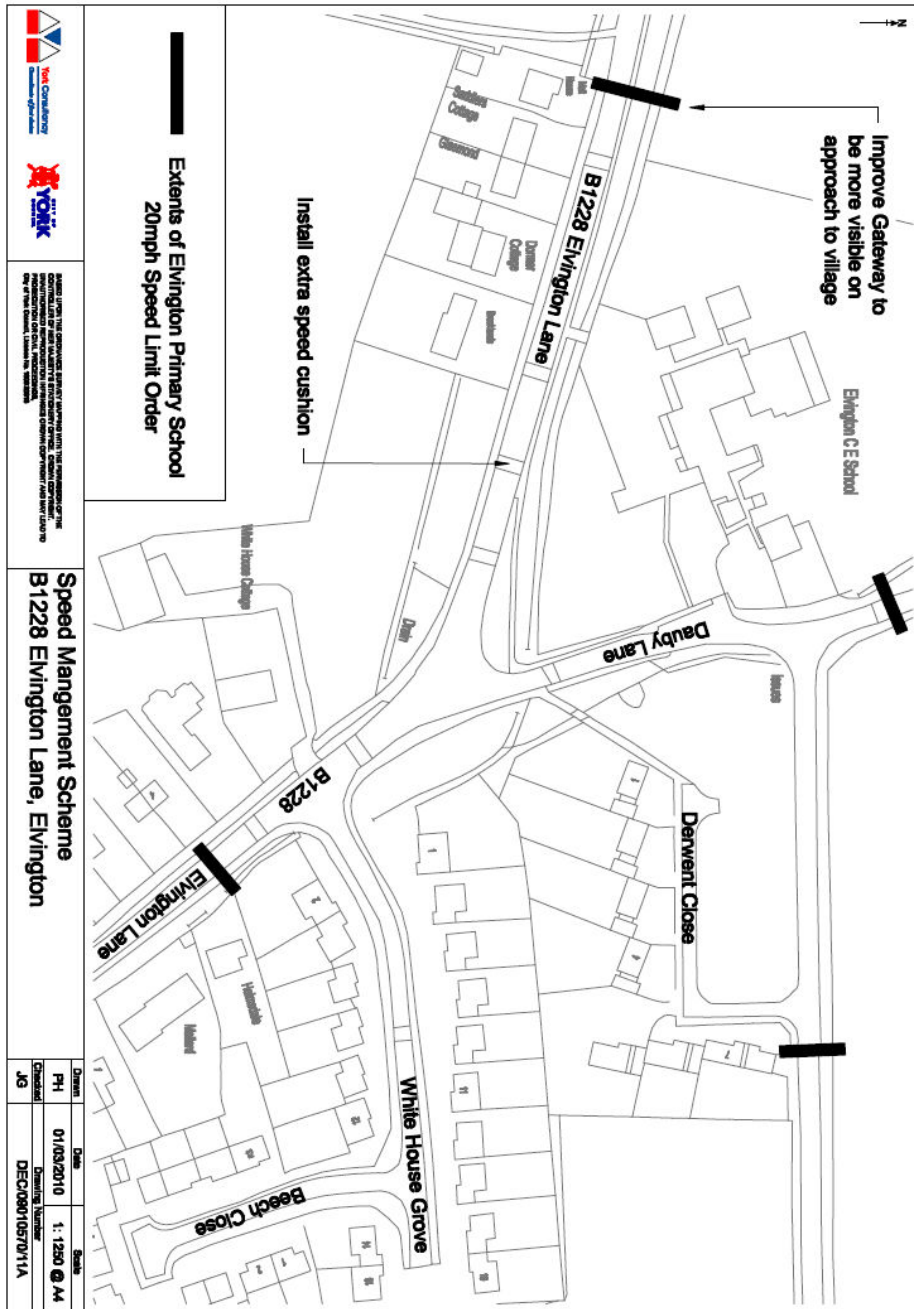
Speeding in the 20mph speed limit.

There is a 20mph zone on Elvington Lane in the vicinity of the school. The area is traffic calmed with speed cushions.

The mean speed of eastbound traffic was 23mph with an 85%ile speed of 28mph. Westbound the mean and 85%ile speeds were 25mph and 30mph respectively.

The area is already traffic calmed with speed cushions on Elvington Lane but there may be scope to increase the number of cushions as these are spaced at some distance apart (around 50 metres).

Because the speed limit changes from a 40 mph to a 20 mph limit it is important that the gateway is made more visible and robust with possible localised narrowing, dragon's teeth road markings, rumble strips, etc. to ensure that speeds are reduced as vehicles enter the 20 mph zone allowing the vertical measures to keep the speeds low. Hitting a speed cushion at speed could cause damage to the vehicle and / or its leaving the carriageway.

The existing gateway should be made more robust to ensure speeds are reduced on entering the 20 mph zone. Consider an extra speed cushion midway between the second and third cushions on the eastern approach along Elvington Lane.

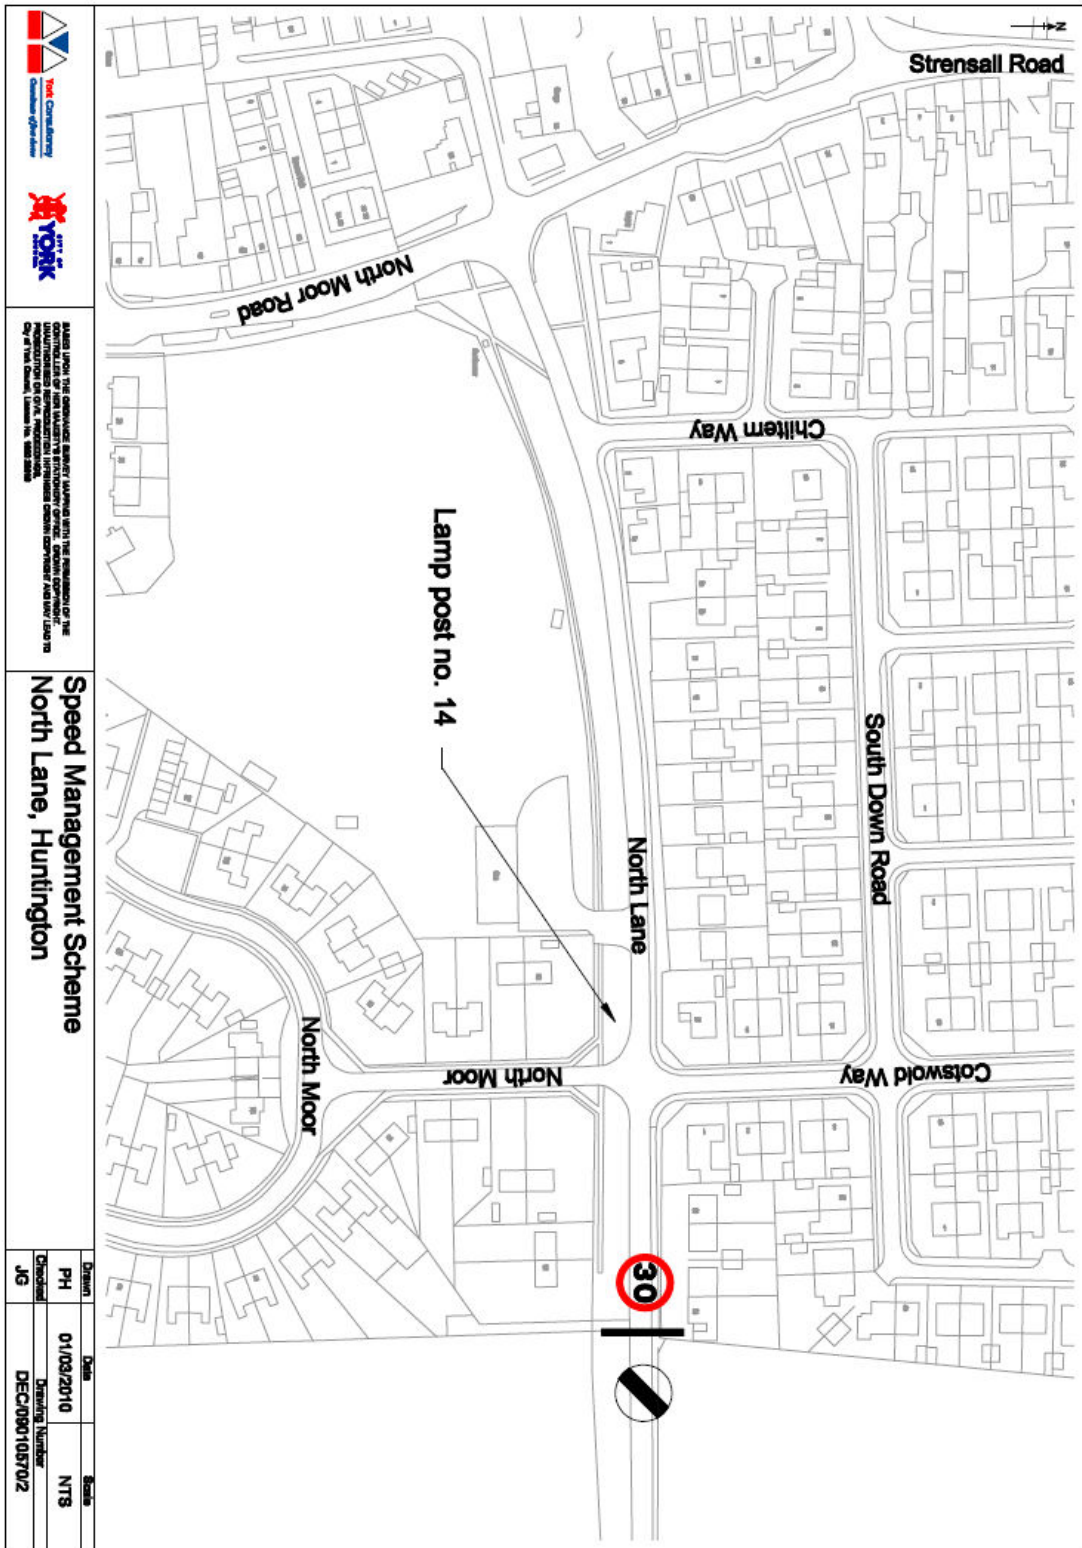
Speed Management Scheme
North Lane, Huntington

Speeding vehicles entering Huntington on North Lane.

The speed limit changes from national speed limit to 30mph at the start of the residential development when travelling east to west. The existing signing consists of 600mm diameter 30mph/national speed limit signs on posts in the verge.

Mean speeds recorded by the Fire and Rescue Service as 28mph and 85th percentile speeds 40mph. Data recorded at lamp column no 14 (see location plan) but direction of travel not known.

Pursue an improved gateway at the start of the 30mph speed limit.

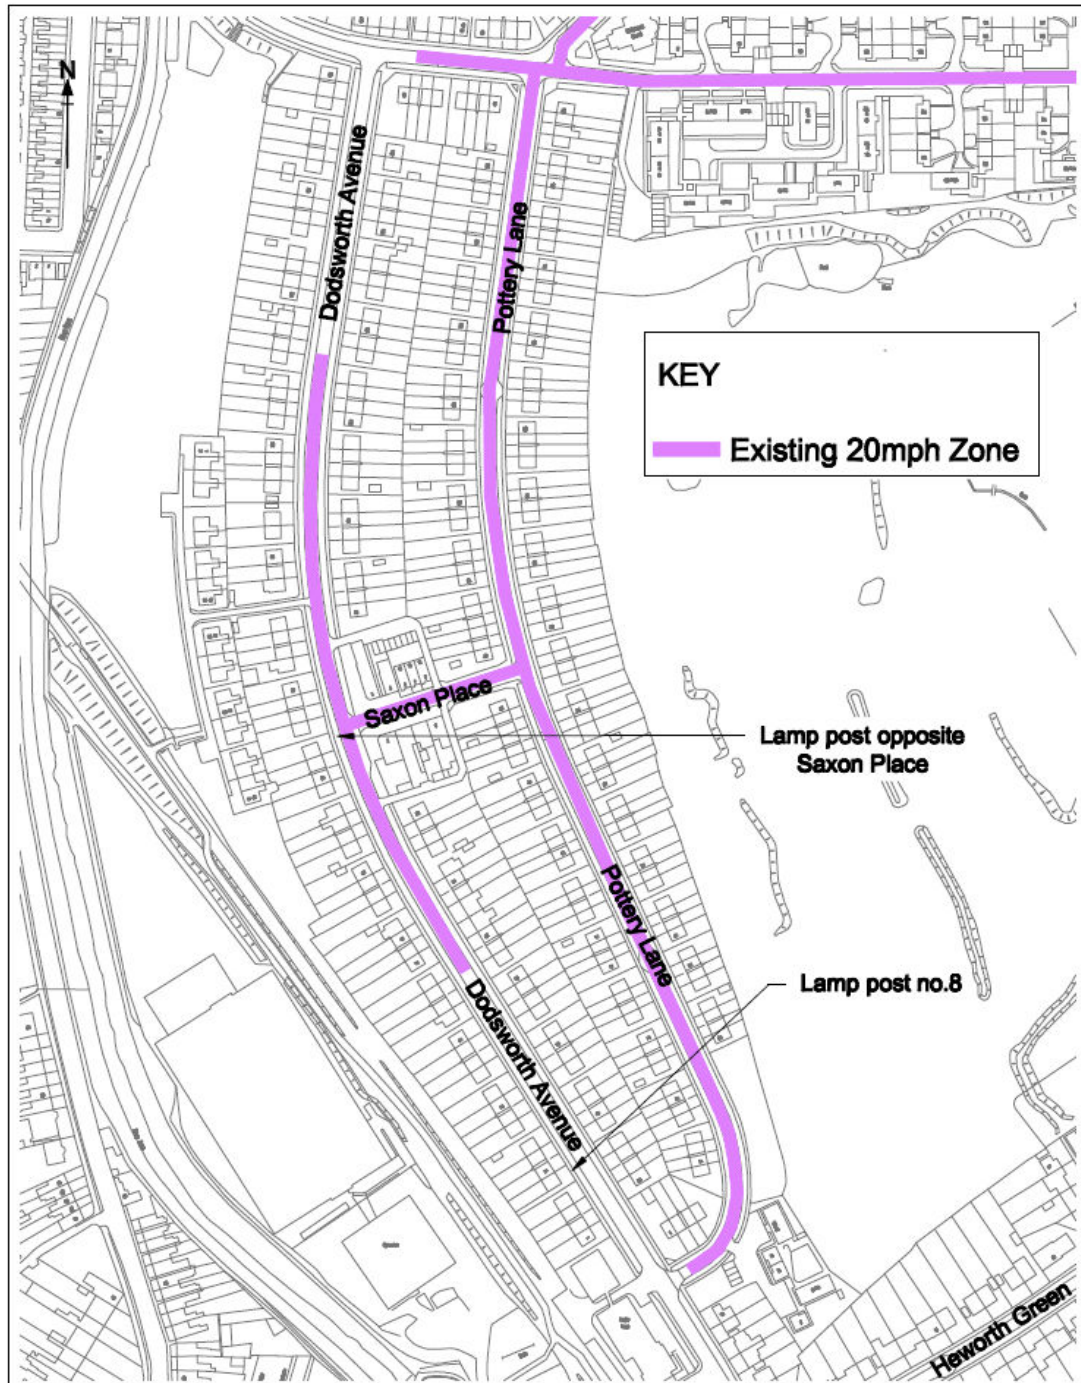
Speed Management Scheme Dodsworth Avenue, Heworth

Concerns over inappropriate speeds in a residential street.

Mean speeds recorded in the 20mph limit by the Fire and Rescue Service as 20mph and 85th percentile speeds 27 mph. Data recorded at the lamp column opposite Saxon Place (see location plan) but direction of travel not known.

The existing markings on the road humps and zebra crossing are faded and would benefit from being refreshed.

Refresh the markings on the road humps and zebra crossing.

Do speed surveys to assess justification for a VAS.

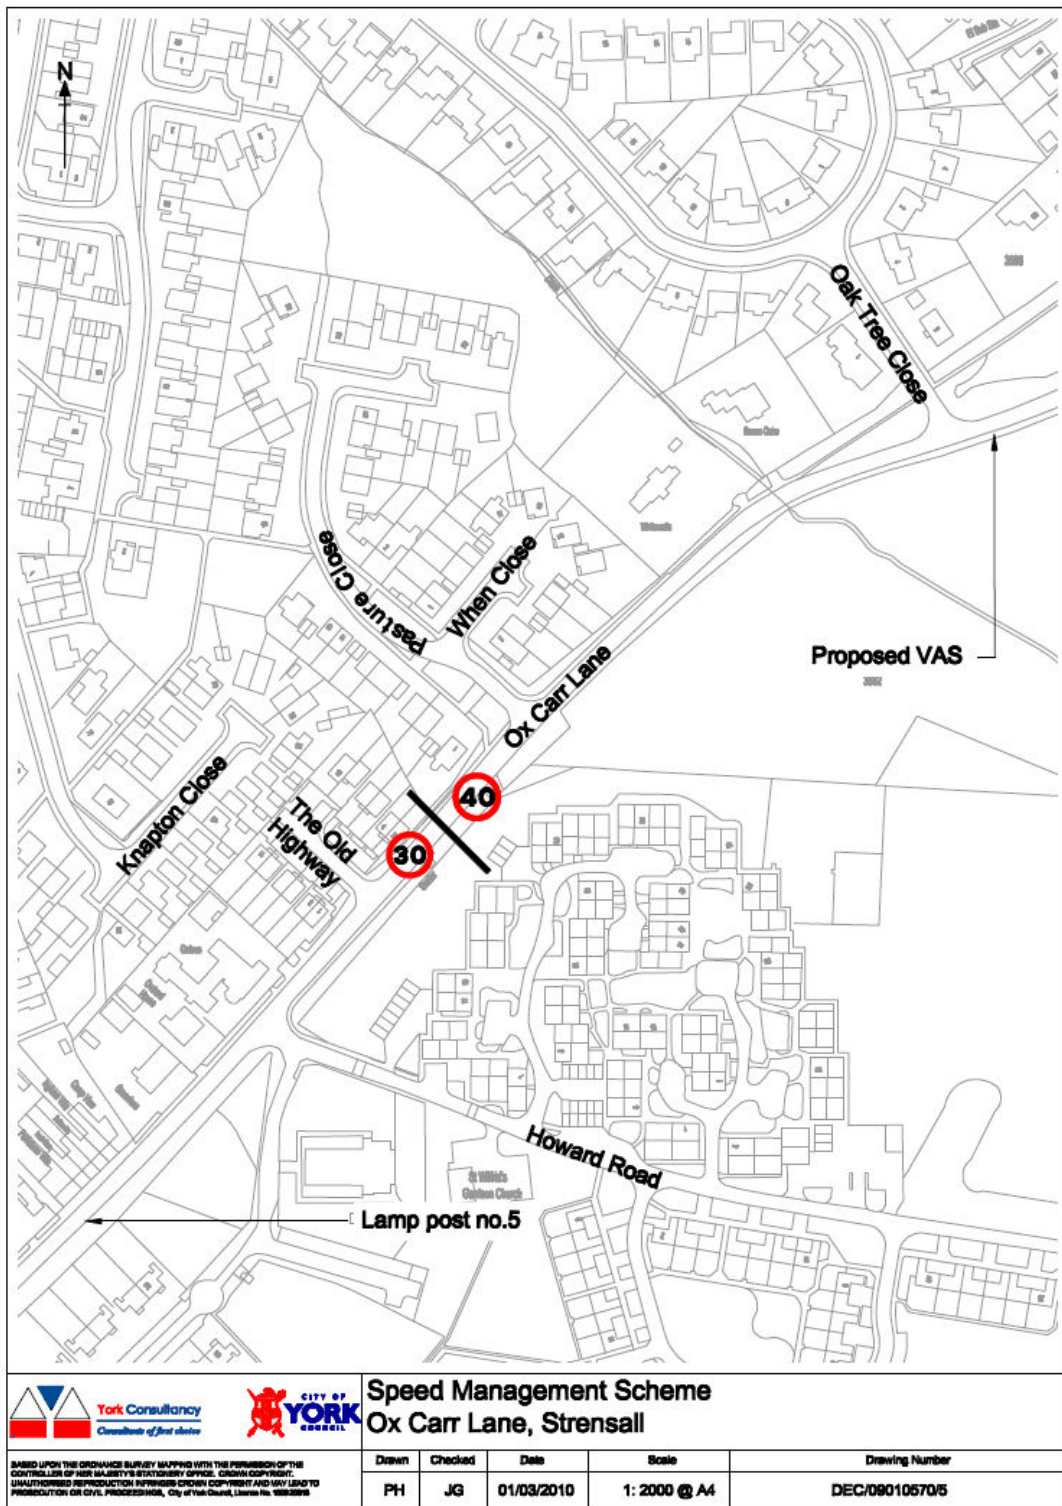
Concerns over inappropriate speeds within the 30mph speed limit.

Mean speeds recorded by the Fire & Rescue Service as 36mph and 85th percentile speeds 41mph. Data recorded at lamp column no 5 (see location plan) but direction of travel not known.

There was a slight injury accident recorded in the area within the three year period ending 31 July 2009. It happened on Tuesday 27 November 2007 at 16.05 in wet, dark conditions, 20metres north of The Old Highway. A 14 year old pedestrian was crossing the road without looking and was in collision with a car travelling north to south.

In view of the fact that a VAS is to be installed shortly within the 40mph speed limit area, which may have a positive effect on speeds within the 30mph area as well. It is recommended that when monitoring takes place 3months after installation that speed surveys are also taken within the 30mph limit.

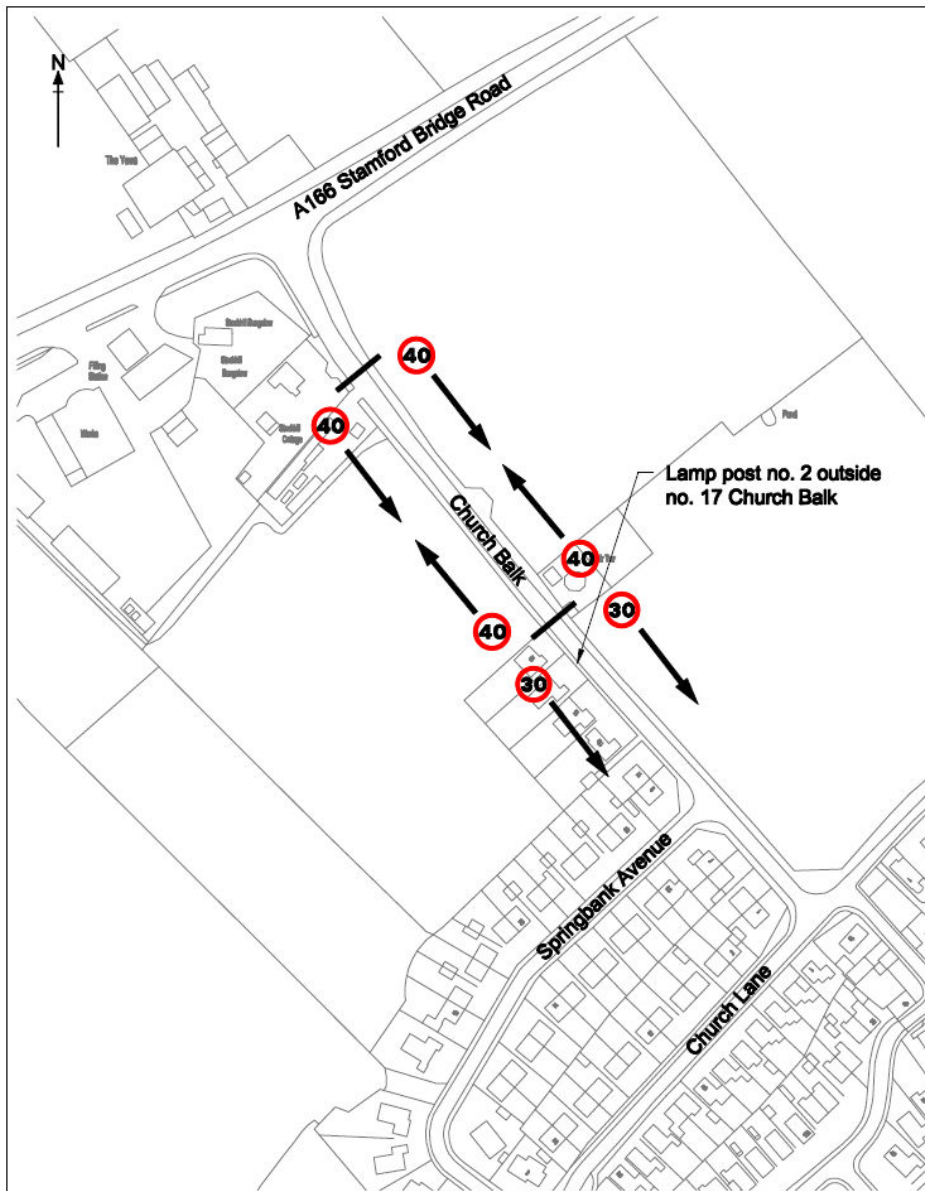
Concerns over traffic speeds.

Mean speeds recorded by the Fire and Rescue Service as 33mph and 85th percentile speeds 39mph. Data recorded at lamp column 2 (see location plan) but direction of travel not known .

The 30 mph speed limit commences just past the junction with the A166 Stamford Bridge Road. The environment here is open fields on both sides and there is housing development on one side only about half way along Church Balk. The high 85th percentile speed (39mph) indicates that the speed limit is being ignored probably because it is inappropriate for this location. It is proposed that the existing 30 mph speed limit is increased to a 40 mph limit, and a 30 mph speed limit is introduced half way along Church Balk at the start of the housing development. This will result in a short length of around 120 metres of 40 mph speed limit which goes against the guidance contained in DfT Circular 01/2006 which recommends an absolute minimum of 300 metres, although it allows you to consider an intermediate speed limit in advance of a 30 mph limit on approach roads to villages. In this case vehicles are turning from the A166 which carries the national speed limit and under the proposal drivers will be confronted with 40 mph signs and then 30 mph signs which should encourage them to slow down, more so than the present situation where they are confronted almost immediately with 30 mph signs, which, if they miss will allow them to continue to drive at speed.

The proposed 30 mph terminal signs should be part of a gateway treatment involving 30 roundels on red surfacing and yellow backing boards for the signs. The existing gateway should be retained at the proposed 40 mph terminal signs with a 40 mph roundel on the carriageway.

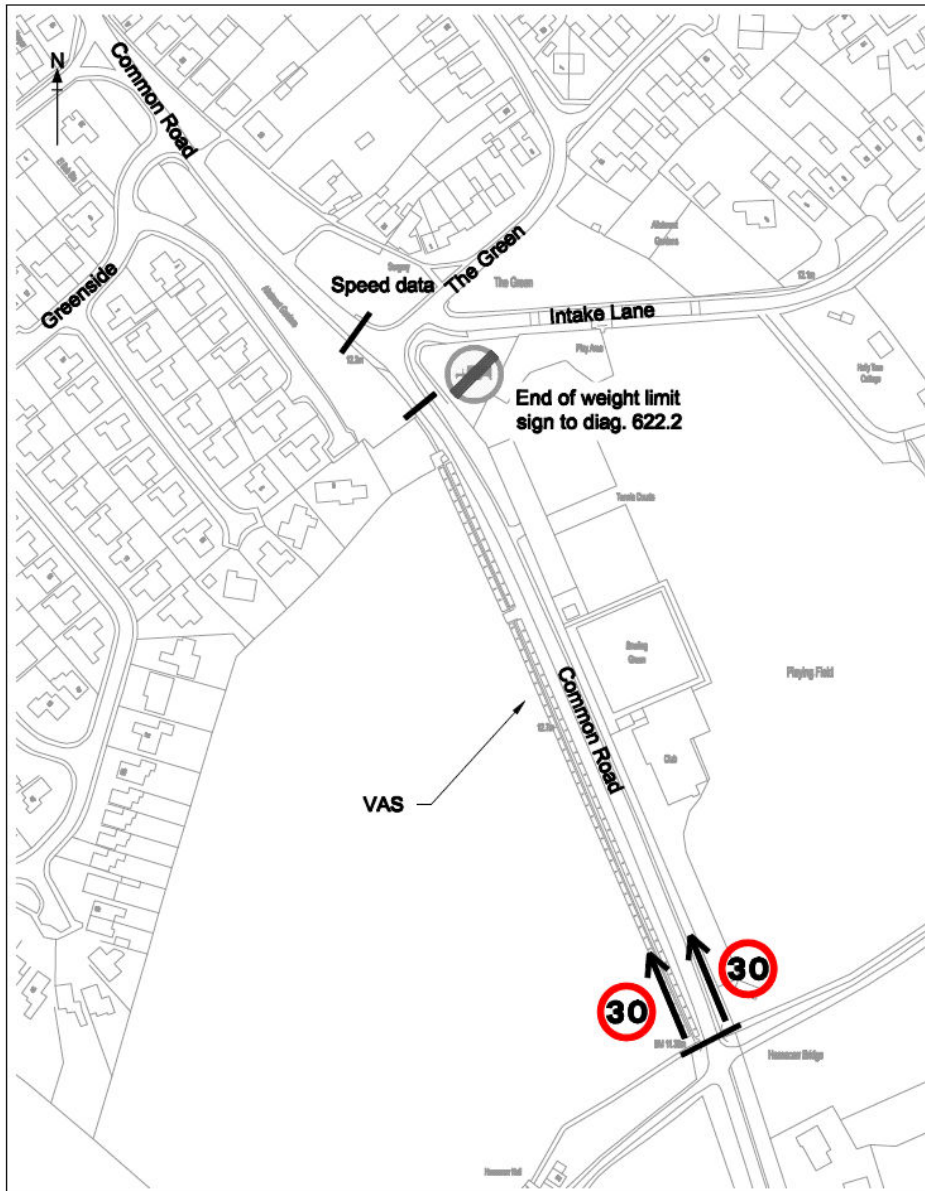
There is an end of weight limit sign to diagram 622.2 on the offside of the road for vehicles travelling south. This is somewhat faded and could from a distance be mistaken for a national speed limit sign. It is recommended that the sign to diagram 622.2 should be replaced.

The faded sign to diagram 622.2 (end of weight limit) should be replaced.

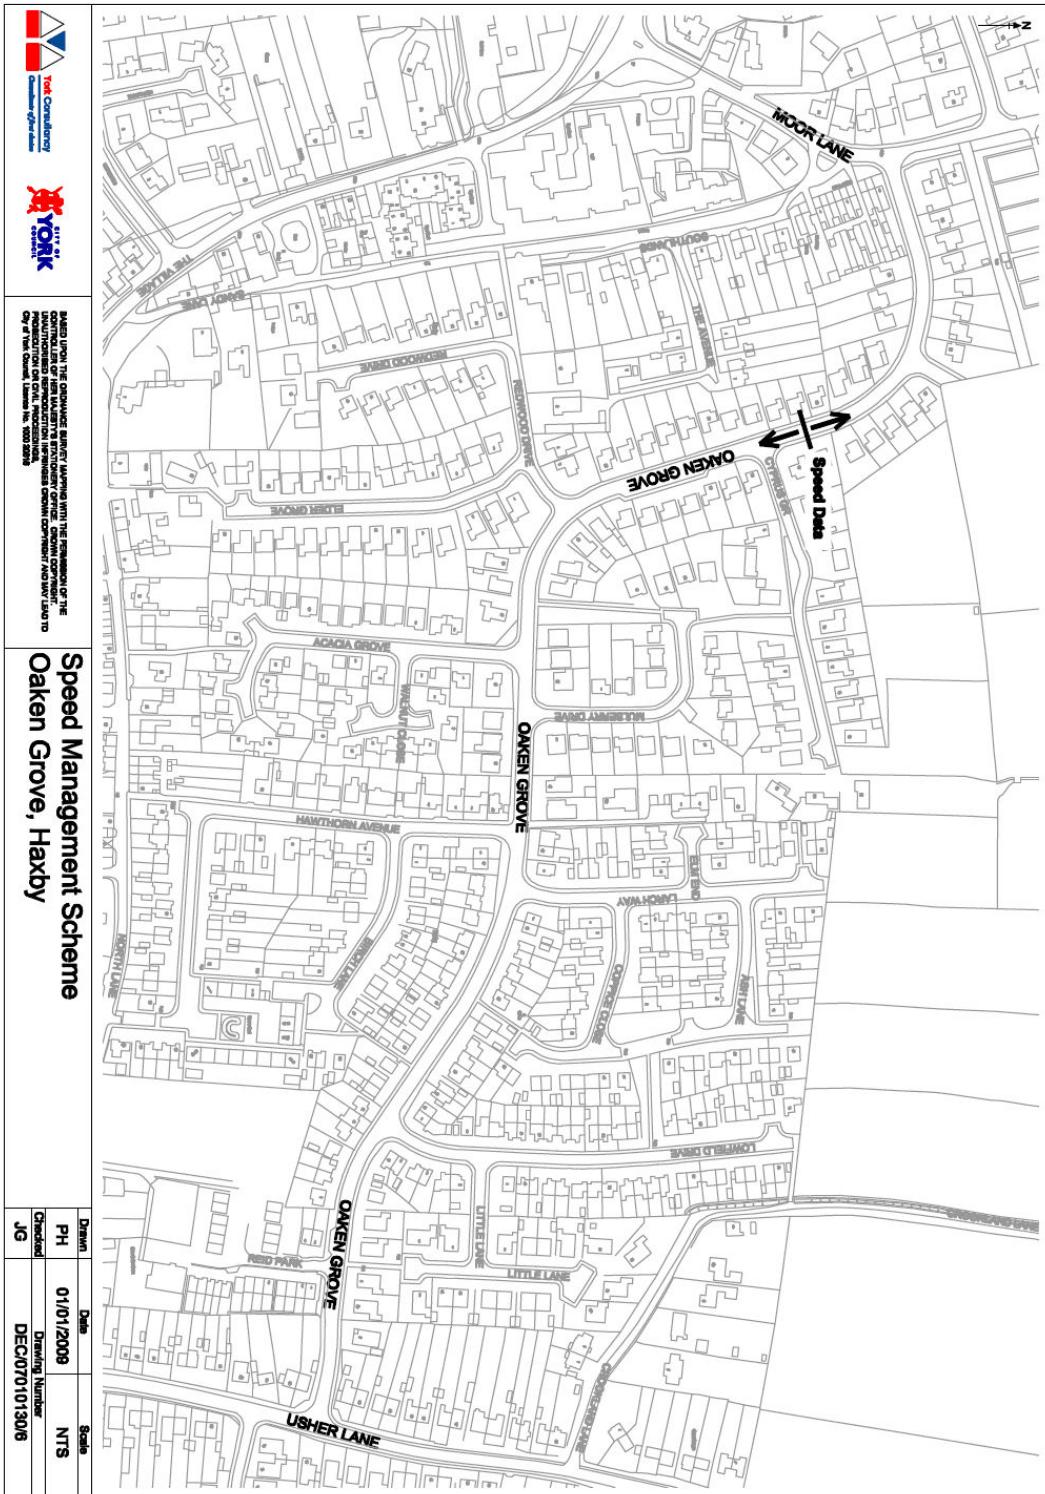
Speed Management Scheme Oaken Grove, Haxby

Oaken Grove is within a 30mph speed limit, and forms a link between Moor Lane and Usher Lane. It is totally residential in nature. The road is wide and can be used to avoid The Village which runs through the centre of Haxby. Some of the road appears to have been resurfaced fairly recently, where the road markings are in good condition. The road markings at the eastern end of Oaken Grove are faded.
