**Ward Committee Scheme 06/07
Report to Fishergate Ward Committee**

Your Reference:- FS- Our Reference:- 0609904 Date:- 31st July 2006
06-01

Broadway Shops – Parking and Pedestrian Access

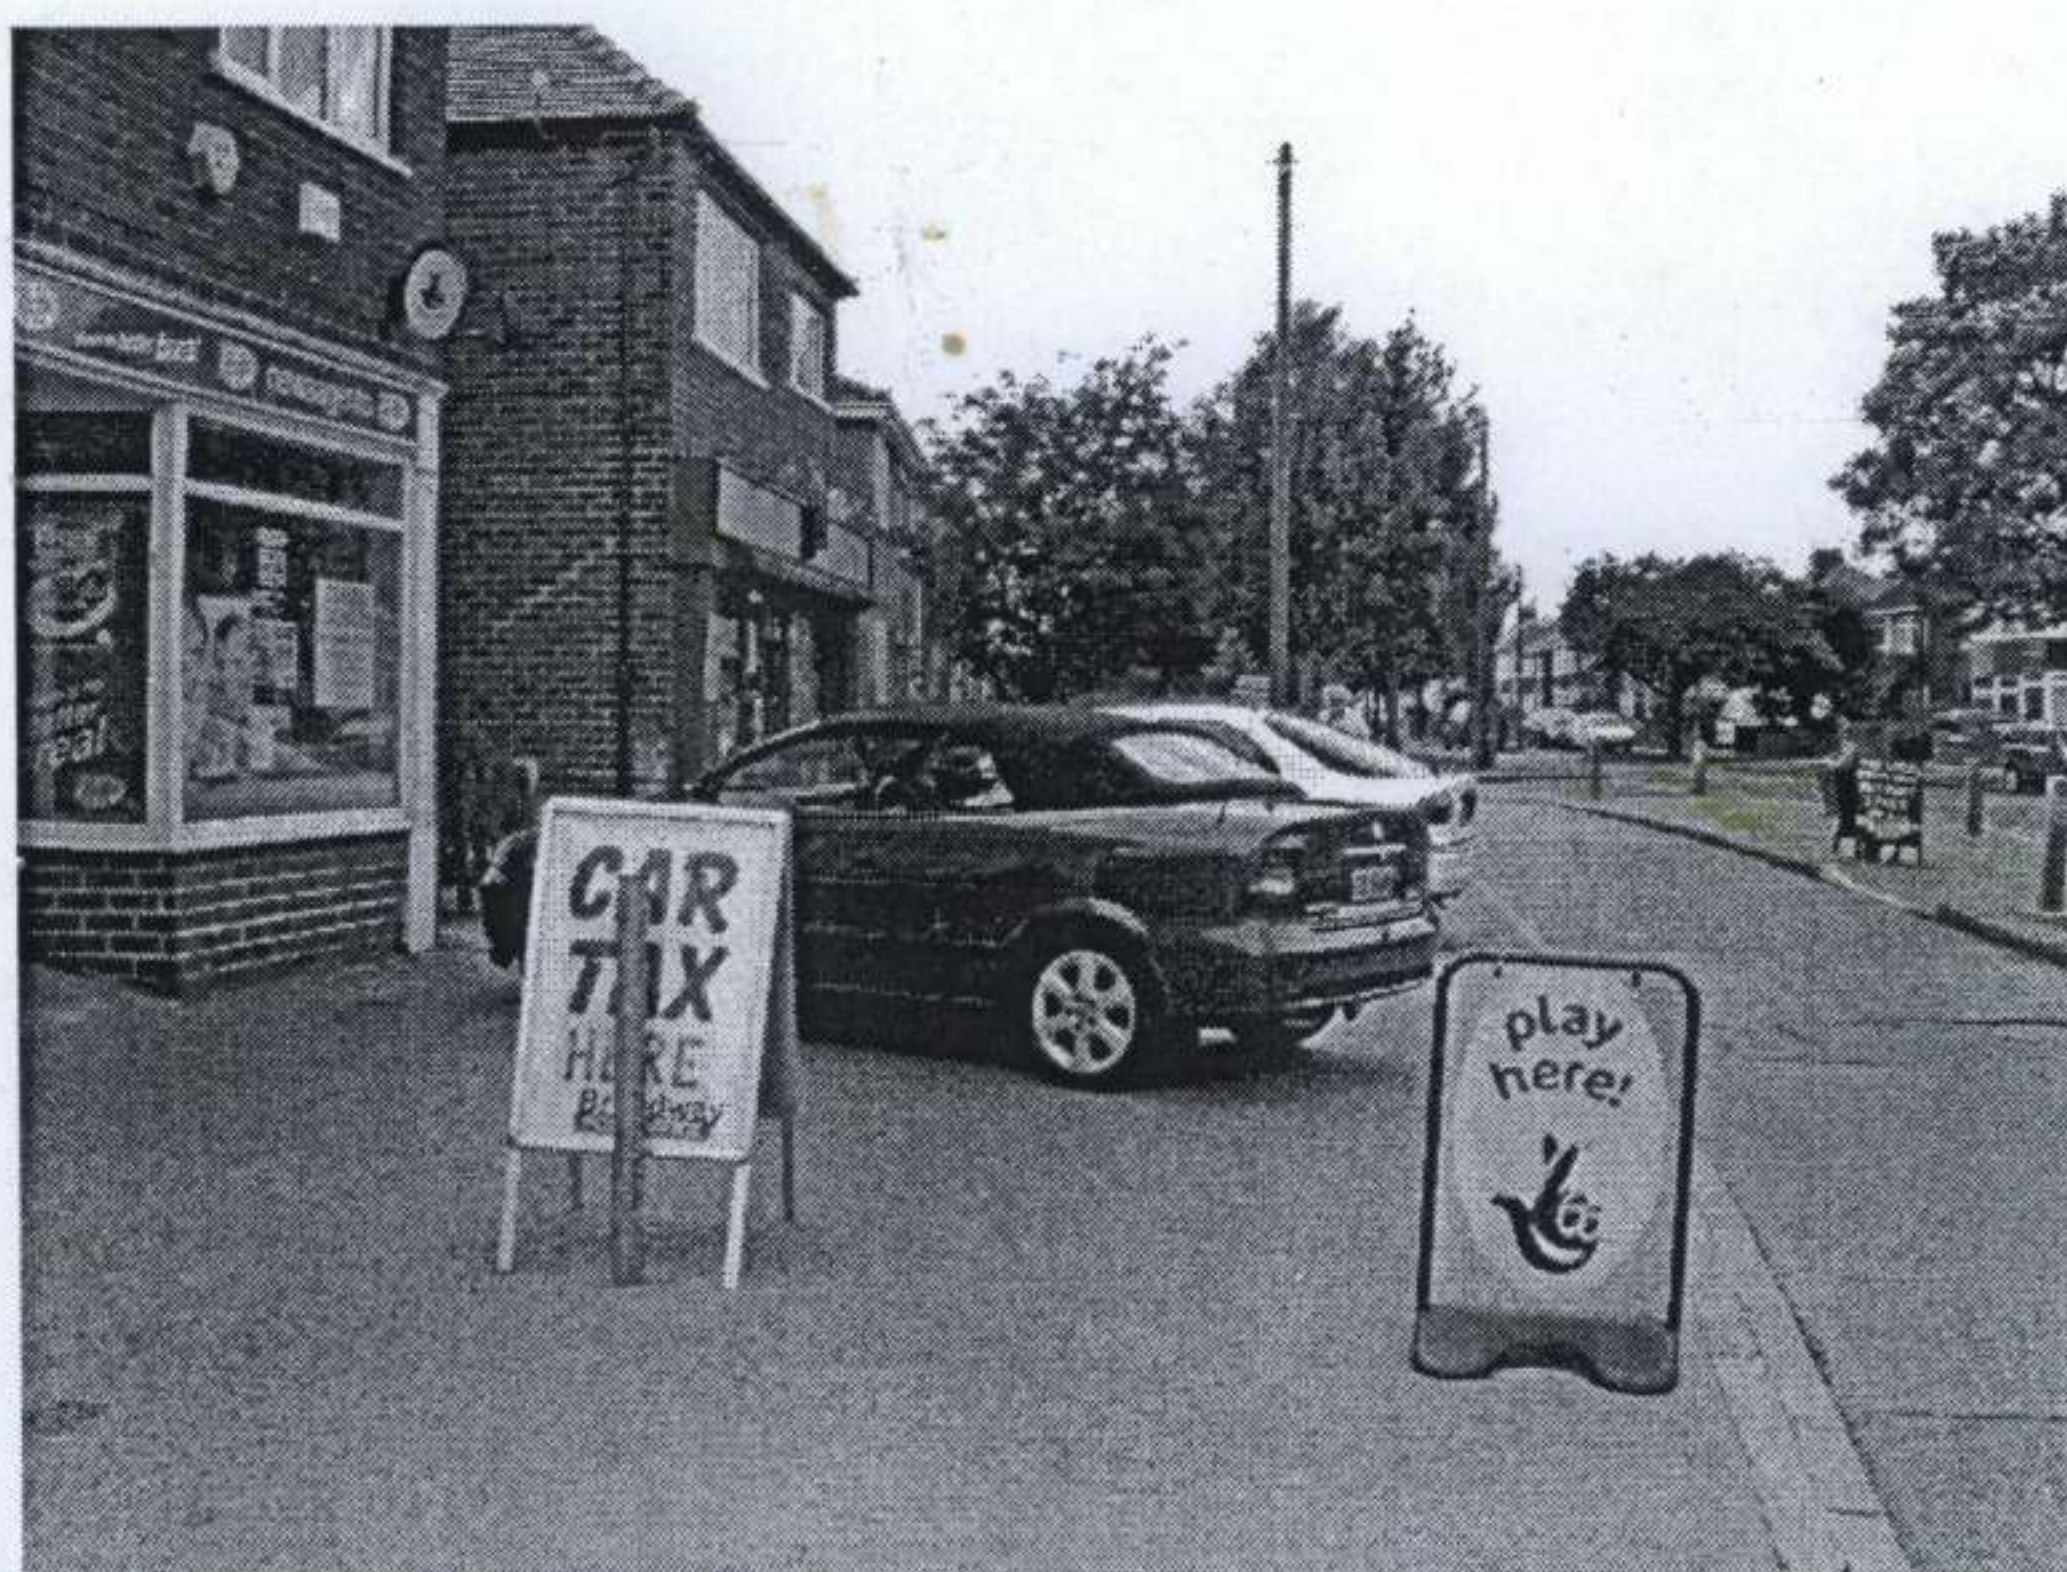
Haphazard parking effectively blocking the forecourt area for pedestrians

- 2.4 At present, vehicles ride up on to the forecourt area and park in a haphazard fashion there, with pedestrians having to thread their way around the parked vehicles, and occasionally having to take evasive action when vehicles ride up unexpectedly on to the forecourt area.
- 2.5 The lack of defined areas for pedestrians and vehicles on this forecourt is at the root of this problem, and poses particular difficulties for visually- impaired pedestrians, those in wheelchairs, and others pushing prams/ buggies.

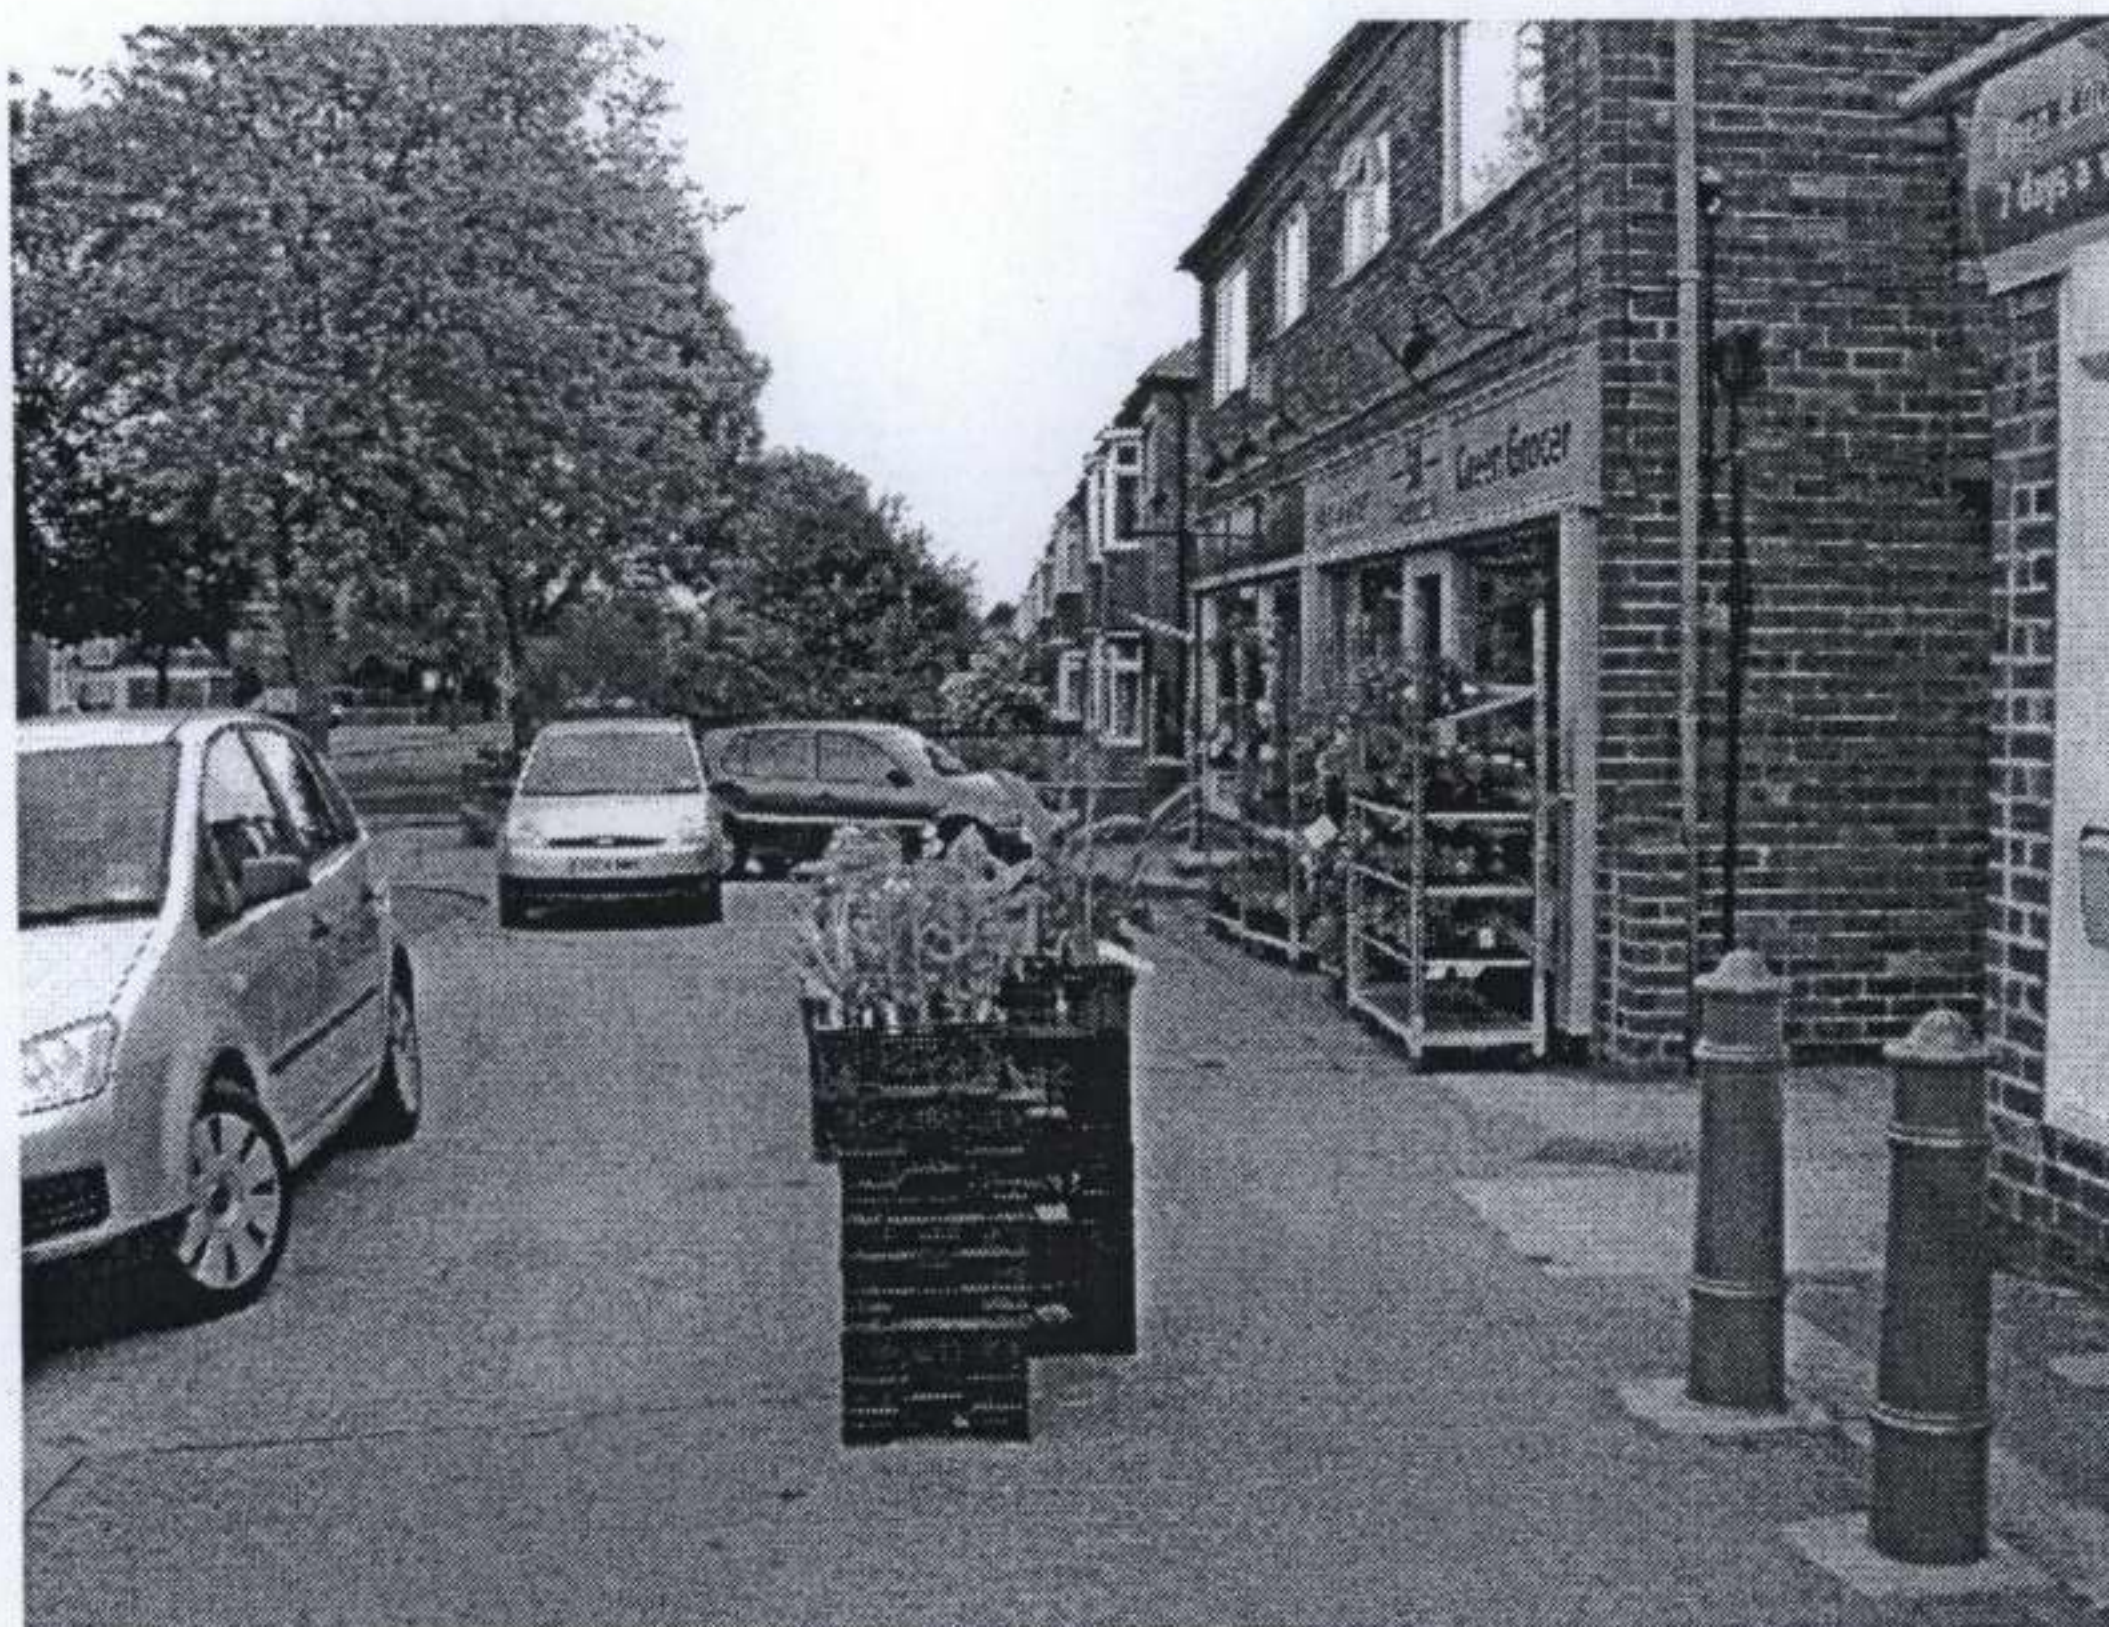
Parking and merchandise on the forecourt area
