## **PRESERVATION AND PROTECTION OF OUR RICH ARCHITECTURAL HERITAGE**

# Protecting Britain's Heritage

One word - **Metalock** - has become synonymous with a complete service for the cold mechanical repair of cast iron and other metals.

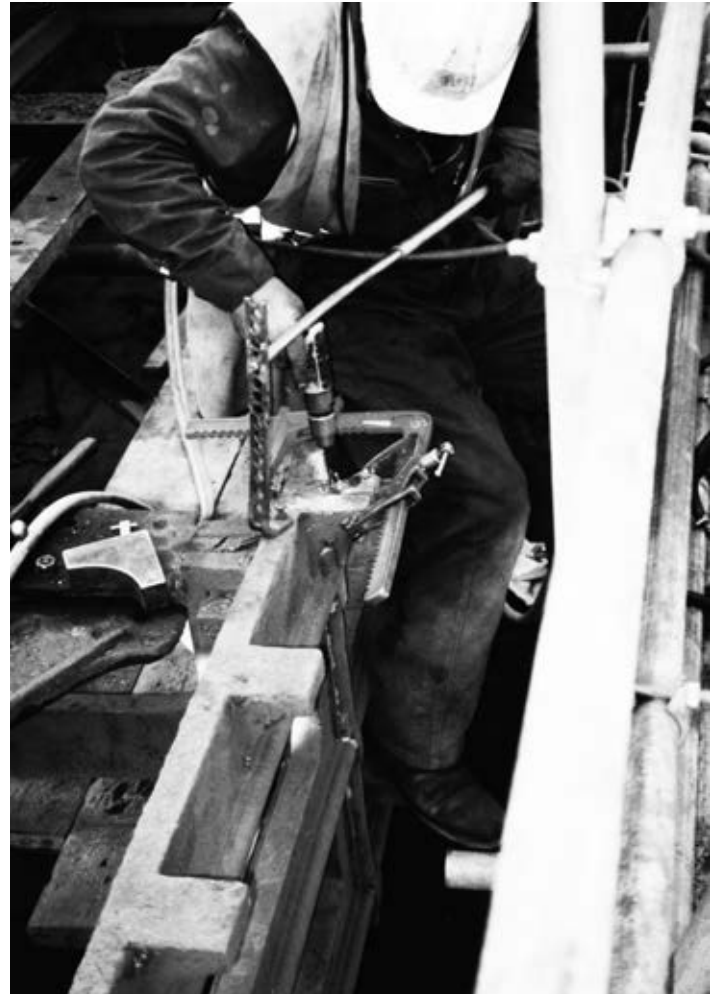
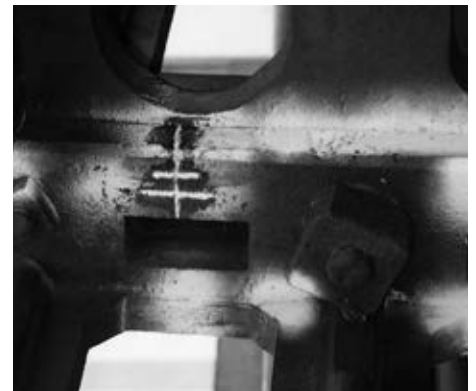
# Charing Cross Bridge

A famous landmark in Central London, the 100 year old Charing Cross Bridge carries 123,000 commuters across the Thames by rail each day. 720 feet of cracks to the structure's sixteen cast iron columns were successfully repaired by the Metallock process with 108,000 drillings and 36,000 tappings performed on site - without disruption to rail services.

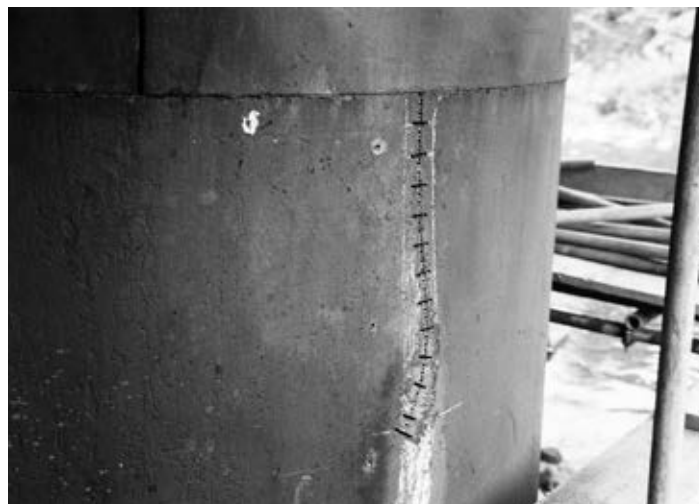
# Northumberland Bridge

Metalock Engineers undertaking repairs to cast iron Column supporting a river bridge in Northumberland.

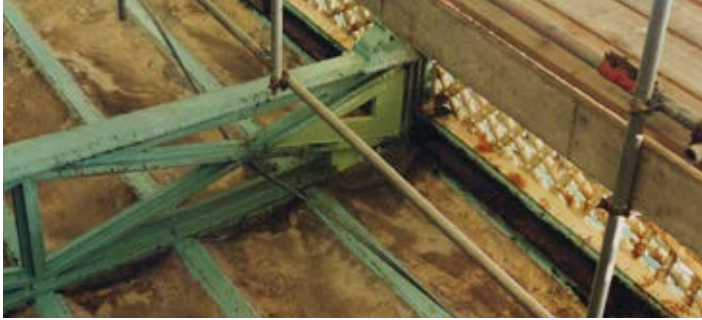
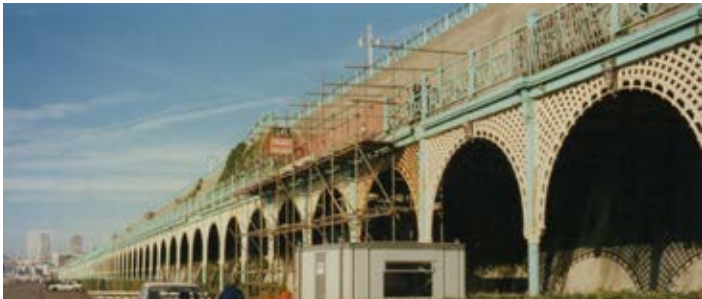
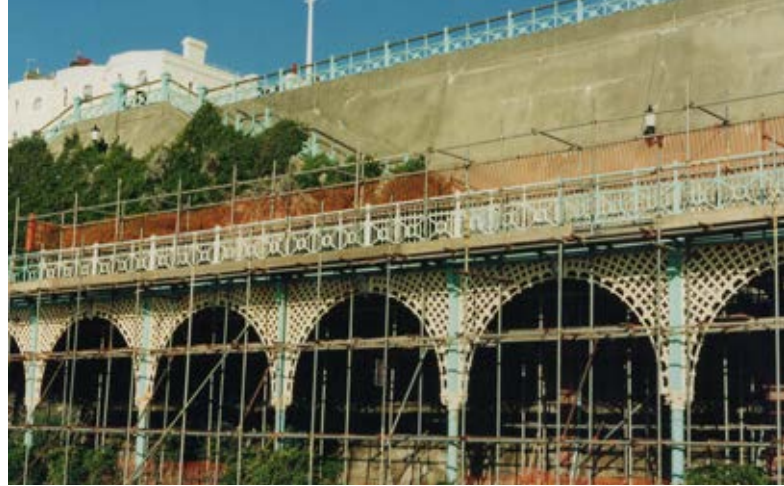
# Madeira Terrace

Visitors to Brighton who will recognise and appreciate the iron terrace built in 1895 will be pleased to learn that Brighton Corporation were able to save the structure with the aid of Metallock.

The repair, accomplished on site, introduced no additional stresses, which would occur if it was conventionally welded, returning the cracked supporting columns to their original strength.

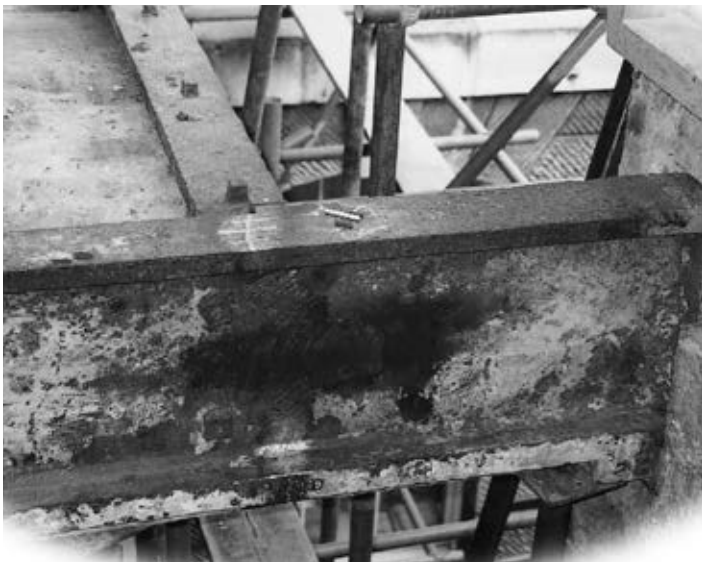
# Somerset House

During refurbishment at Somerset House, inspection to the Main Support Girders showed extensive fractures. These fractures were repaired using a combination of Masterlocks and Metallock Keys, giving additional strength to the repair.

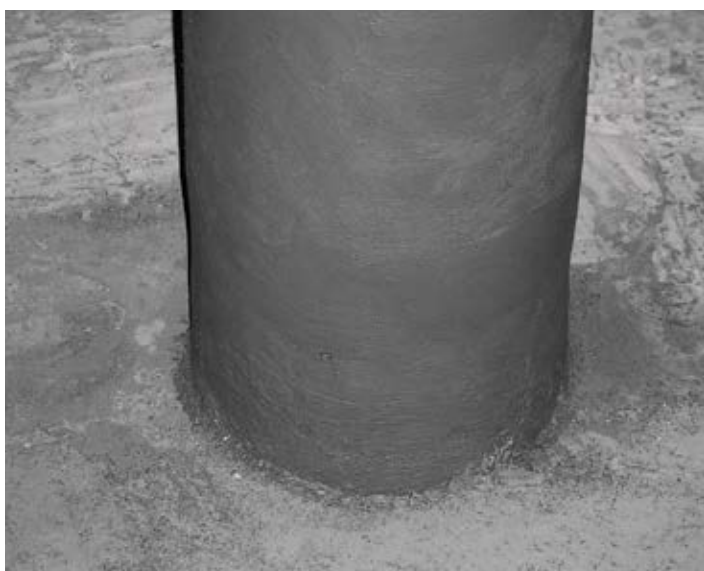
**Above:** Support column repair from beginning to end, using the Metallock process.

Metalock repairs can be carried out to all sorts of support columns, under workshop conditions or on-site, without the costly need to remove the column. A new section can be cast and split in two halves and cut out of the column to match one of the halves. The new section can be inserted and secured by the Metalock process, the remaining section can then be removed and replaced with the second new section and finally secured into position.

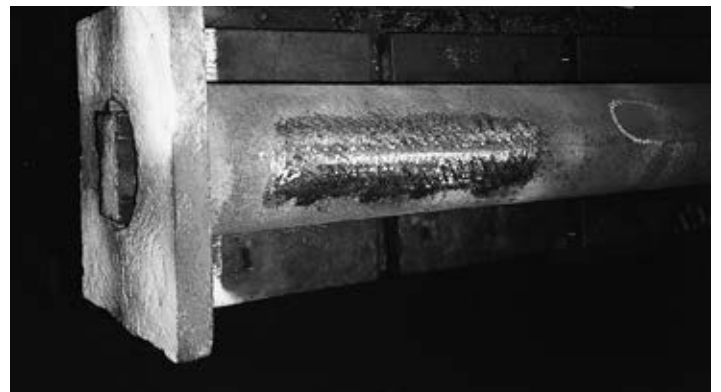
**Below:** Bellway Home support columns showing the removal and replacement of damaged sections in the workshop.
