**Notice of a public  
Decision Session - Executive Member for Environment**

**5. York 5 Year Flood Plan Update** (Pages 11 - 24)

# York 13<sup>th</sup> August 2018 Section 19 Surface Water Flood Investigation

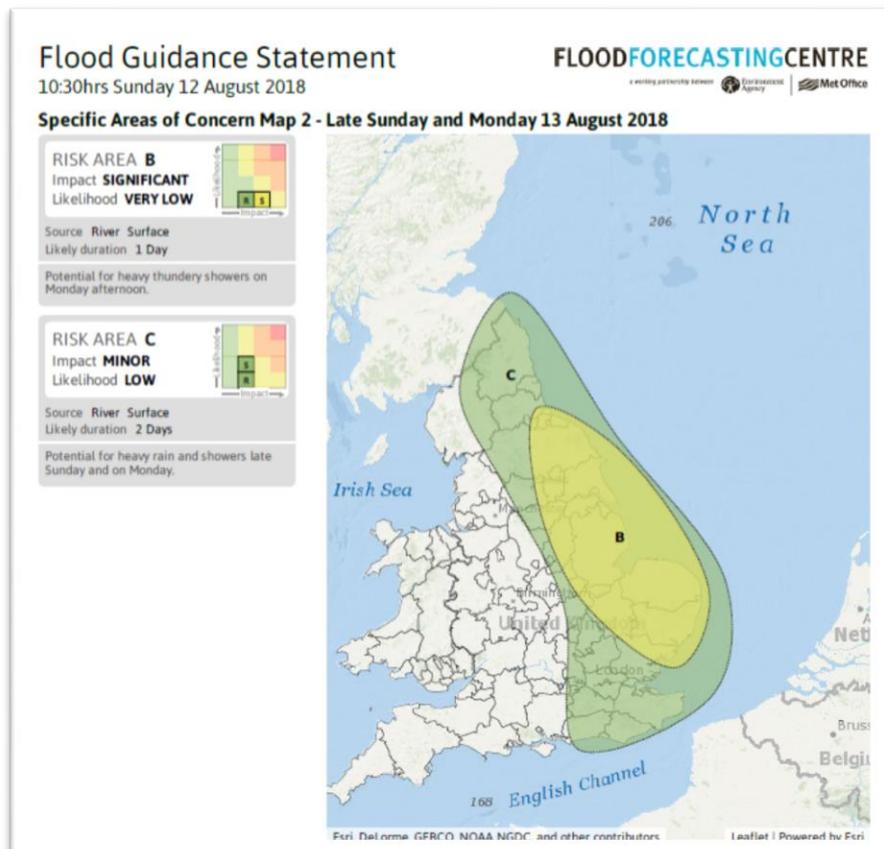
Figure 2 – Flood Guidance Statement 10:30hrs 12 August 2018

The forecast for 13<sup>th</sup> August 2018 highlighted the potential for thundery downpours, on Sunday 12<sup>th</sup> August the Flood Guidance Statement indicated a very low likelihood of a significant impact occurring, this was updated at 10.30am on the 13<sup>th</sup> to detail a low likelihood of significant impact see Figures 2 and 3.

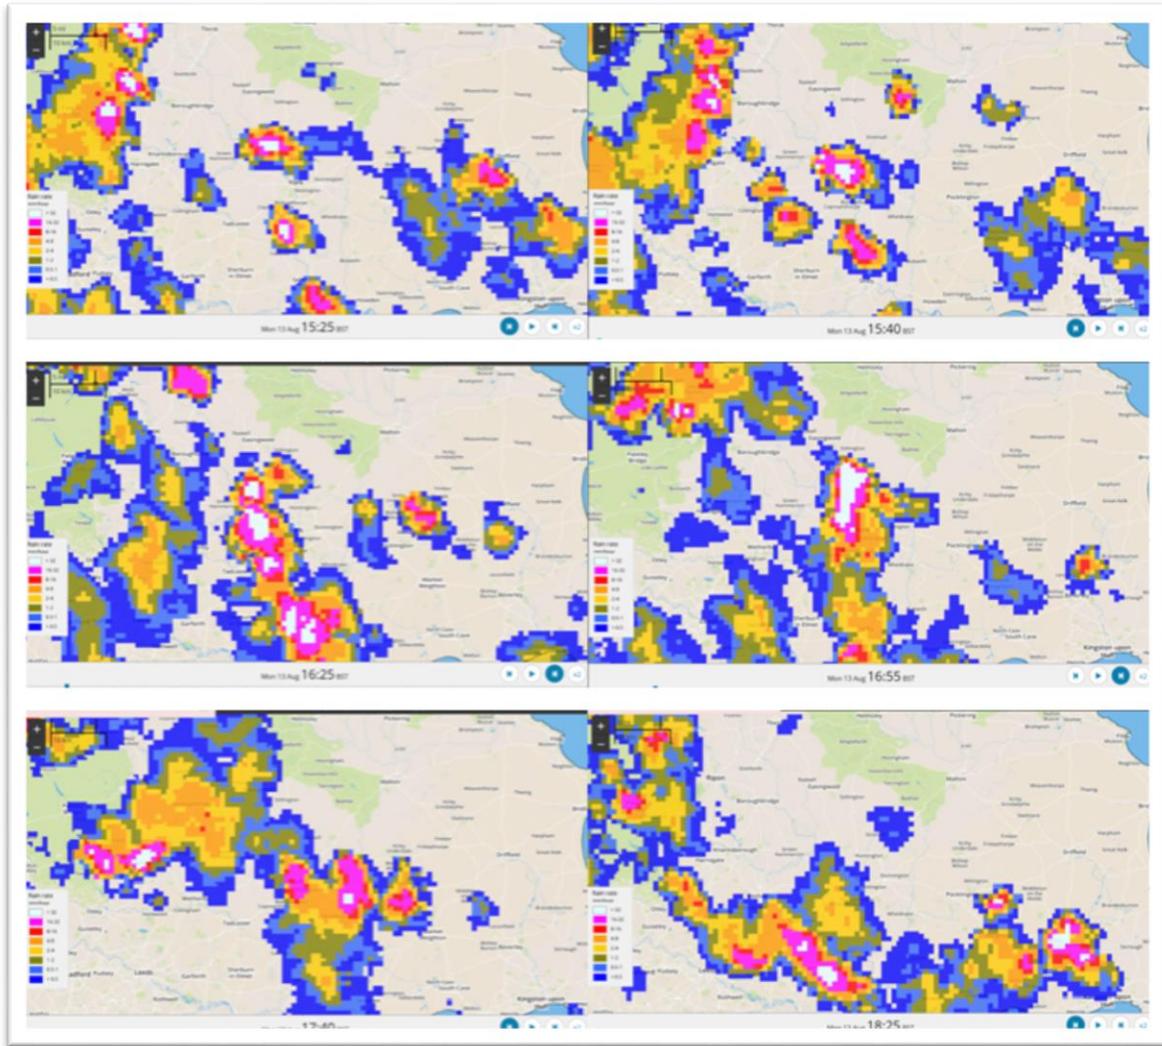
Figure 4 – Hazard Manager Rainfall Radar 13 August 2018

Figure 4 details the outputs from the Met Office Hazard Manager tool available to CYC, the sequence of figures illustrate how the intense rainfall - >32mm/hr – slowed and sat over the city leading to significant rainfall volumes falling on already surcharged drainage systems.

Rain gauges recorded more than 40mm of rainfall in less than 20 minutes in some parts of the city, this is in excess of 120mm/hr.
