This project aims to address issues for cyclists on the three city centre bridges (Skeldergate, Ouse and Lendal). The project will focus on safety and amenity concerns for cyclists, specifically focusing on reducing conflicts between cyclists and vehicles; for example, close overtaking.

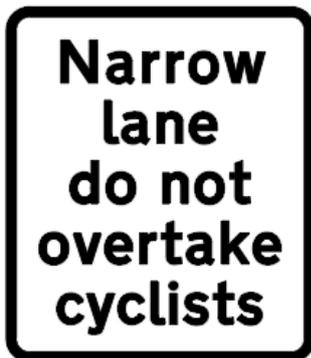
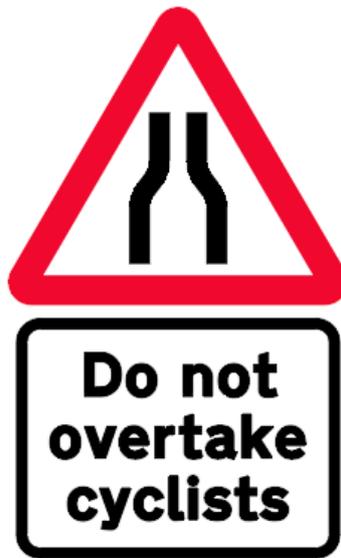
The recommended sign would be a combination of the Diagram 516 "narrow road" warning sign and the custom "Do not overtake cyclists" sign.

Regulations stipulating the minimum distance from the hazard that the warning sign can be placed and the minimum distance for visibility need to be adhered to. Given the nature of the environment round the three bridges it is difficult to place the signs within the highway in suitable locations. Minimum distances / visibility thresholds are not met for Ouse Bridge. Signs on the approaches to Lendal Bridge would need to be suitably consulted on as they would need to be erected close to the City Walls or in front of historic buildings.

Signs on the approach to Skeldergate Bridge could be able to be installed at appropriate locations, however, the road does not actually significantly narrow over the bridge and the above proposed sign would not seem appropriate for use. The provision of cycle lanes and the sign together may also provide motorists with conflicting information and this is not seen as beneficial.

Because of some of the sign sites not meeting the regulations, any application to the DfT for use of a special custom sign in these locations is likely to be denied and is thus not recommended.

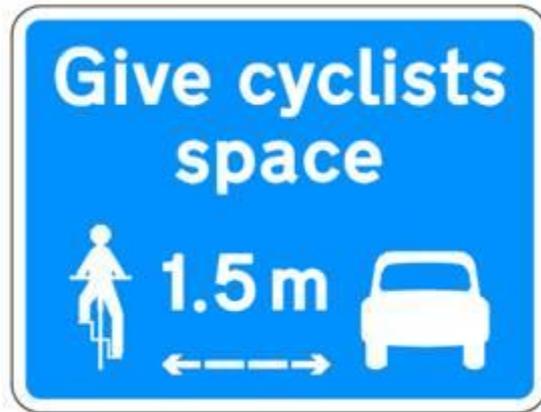
The following information sign was created to provide drivers information on the distance to give cyclists when overtaking in a 30mph area. As this is an information sign the requirements for its location as not as strictly defined as that of a regulatory sign and thus provides more scope for its deployment on the approach to the City Centre Bridges.

The alternative to this approach was to design a custom sign as per that recently approved by Transport Scotland which would, instead of preventing overtaking of cyclists, remind drivers of motor vehicles how to do so safely. This is seen as a more likely solution to gain authorisation given the legal issues regarding preventing overtaking cyclists.

- 1) Liaise with North Yorkshire Police to carry out a driver education programme on the dangers of close passes to cyclists.
- 2) Apply to the Department for Transport for Signs Authorisation to use the "Give Cyclists Space" sign for all bridges. If authorisation is granted, then the design of these signs will be taken forward.
- 3) Design road markings using cyclist symbols (Diag 1057) for Ouse Bridge and Lendal Bridge. The Lendal Bridge road markings would be installed following the maintenance and resurfacing works of the bridge.

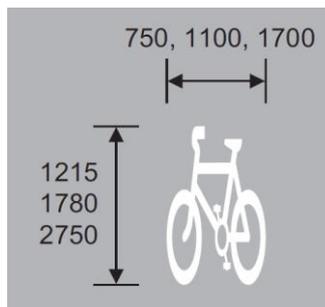
Diag 1057: Cycle Route Road Marking

As detailed above, actual cycle lanes to current best practice, advised or mandatory, are not possible due to lack of space. However, bicycle markings to Diagram 1057 could be installed, without cycle lanes, to give more awareness of cyclists. This has been done in other locations in York to some effect i.e. Tadcaster Road.

These road markings provide reinforcement that cyclists are present and they should be given ample room.

Ouse Bridge may benefit from the installation of cyclist symbols on the carriageway. This would highlight the presence of cyclists and may provide some minor safety benefit.
