**INSPECTION REPORT
River Ouse Riverbank**

**Report 22594-H-RP-001-R0
20 November 2024**

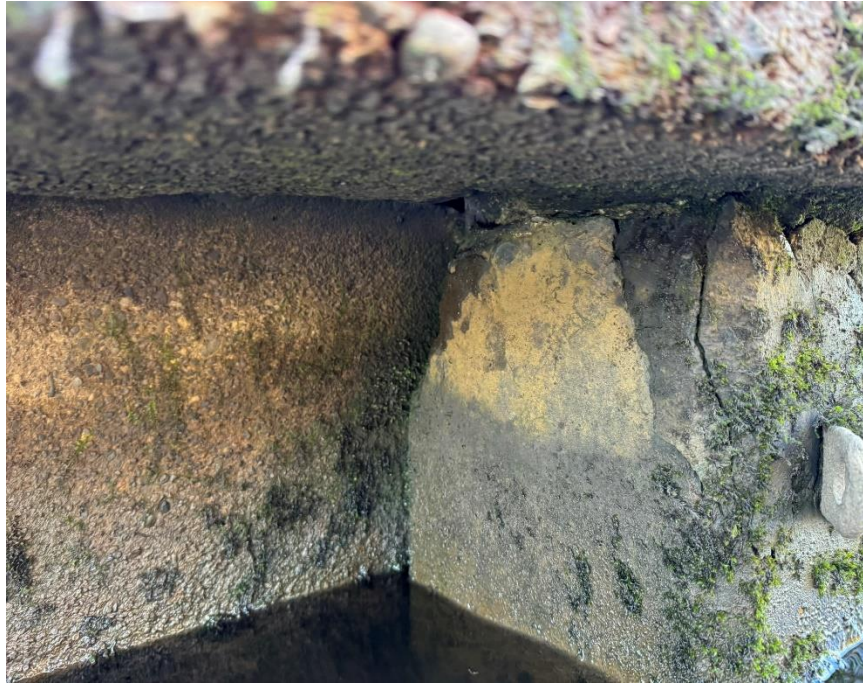
50 Spalling of concrete at the top of the pile. Corroded steel reinforcement bars are exposed.
