FLOODING INVESTIGATION REPORT

BADGER HILL / HULL ROAD, YORK

Incident Date: 10 June, 2012

March 2013

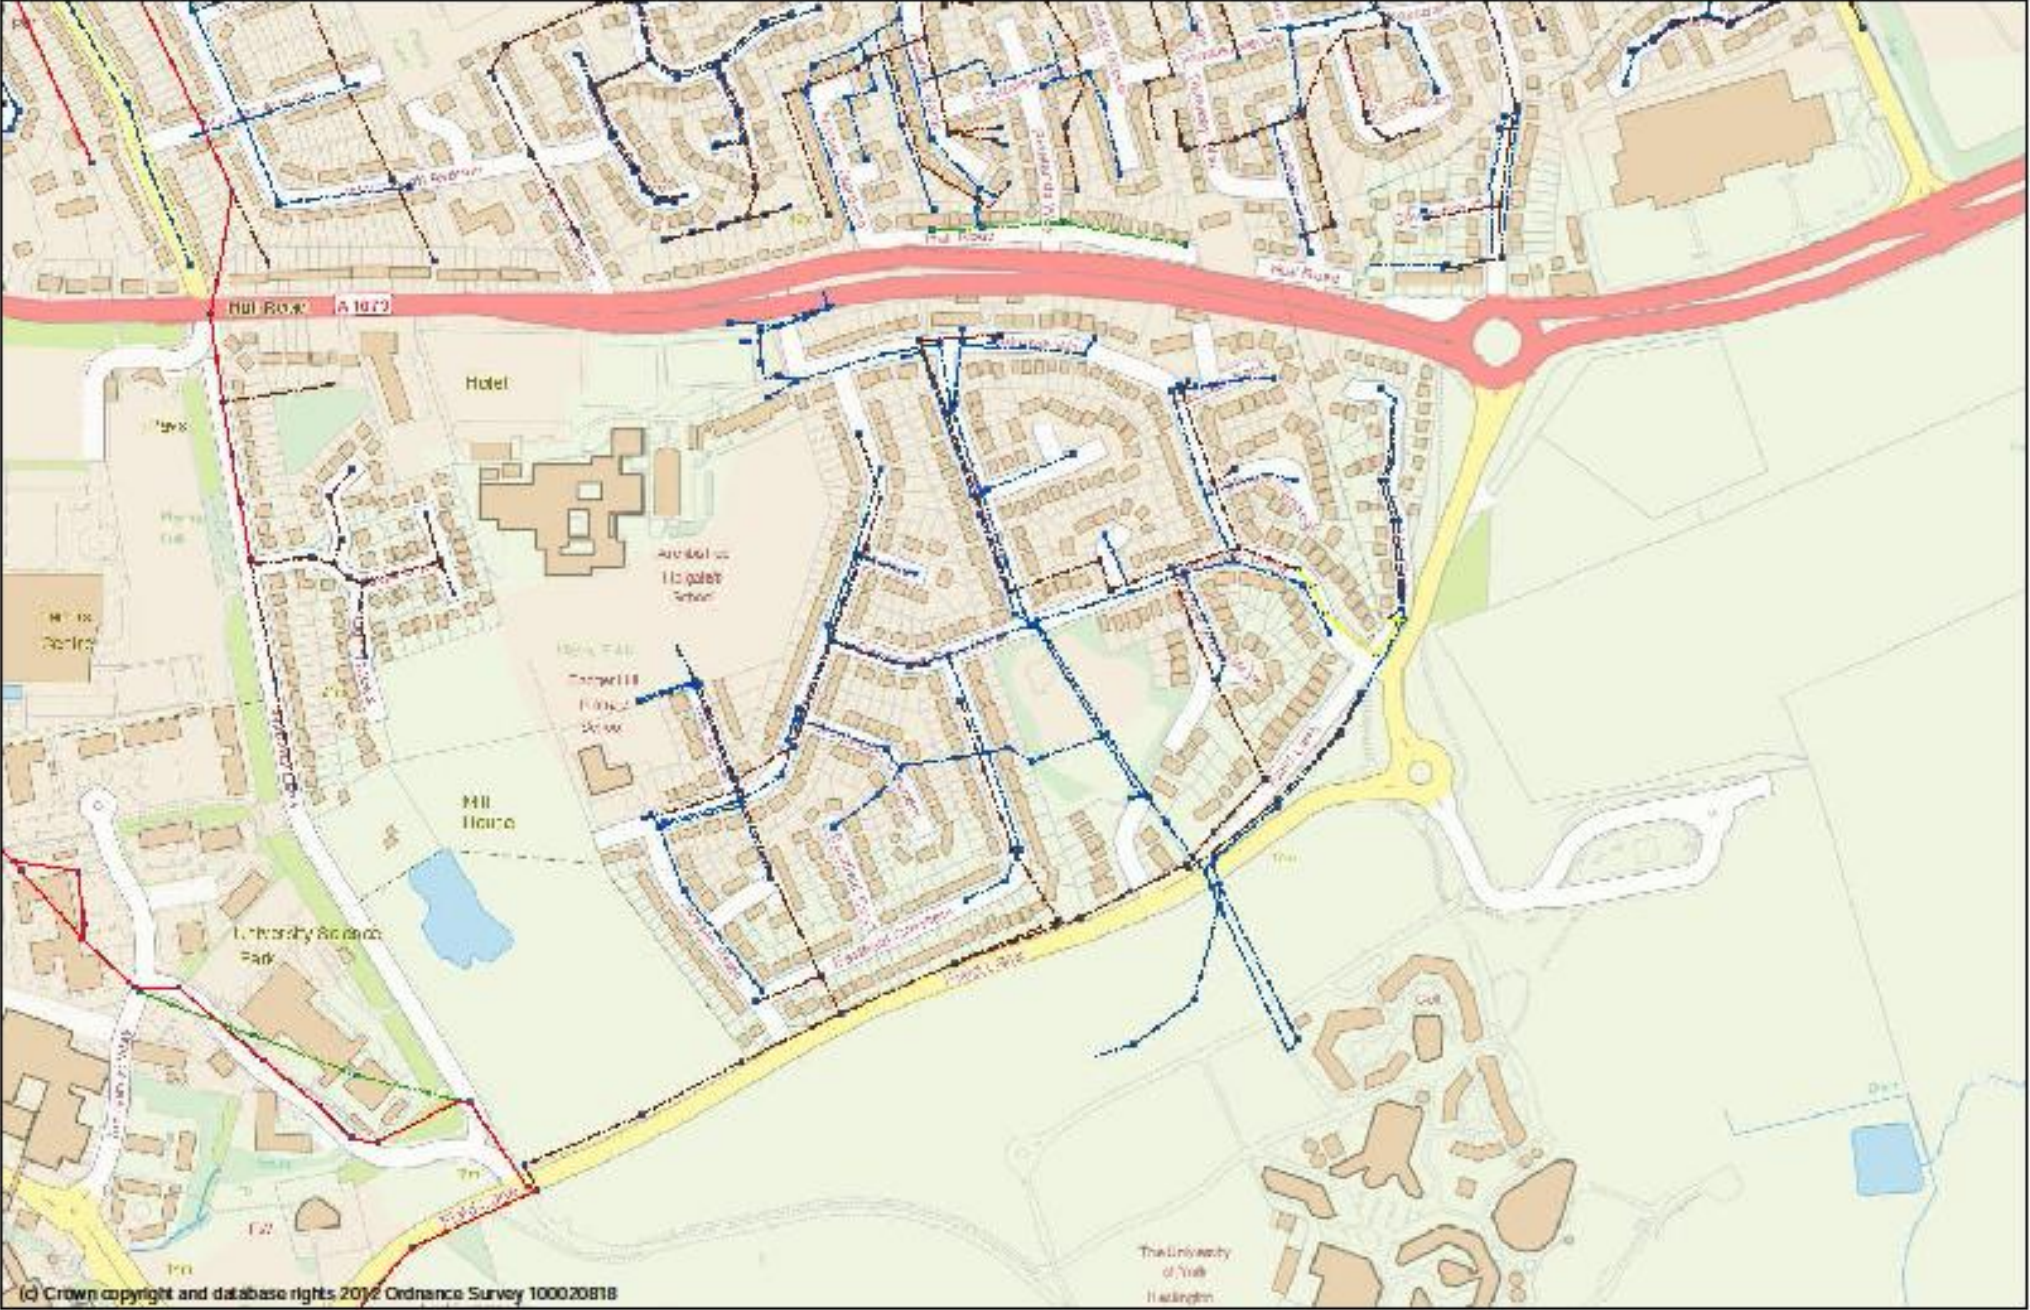
Figure 2: Yorkshire Water Services Public Sewerage Network

Figure 2 shows the recorded extent of the Yorkshire Water Services (YWS) public sewerage network. The Badger Hill estate is served by separate foul and surface water sewers which flow in a generally southerly direction.
