**STRUCTURAL INSPECTION AT
REYNARDS GARAGE, 17-21 PICCADILLY, YORK
FOR CITY OF YORK**

JOB NO: 10823/12.0

DATE: APRIL 2015

Document Title: Structural Inspection

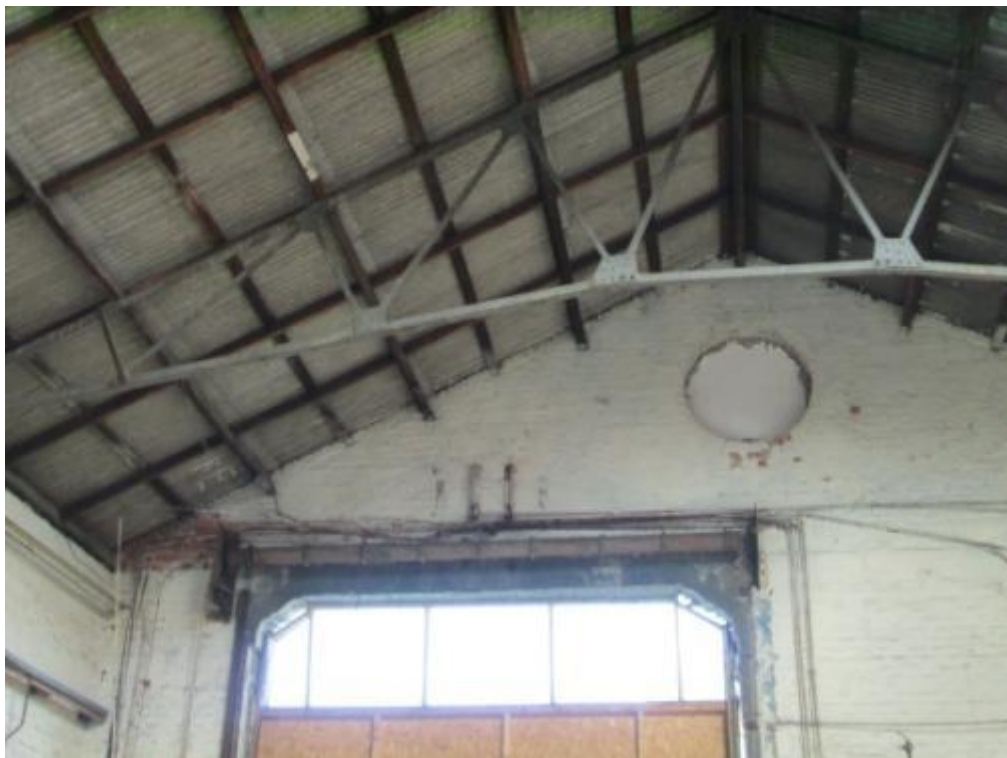
Photograph 37 – Internal view towards North West entrance

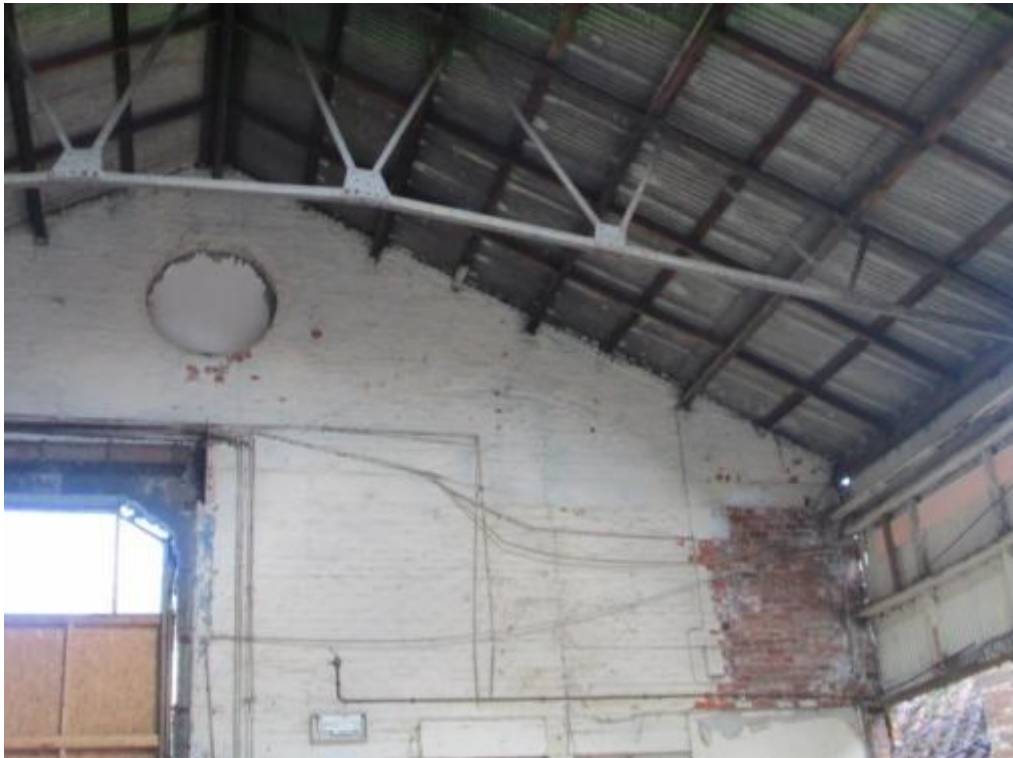
Photograph 38 – Internal view towards North West entrance

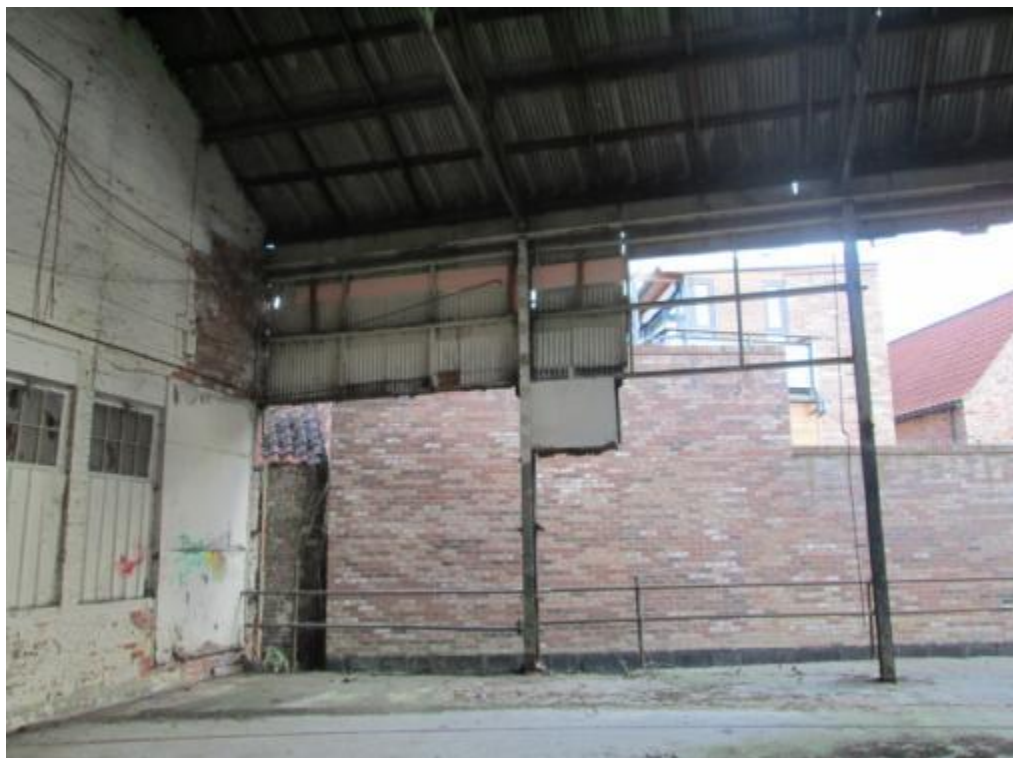
Photograph 39 – Part view on rear elevation

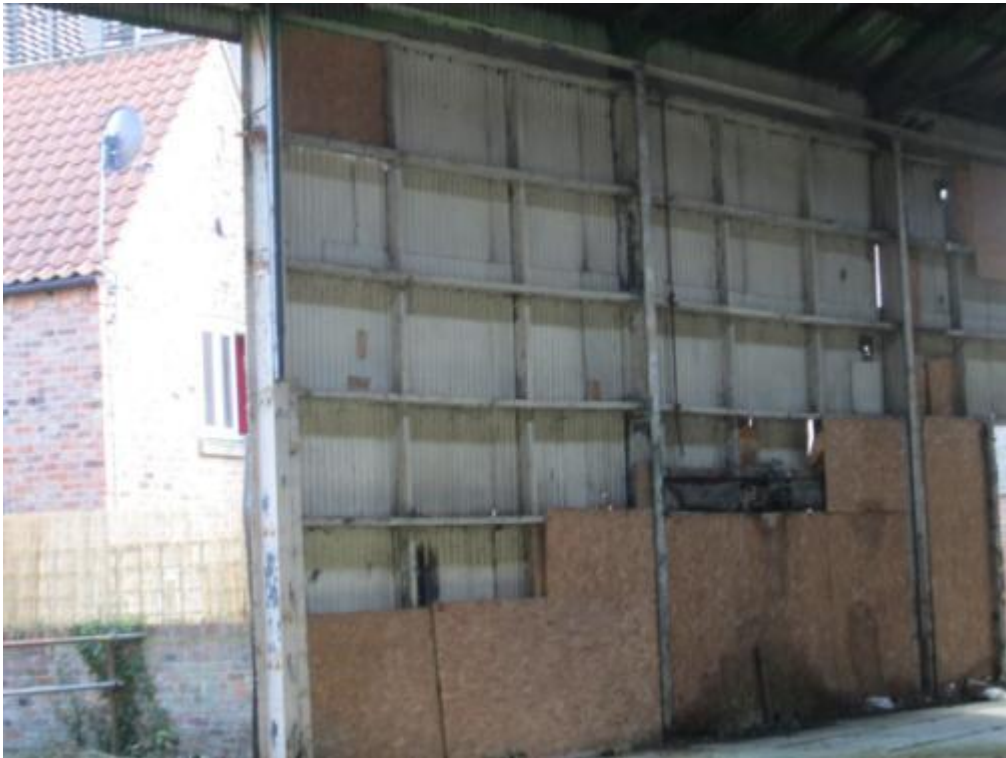
Photograph 40 – Part view on rear elevation

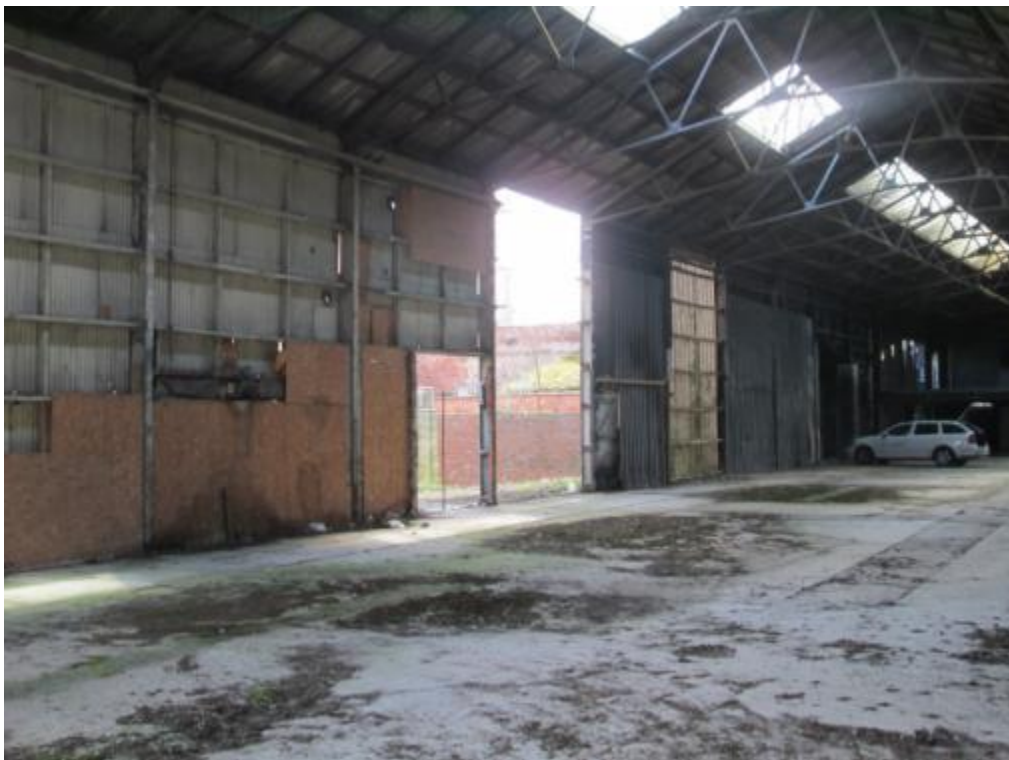
Photograph 41 – Part view on rear elevation

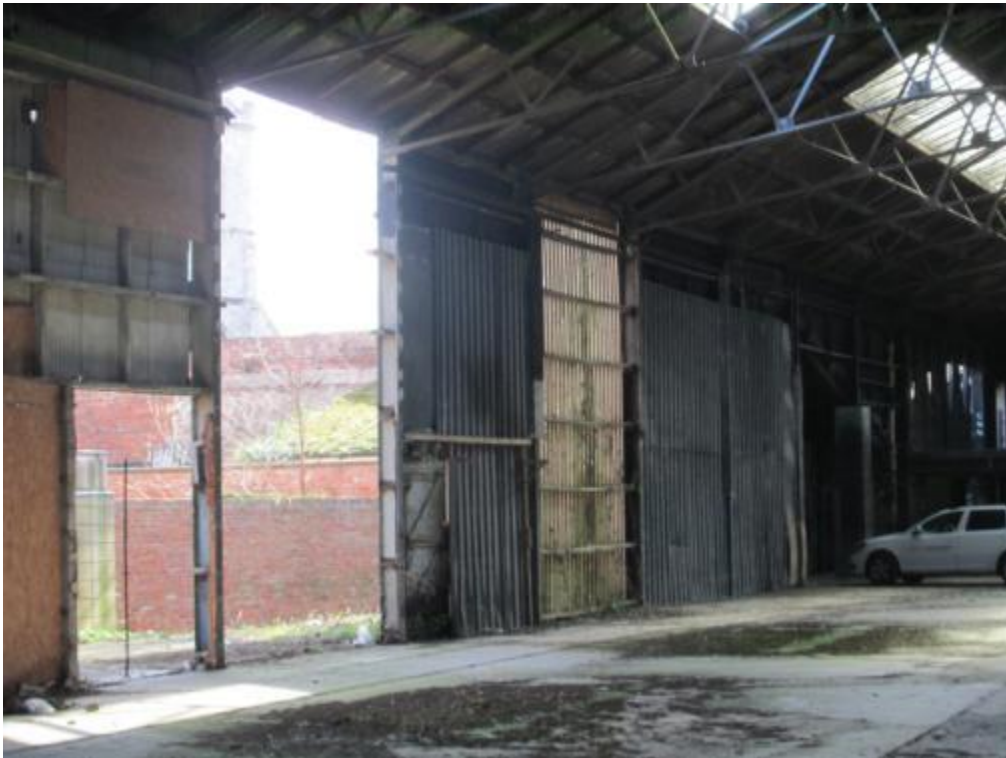
Photograph 41a – Part view on rear elevation

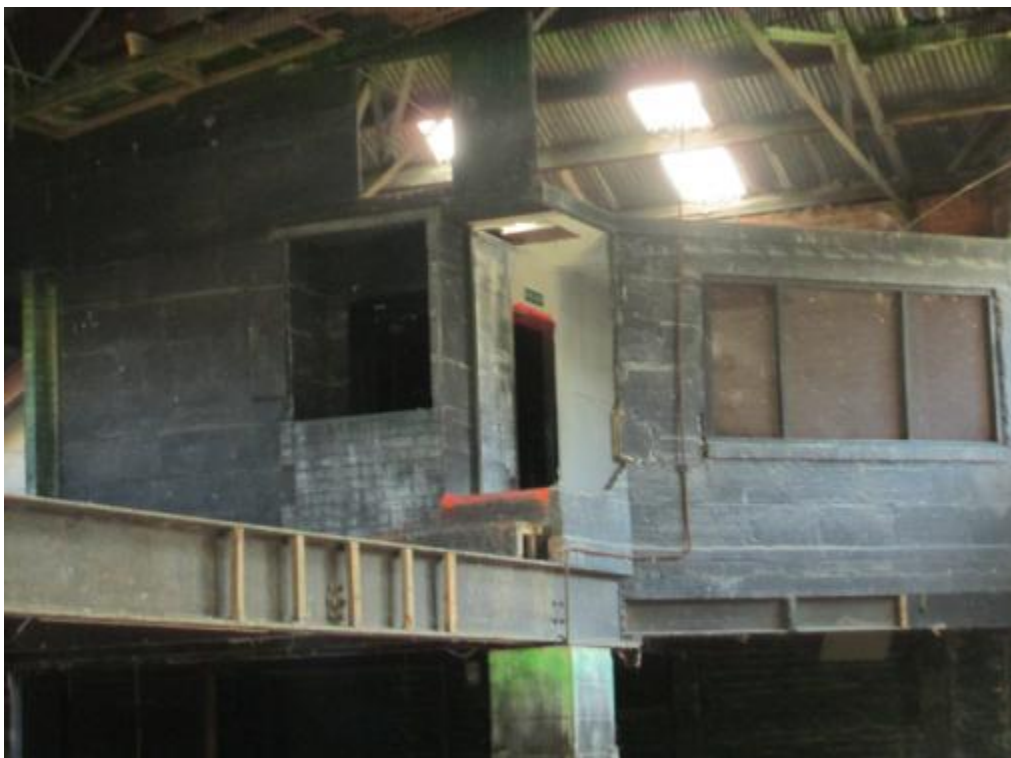
Photograph 42 – Partially demolished wall at Dennis Street

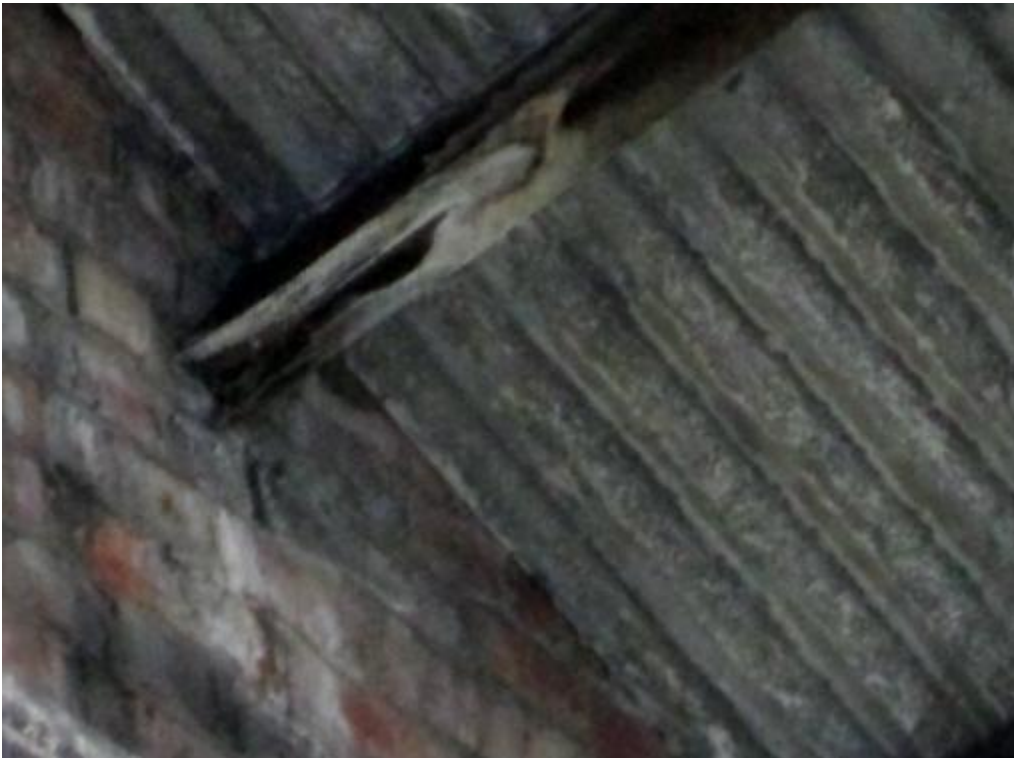
Photograph 47 – Purlin bearing into wall above Piccadilly entrance

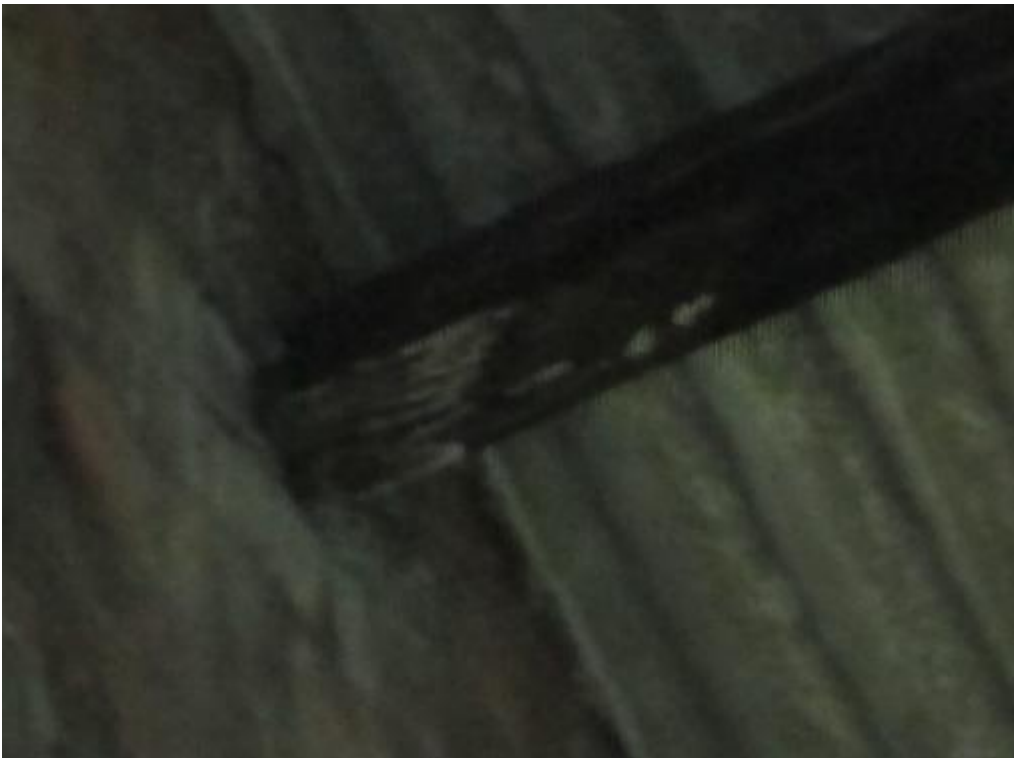
Photograph 48 – Purlin bearing into wall above Piccadilly entrance

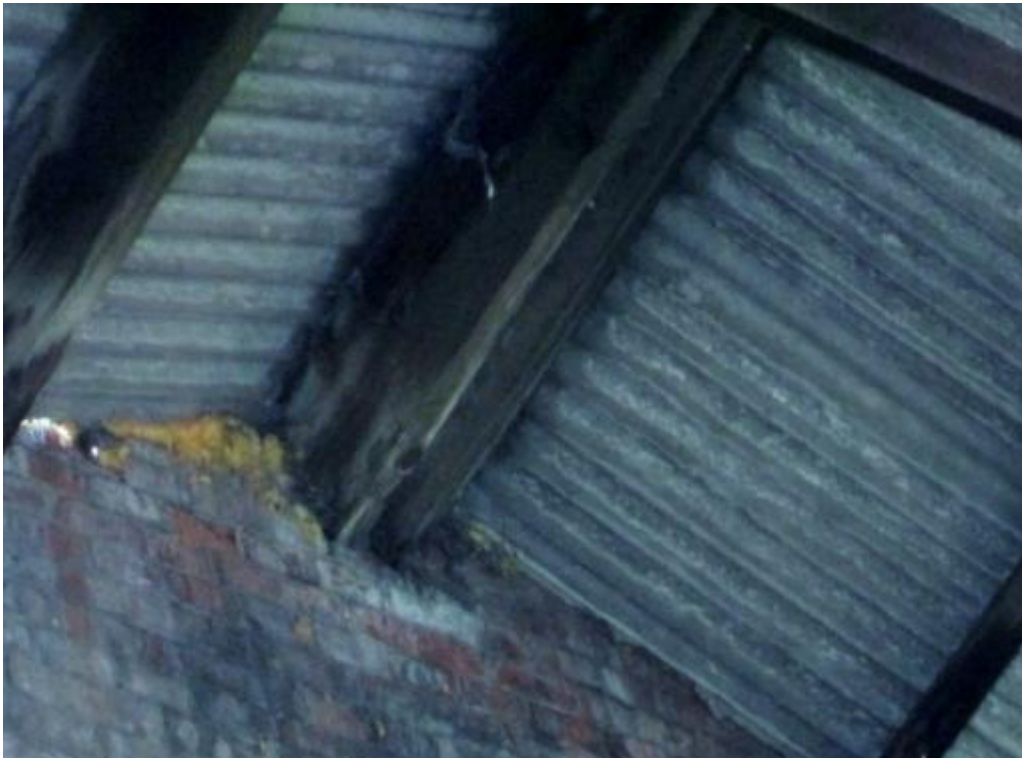
Photograph 49 – Purlins bearing into wall above Piccadilly entrance

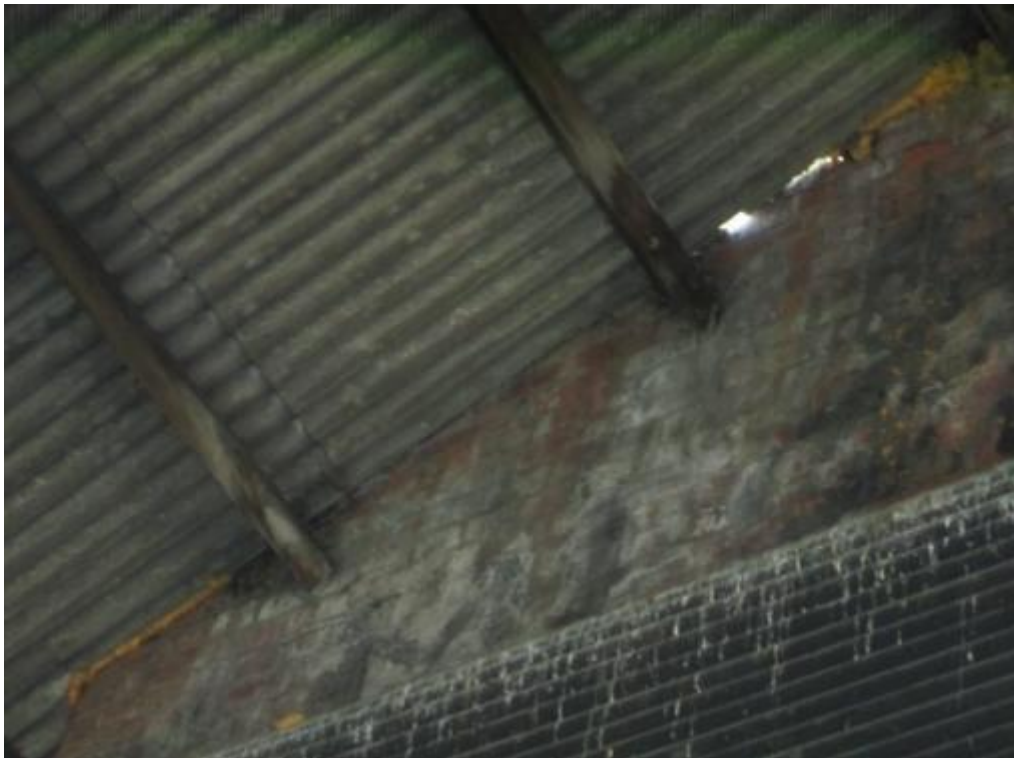
Photograph 49-50 - Purlins bearing into wall above Piccadilly entrance

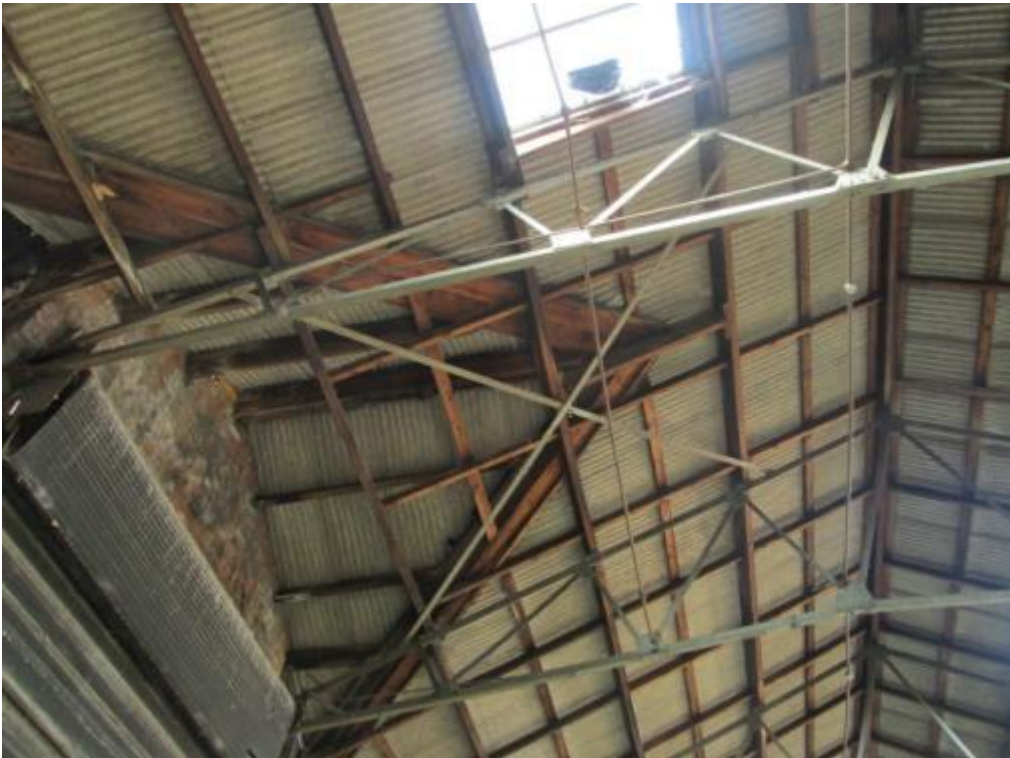
Photograph 52 – Cross bracing in roof

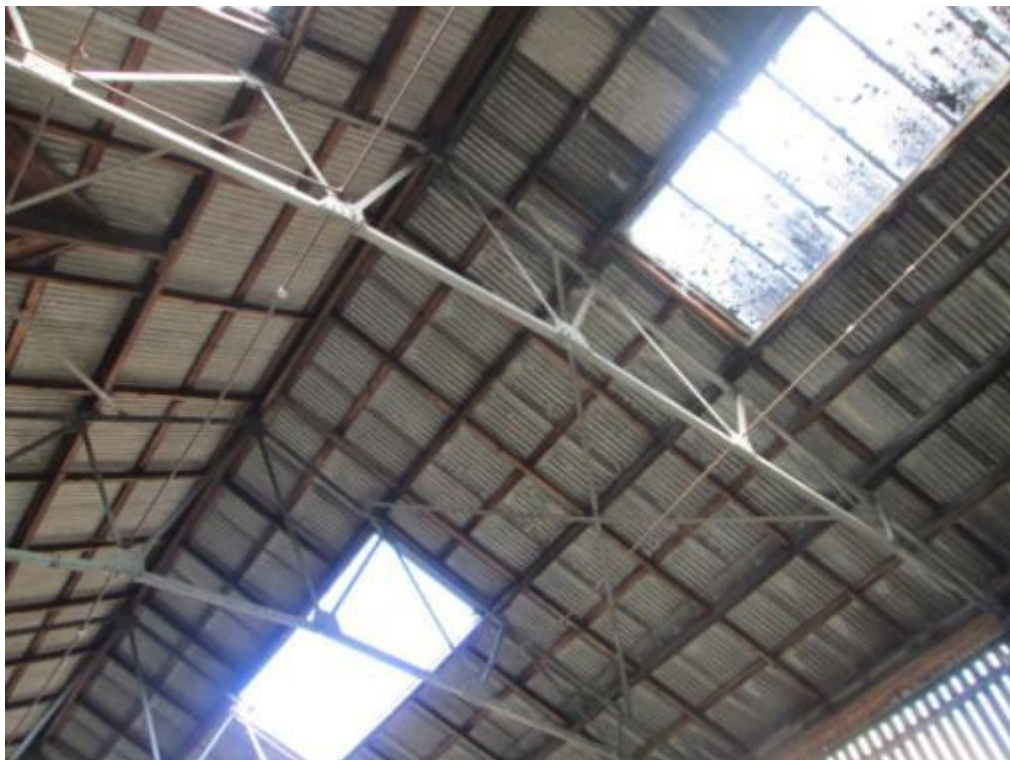
Photograph 53 – Cross bracing in roof

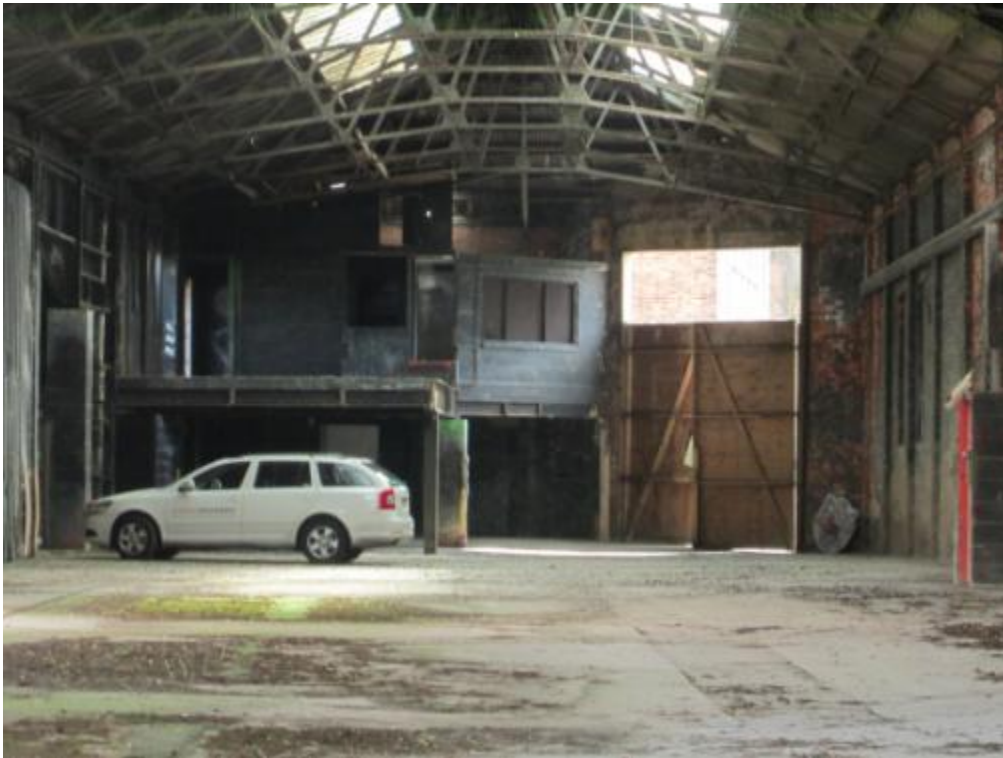
Photograph 59 – Internal view towards Denis Street

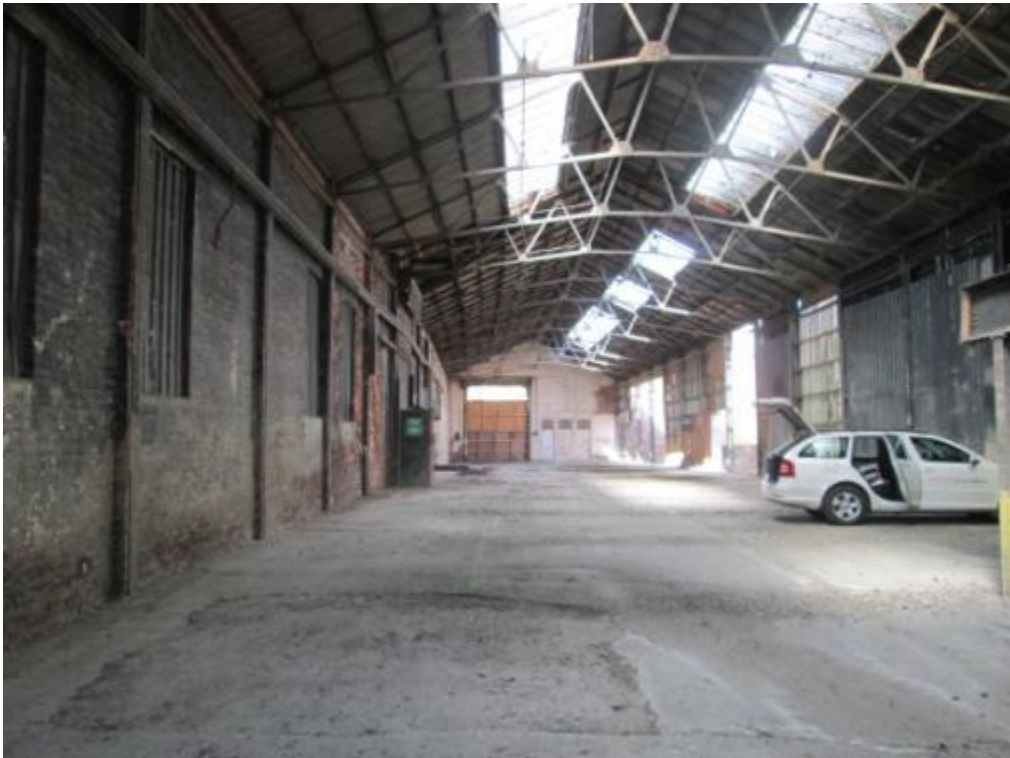
Photograph 61 – Internal view from Dennis Street

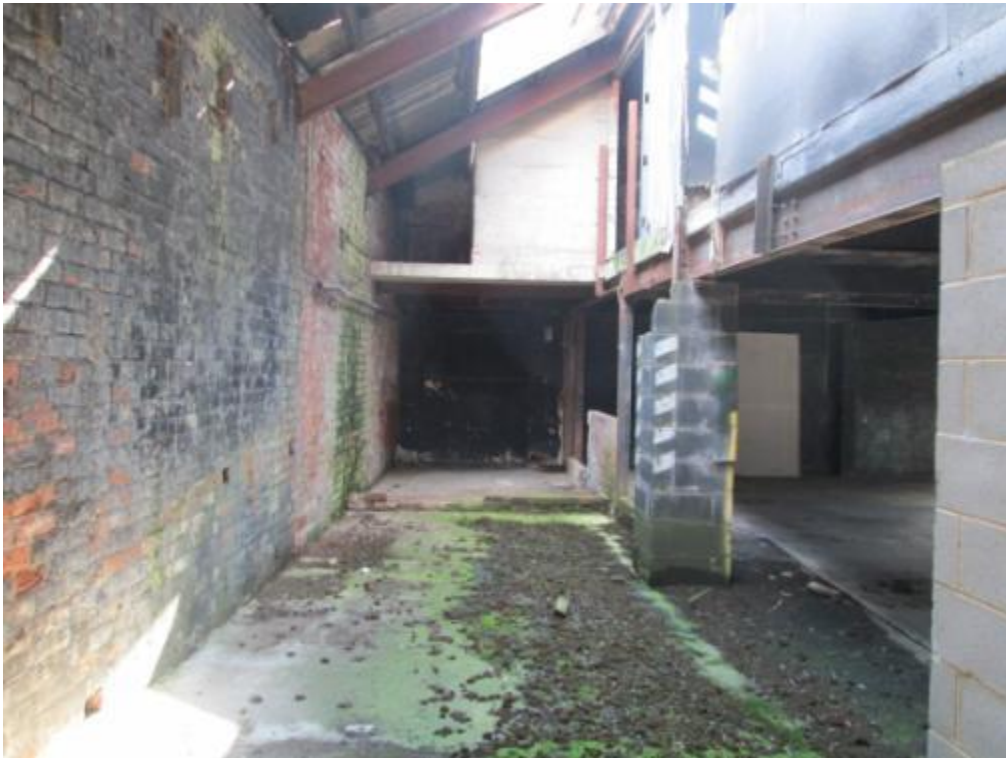
Photograph 63 – Internal view within lean-to looking towards Dennis Street end

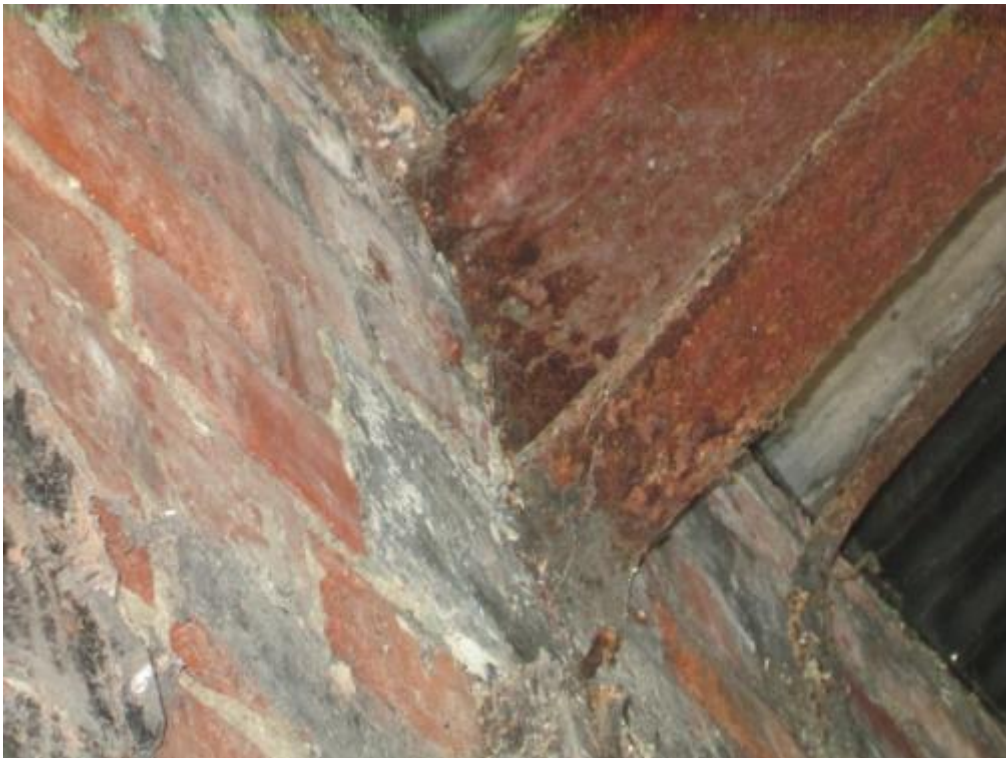
Photograph 67 – Steel rafter over lean-to bearing on external wall

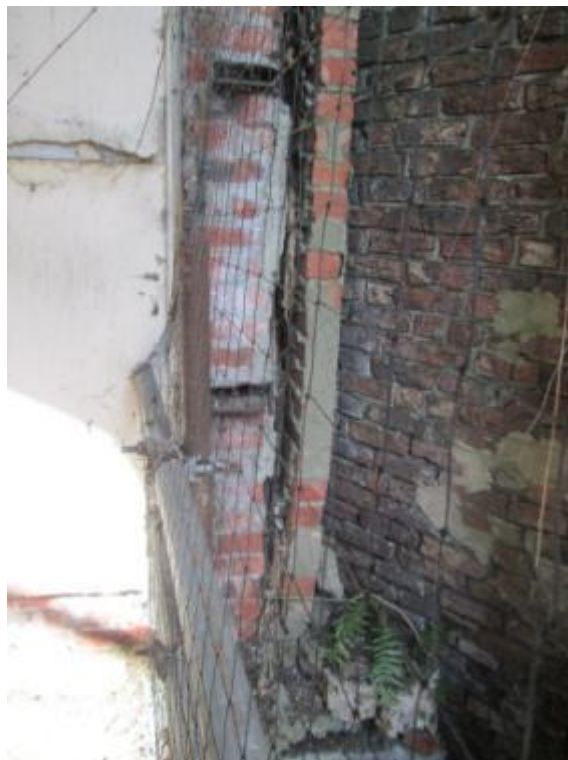
Photograph 71 – Internal view of North West elevation rear corner

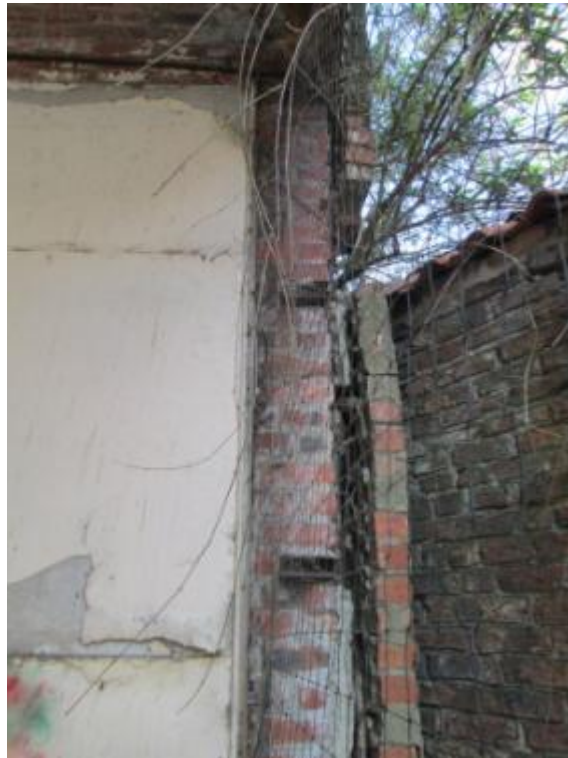
Photograph 72 – Internal view of North West elevation rear corner

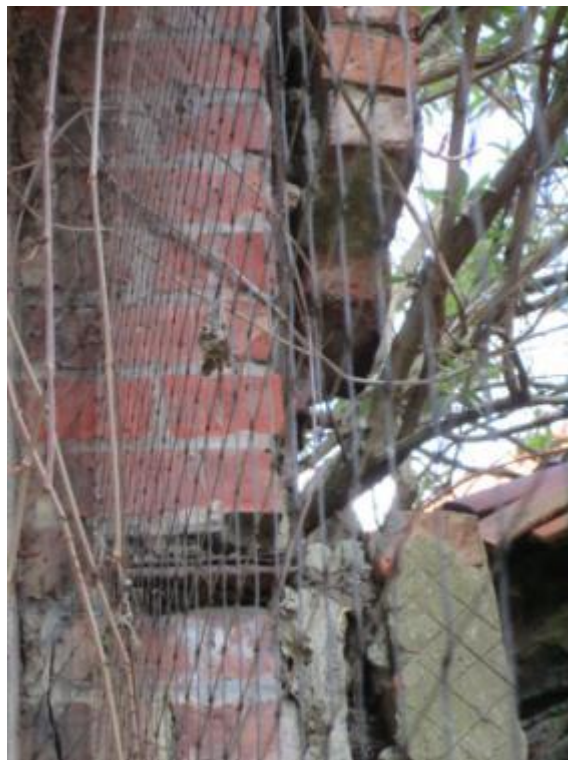
Photograph 73 – Internal view of North West elevation rear corner
