York 13th August 2018 Section 19 Surface Water Flood Investigation

Revision Schedule
City of York Council

Executive Summary

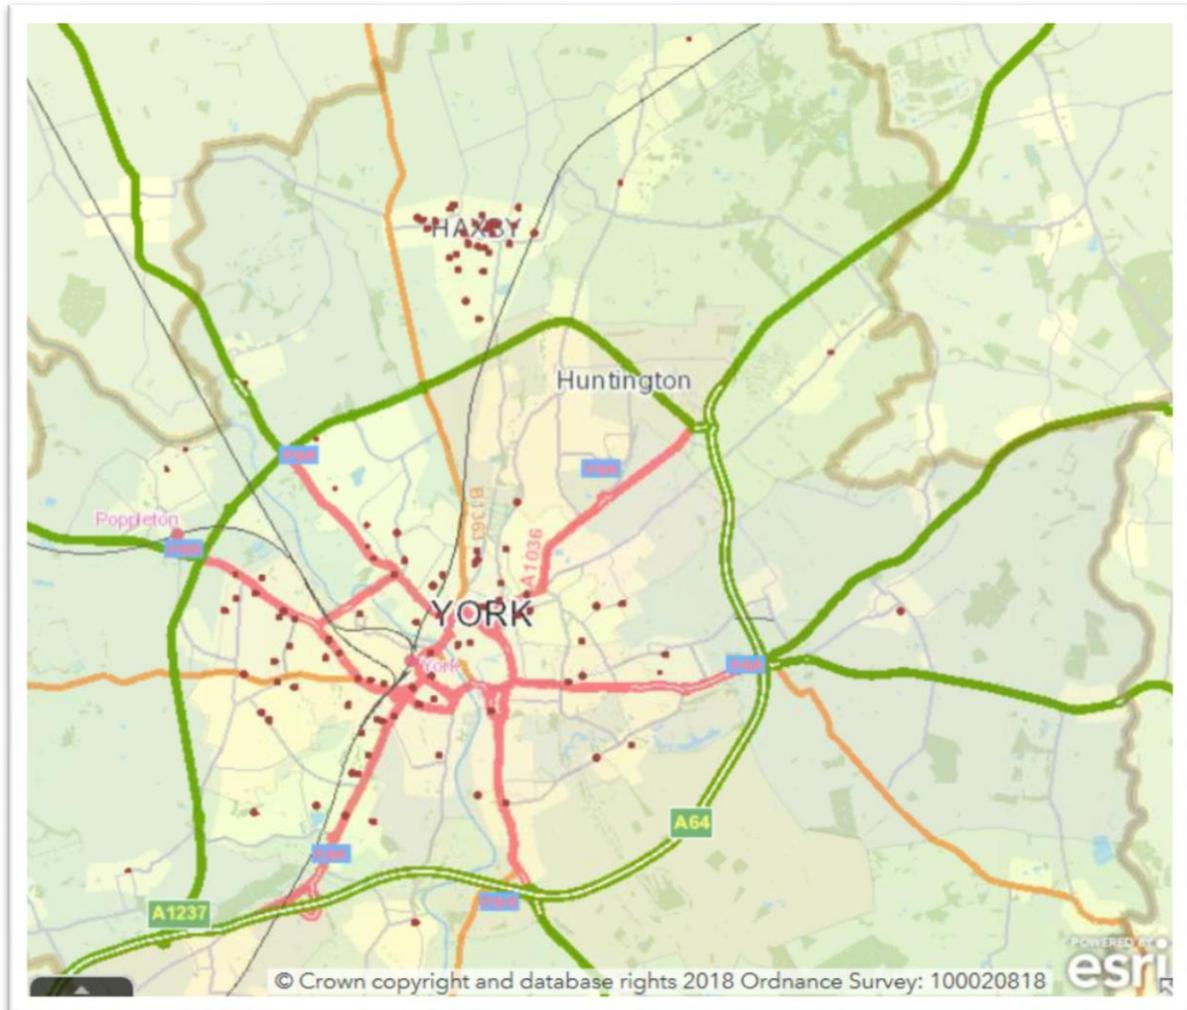
Figure 1 shows the location of significant flooding detailed in Annex 1, wider areas of the highway network which suffered from standing water and temporary blockages are not shown on the map.

Figure 1 – indicative map of flooded locations
