**The Royal Society for the Prevention
of Accidents**

Water Safety Review for:
City of York Council

04 September 2014

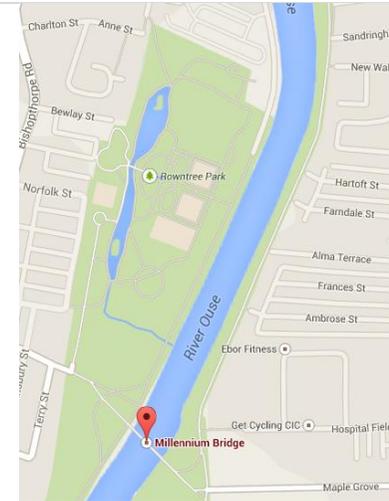
2 West Bank(riverside pathway) from Rowntree park along Terry Avenue to Skeldergate Bridge along Skeldergate with access checked towards Ouse Bridge

<p>Principle hazards observed</p> <p><u>Water</u></p> <ul style="list-style-type: none"> Viewing structure - fall/height Deeper cold water. 	<p><u>Other</u></p> <ul style="list-style-type: none"> See comments relating to the Bridge

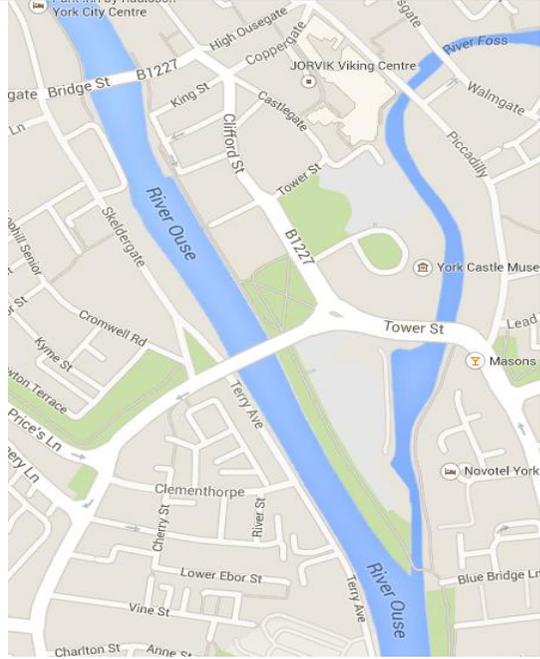
<p>Principle hazards observed</p> <p><u>Water</u></p> <ul style="list-style-type: none"> • Vehicle access/ Turning Circle on Queens Staith • Access to moorings • Access to boats moored by riparian owners • Moorings. 	<p><u>Other</u></p> <ul style="list-style-type: none"> • Riparian ownership restricts access 	
<p><u>Access:</u> Skeldergate.</p> <p><u>Site reviewed:</u> 10/04/14</p>

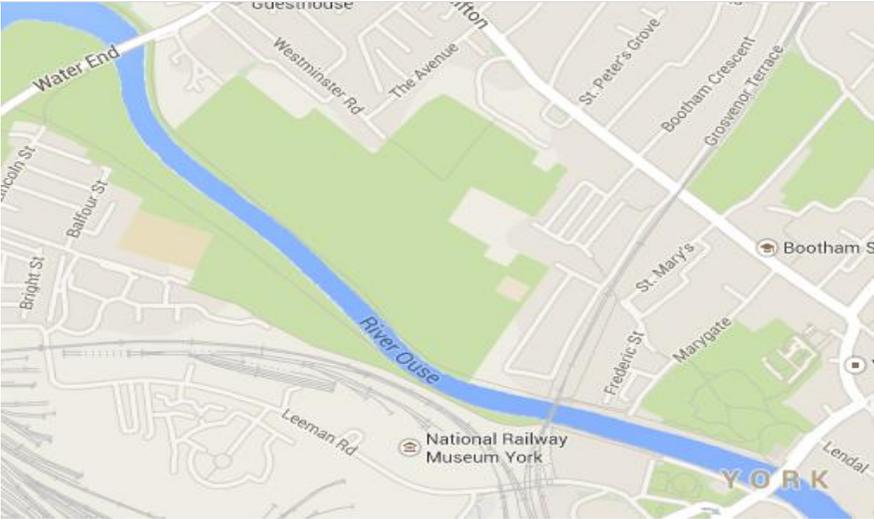
<p>Principle hazards observed</p> <p><u>Water</u></p> <ul style="list-style-type: none"> • Lack of pathway • Popular walking route • Steep slope to water 	<p><u>Other</u></p> <ul style="list-style-type: none"> • Hire boats causing disruption for rowers due to not following speed limit, wearing PRE or following the river code of conduct 	
<p><u>Access:</u> Jubilee Terrace or opposite bank</p> <p><u>Site reviewed:</u> 10/04/14</p>

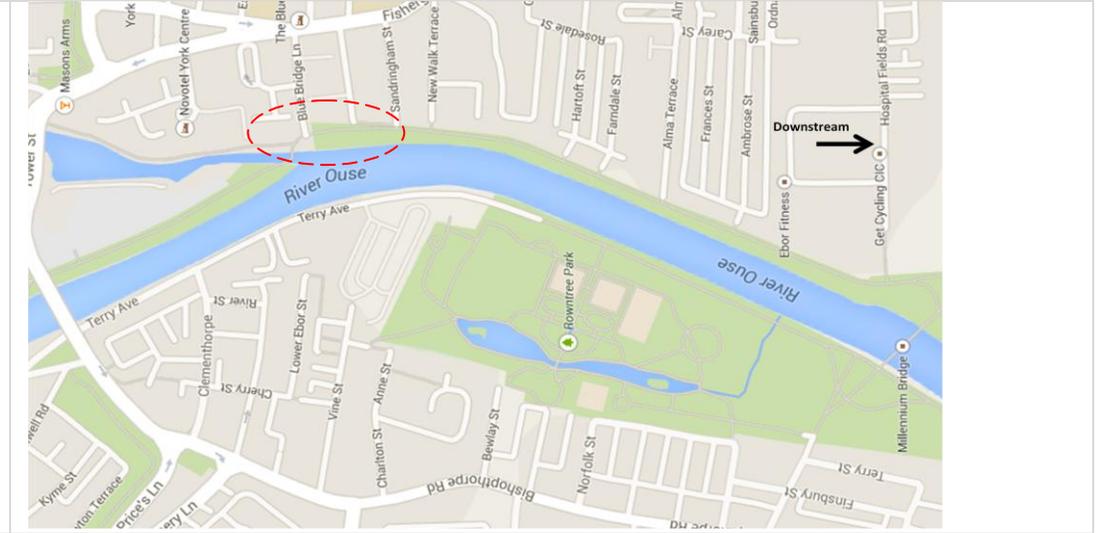
Description:

- This is a very popular area with high footfall and bars close by.
- The coping stones/edge and drains are indistinct and could lead to a trip into the water.

Edge demarcation and fencing improvements, improved rescue equipment.

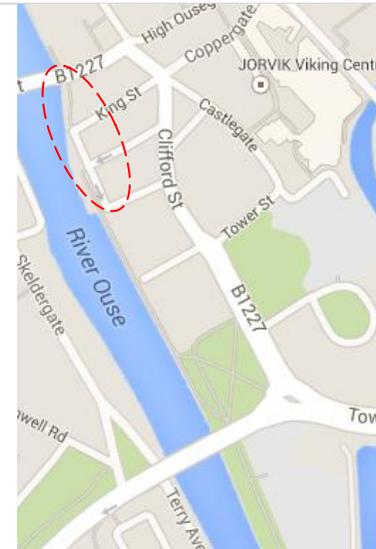
Description:

- Access to the water is protected by suitable railings.
- Terrace to rear of bars shows memorial to Anthony Horrocks who died in 2011. In need of renovation. No swimming or diving signage provided under the memorial, and along the fencing at other locations.

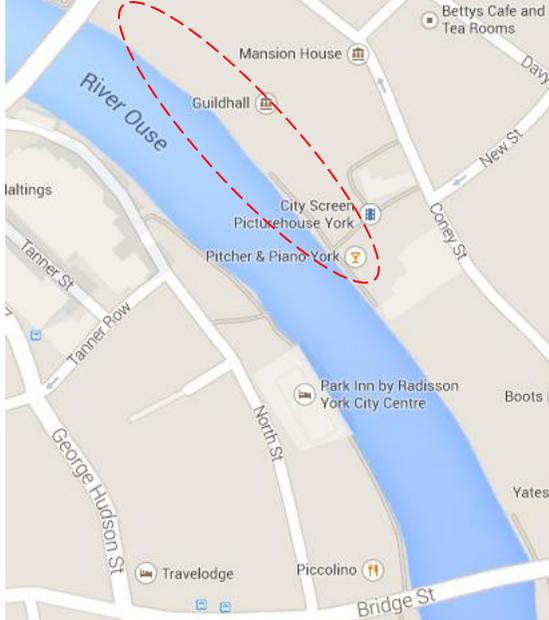
Description:

- Narrow walkway has edge protection provided, the opening out to riverside walk with no edge protection. The embankment is visually distinguishable by cobbles, there are steps down to the lower tier, and a small number of these steps have handrails down to the water's edge.

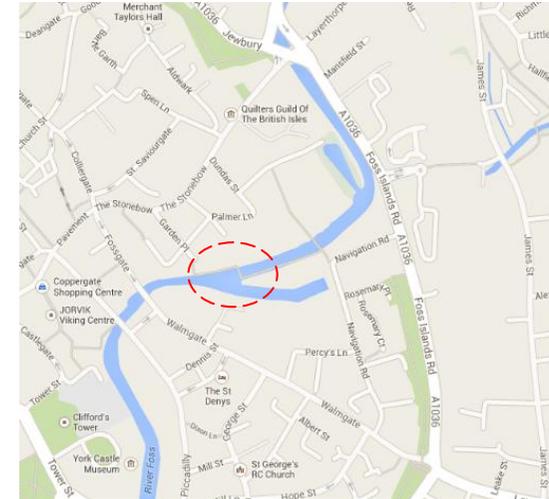
Description:

- No edge protection and high freeboard into water.
- No grab chain along lower part of pathway – exit would require swimming along/ across the river to the opposite bank.
- Both life rings are in a poor condition
- Many changes in surface materials indicating a high risk of trip hazards over time as materials move.
- Old wharf features which are attractive as play features to children (children overheard suggesting they had played a game of leaping between them)
- Old pedestrian bridge has been closed
- Fencing older style metal 4 rail fence, old but serviceable condition, flat wide pavement
- Life rings provided on private properties on far bank – appear to be inaccessible
- It was unclear why the balcony feature had exclusion fencing provided.
- Handrail and textured surface applied to old boardwalk to reduce slipping – good feature

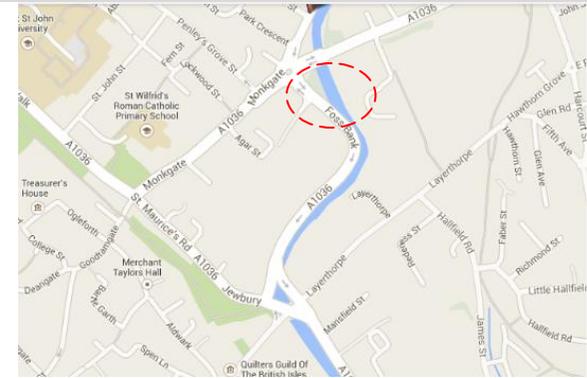
Description:

- Life rings provided in park in visible locations. No signage provided, many opportunities for children to feed the water birds. Many birds indicating a popular feeding spot. Tactile paving to parts of the edge.

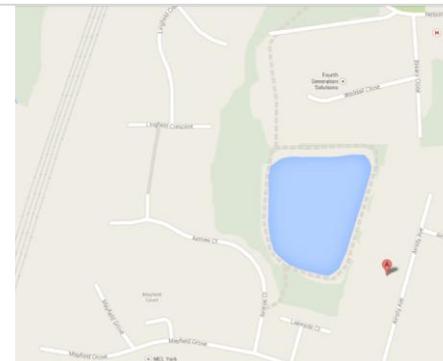
Description:

- Medium sized attenuation reservoir linked to Dale Dyke, adjacent to Rawcliffe Infant and Junior school.
- Two sluice structures at either end of lake, along with overflow channel form Dyke.
- The majority of lake hinterland is open grass with a shallow aspect.
- Path set back between 3-5metres.
- A number of small floating (bird) islands sit some 70metres out.
- Signage notes 'no boating' and 'alcohol' and 'deep water'.
- Perry Buoy PRE used at several points around lake, with buoys in housing.
