York Consultancy <i>Consultants of first choice</i>		 CITY OF YORK council	
DRAWN BY Engineer Brian Carter	INITIAL DRowntree Brian Carter	REV 3a 3b	AMENDMENT New Timber bollards + tactile moved outside no.54 Crossing point removed to retain 2 on street car parking spaces. Additional single drop kerb near bus stop provided.
SCALE 1:250 @A.3	DATE JULY 2004	DATE 11.04 01.05	DATE 11.04 01.05
Fishergate Ward Committee Pedestrian crossing improvements, Broadway			
TSWC/0409245/03 b

Ward Committee Scheme 06/07 Report to Fishergate Ward Committee

Broadway Shops – Parking and Pedestrian Access

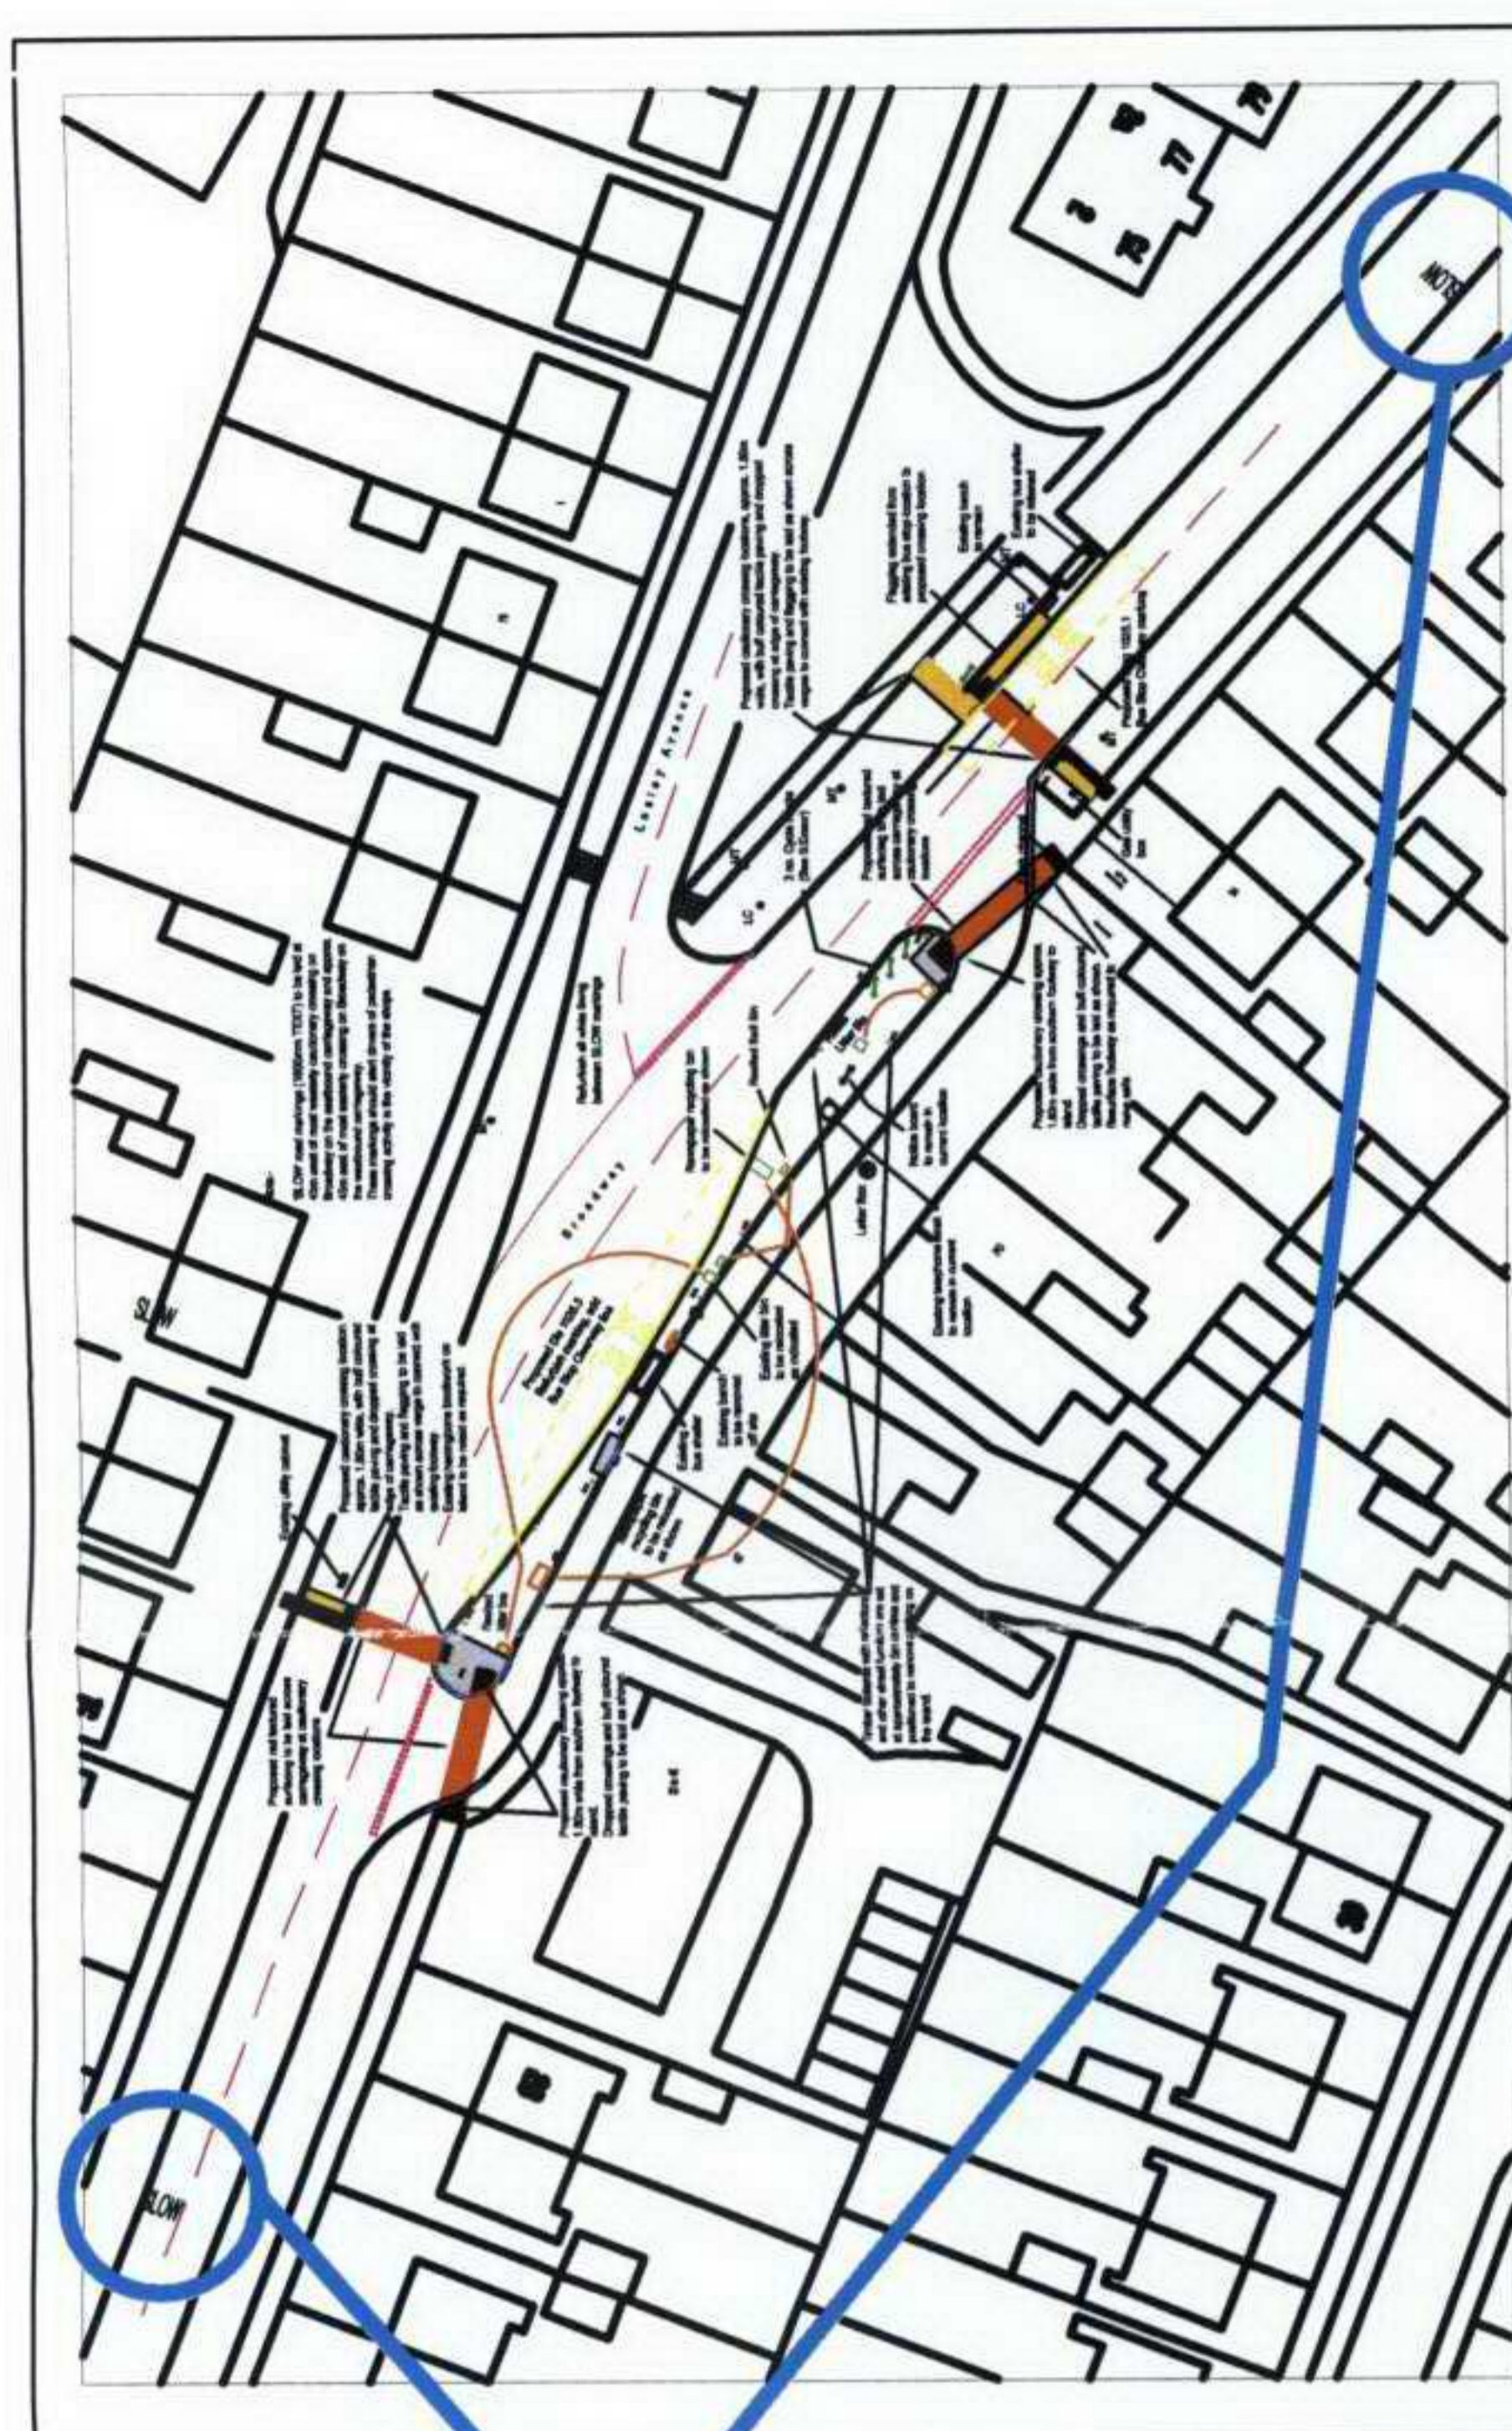
Note:-
 'SLOW' road markings (1600mm TEXT) to be laid at 45m west of most westerly cautionary crossing on Broadway on the eastbound carriageway and approx. 45m east of most easterly crossing on Broadway on the westbound carriageway.
 These markings should alert drivers of pedestrian crossing activity in the vicinity of the shops.

Proposed red textured surfacing to be laid across carriageway at cautionary crossing locations

Proposed cautionary crossing location, approx. 1.80m wide, with buff coloured tactile paving and dropped crossing at edge of carriageway.
 Tactile paving and flagging to be laid as shown across verge to connect with existing footway.
 Existing herringbone blockwork on island to be relaid as required.

Proposed cautionary crossing approx. 1.80m wide from southern footway to island.
 Dropped crossings and buff coloured tactile paving to be laid as shown.

Proposed cautionary crossing locations, approx. 1.80m wide, with buff coloured tactile paving and dropped crossing at edge of carriageway.
 Tactile paving and flagging to be laid as shown across verges to connect with existing footway.

Proposed cautionary crossing approx. 1.80m wide from southern footway to island.
 Dropped crossings and buff coloured tactile paving to be laid as shown.
 Resurface footway as required to make safe.

Timber bollards with reflectors and other street furniture are set at approximately 5m centres and positioned to remove parking on the island.

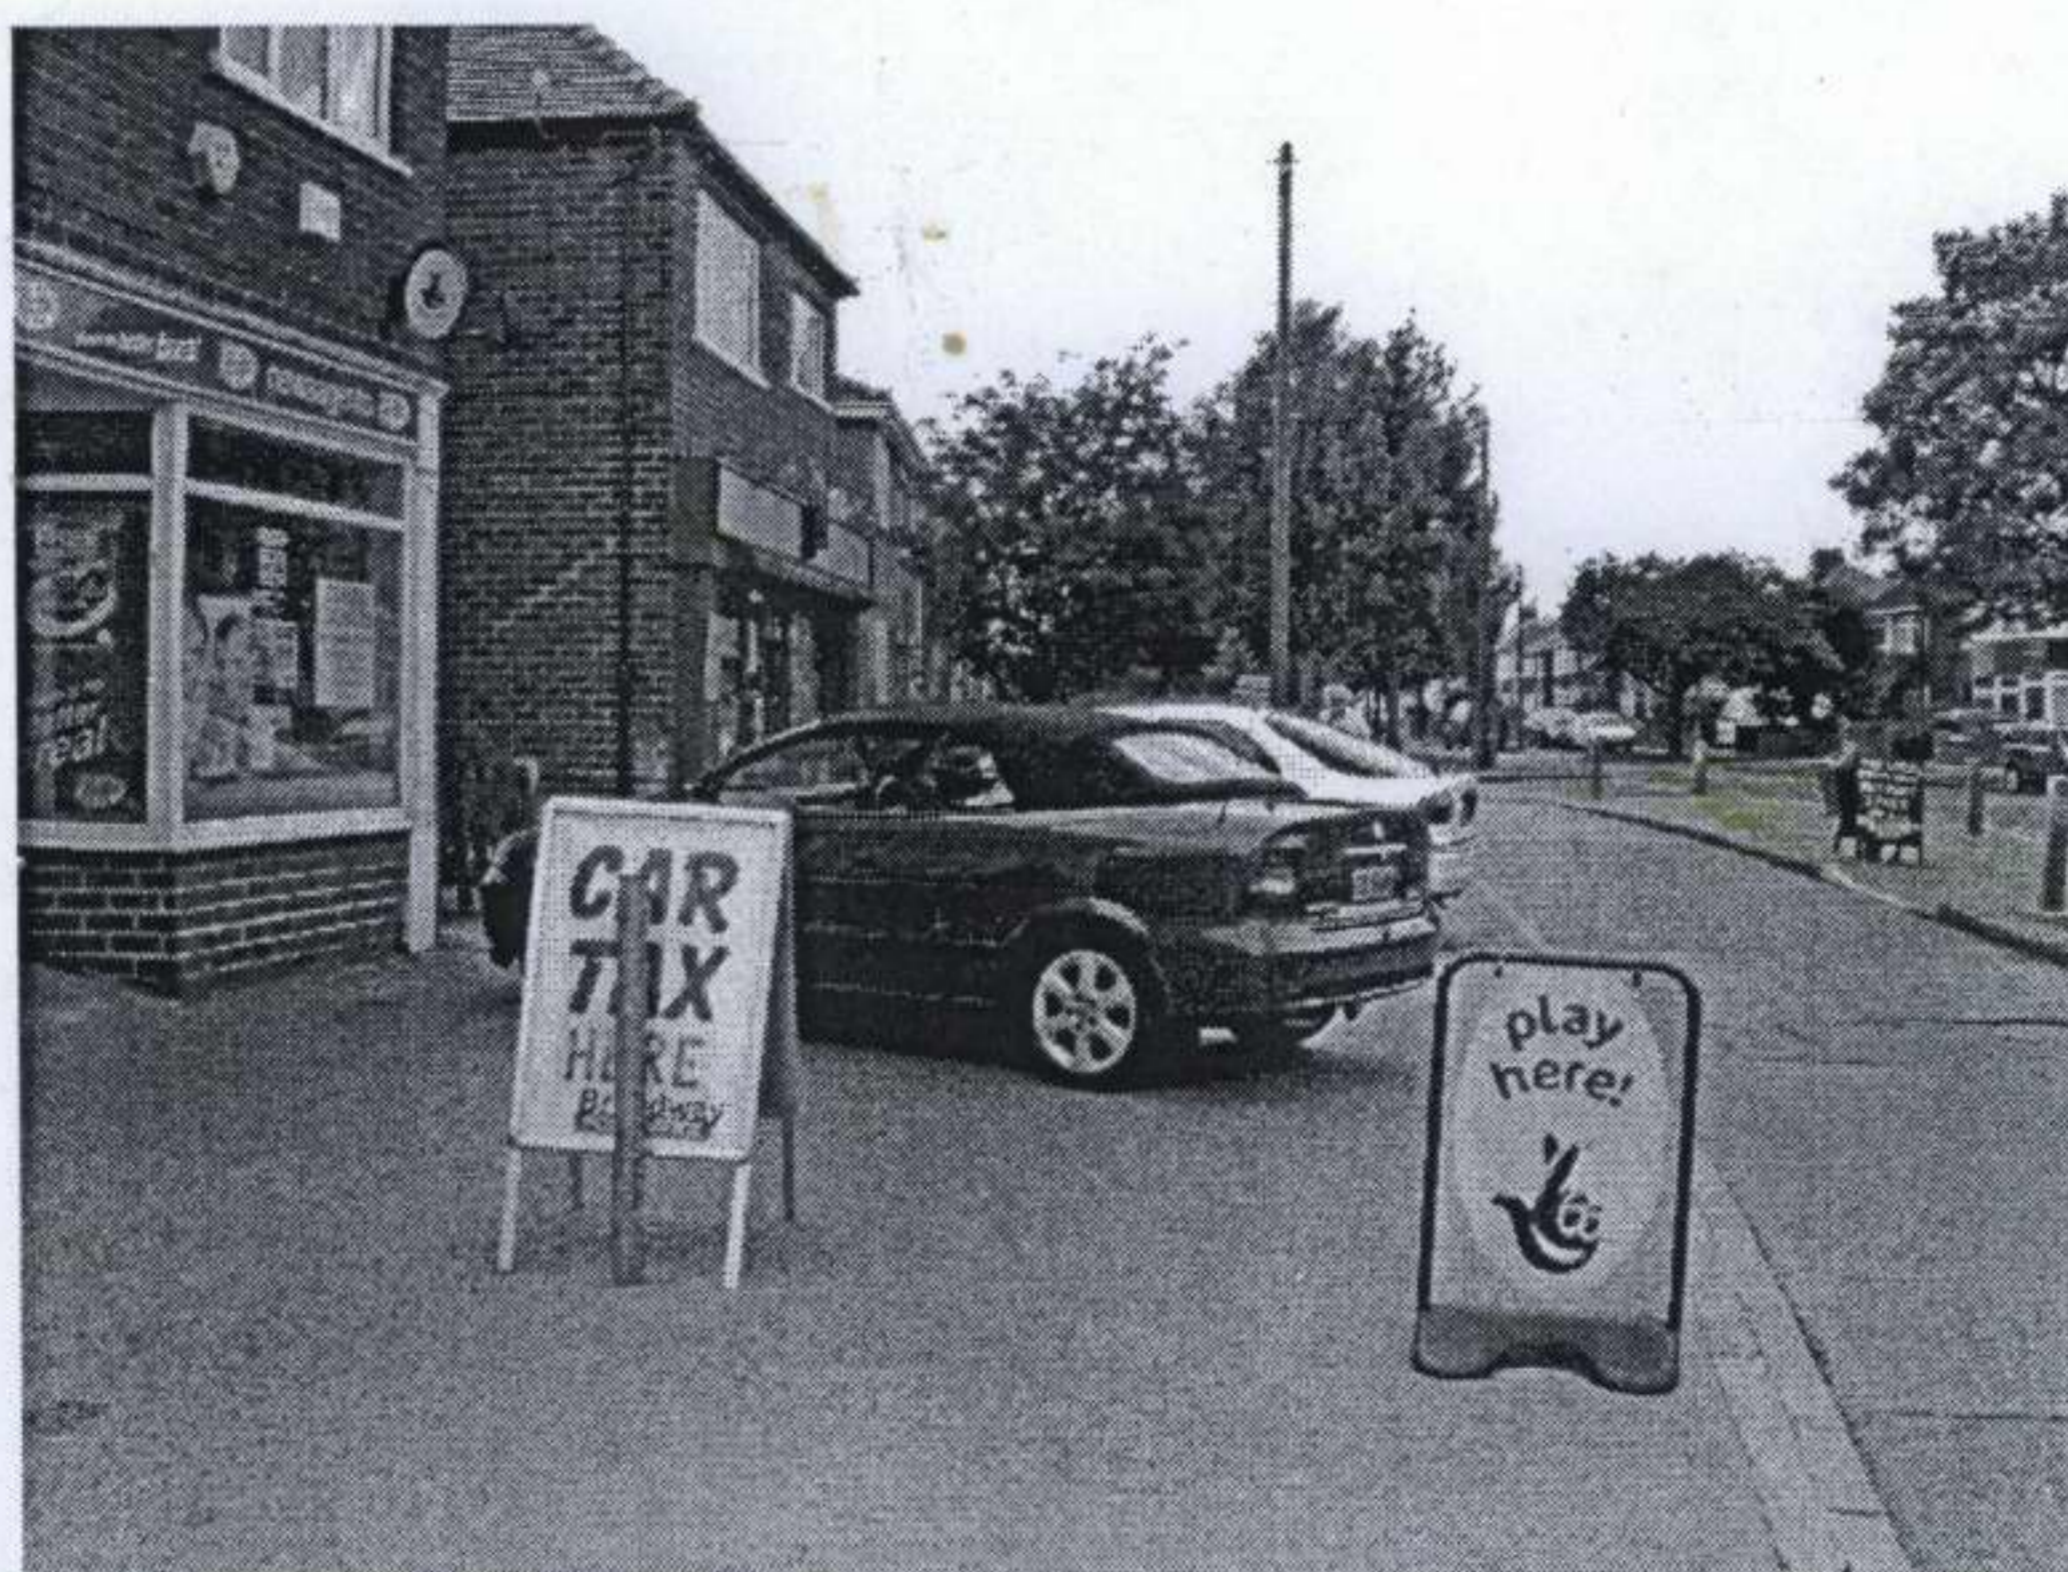
Haphazard parking effectively blocking the forecourt area for pedestrians

- 2.4 At present, vehicles ride up on to the forecourt area and park in a haphazard fashion there, with pedestrians having to thread their way around the parked vehicles, and occasionally having to take evasive action when vehicles ride up unexpectedly on to the forecourt area.
- 2.5 The lack of defined areas for pedestrians and vehicles on this forecourt is at the root of this problem, and poses particular difficulties for visually- impaired pedestrians, those in wheelchairs, and others pushing prams/ buggies.

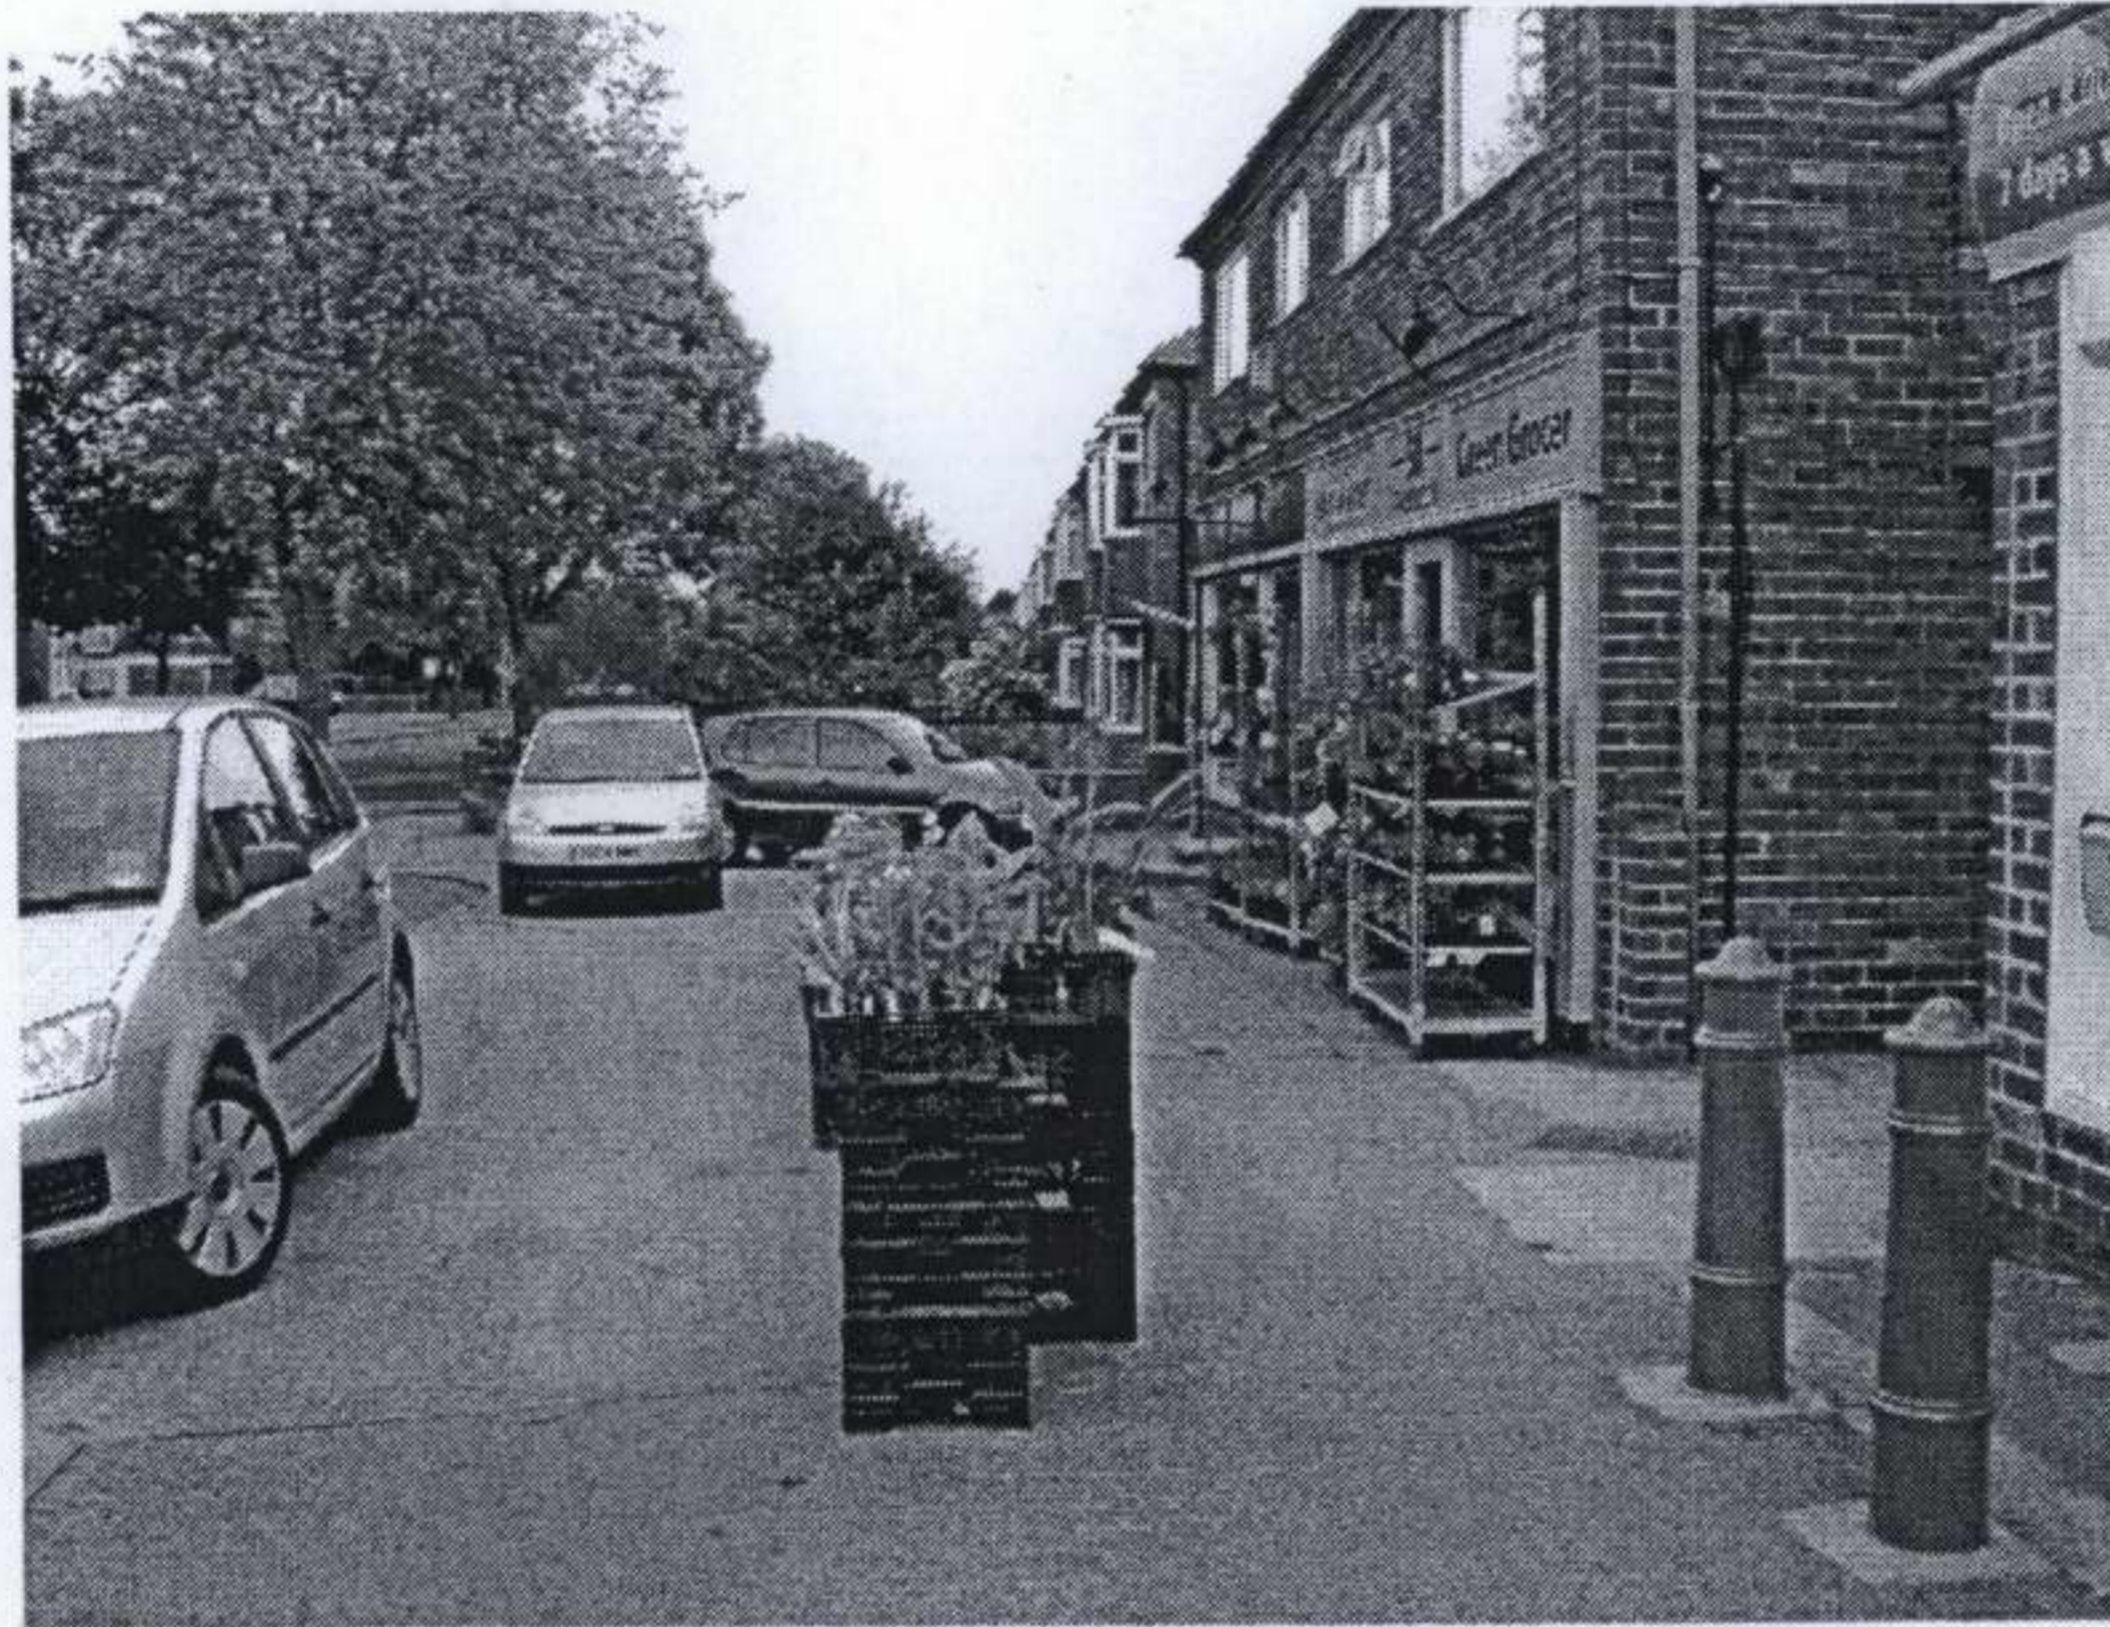
Parking and merchandise on the forecourt area
