Surface Water Management Plan

Executive Summary

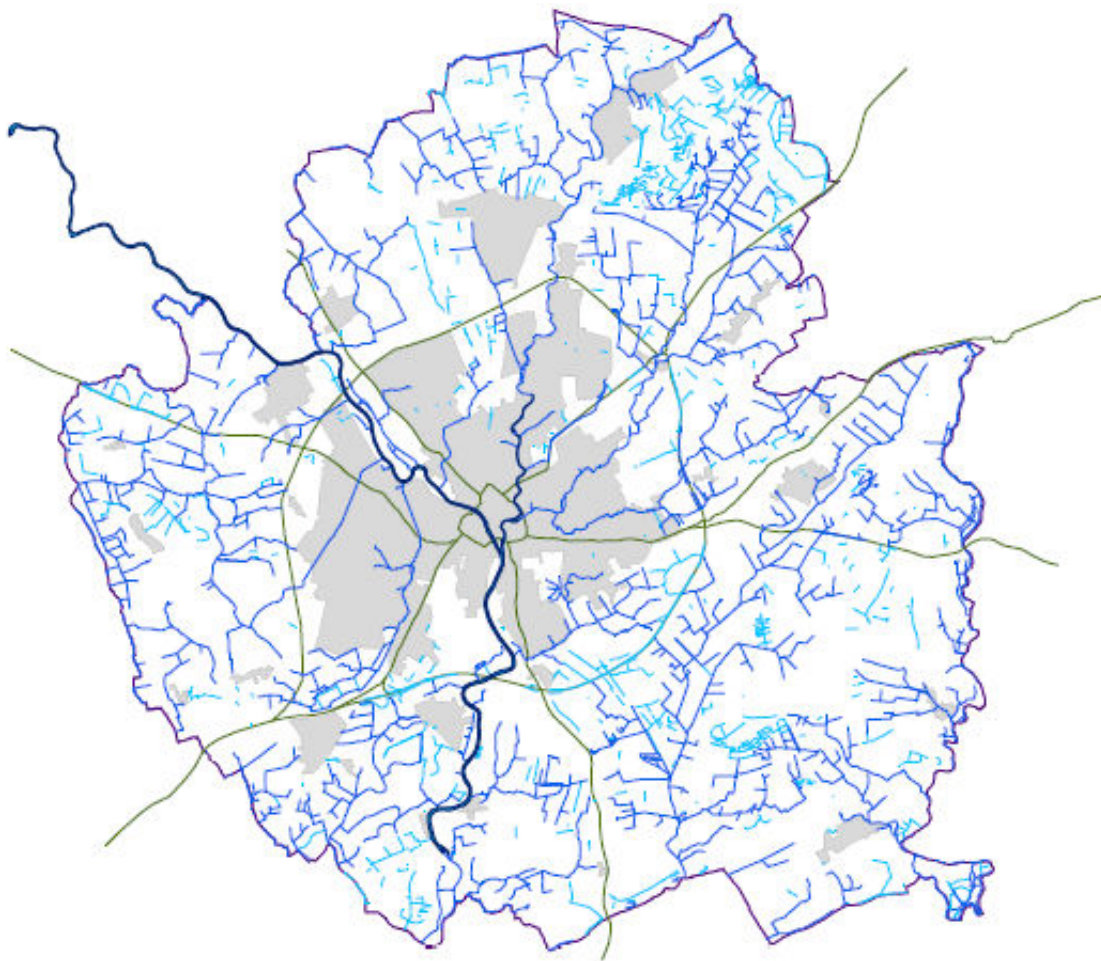
- 1.14 York is located at the confluence of the River Ouse and the River Foss with the River Derwent forming its eastern boundary with East Riding of Yorkshire Council. These rivers drain three catchments, the Yorkshire Dales, Howardian Hills and North York Moors respectively. The Ouse and Derwent are classified as Main Rivers, under the management of the Environment Agency, for their entire length though the area. The Foss is Main River for a distance of 3.3 km upstream of its confluence with the Ouse and beyond that point is an ordinary watercourse, the responsibility of the Foss (2008) IDB.
- 1.15 The three Main Rivers all run generally in a southwards direction, fed by a number of various sized tributaries. The river network is shown on Figure 1.4.

Figure 1.4 – Detailed River Network
