**INSPECTION REPORT
River Ouse Riverbank**

**Report 22594-H-RP-001-R0
20 November 2024**

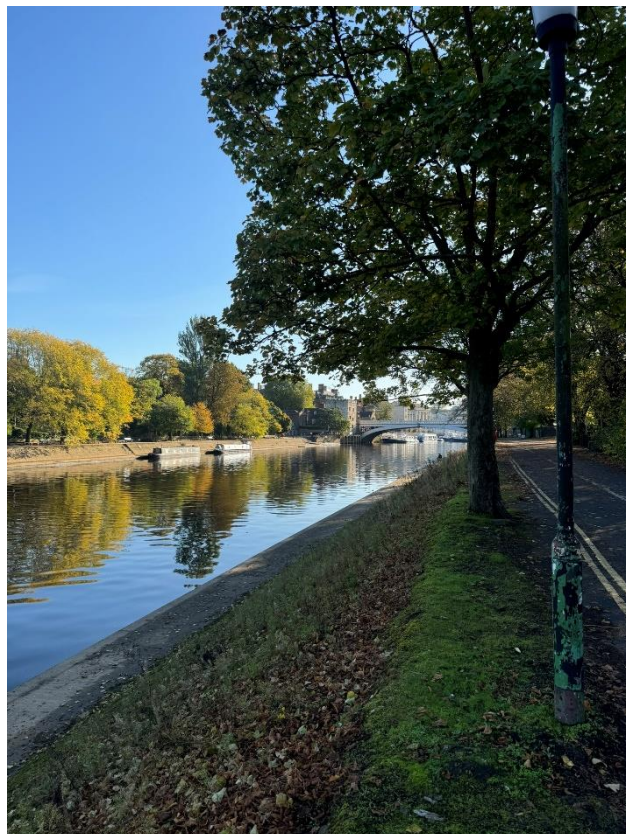
01 Photo of the river embankment from the Scarborough Rail Bridge looking eastwards towards York city centre.

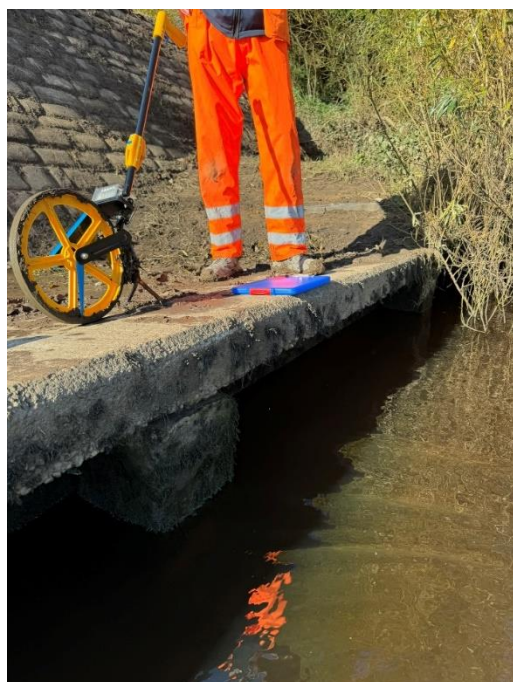
02 Capping beam at the furthest point along the riverbank, approximately 270m upstream from the Scarborough Rail Bridge.

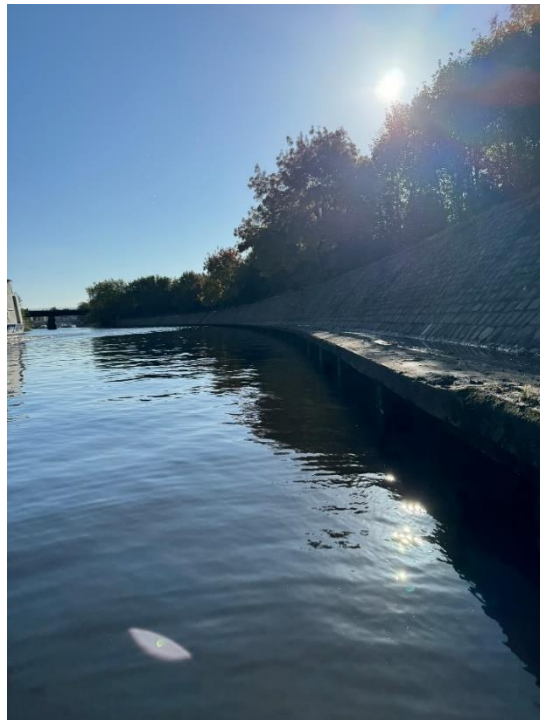
03 Looking downstream towards the Scarborough Rail Bridge.

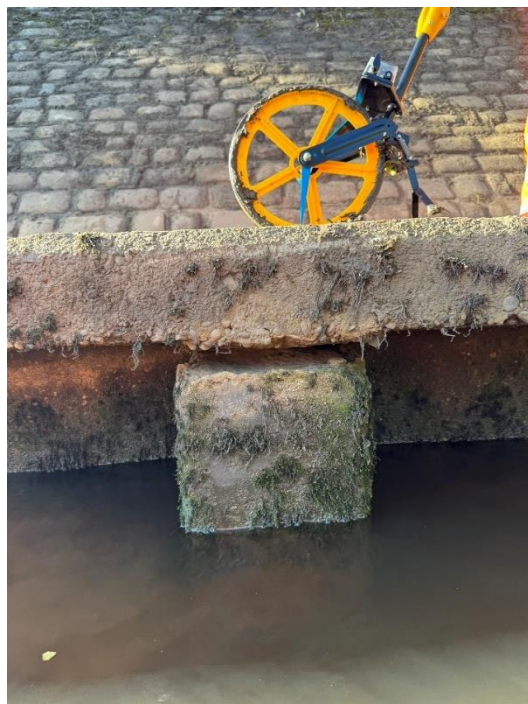
04 Gap between the capping beam and pile. The capping beam not bearing onto the pile. Steel reinforcement exposed on the top of the pile.

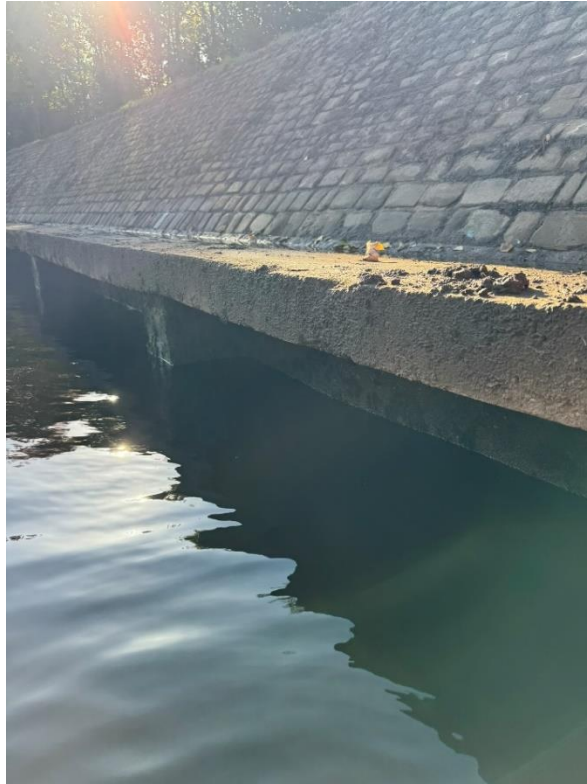
09 Photo of capping beam in ok condition.

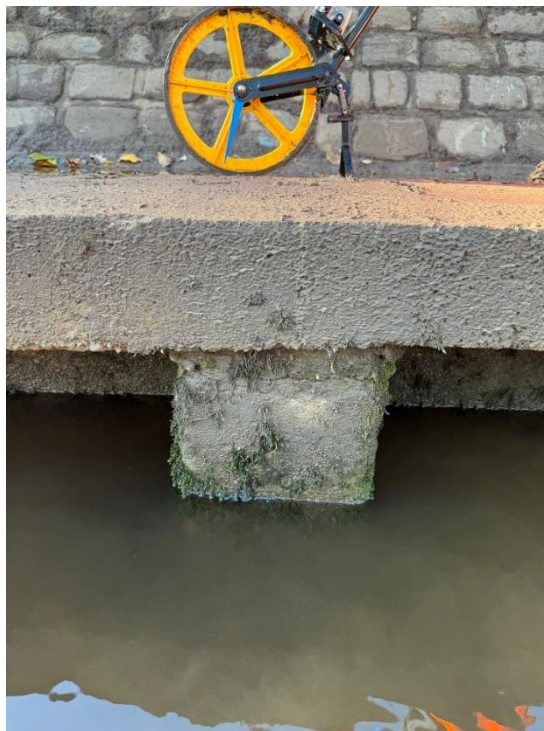
10 Photo of capping beam in ok condition. Cracks in the top of the pile.

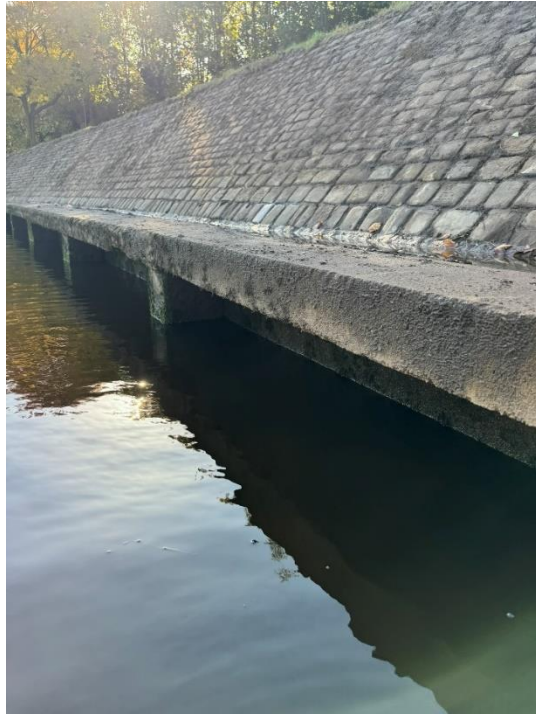
11 Photo of capping beam in ok condition.

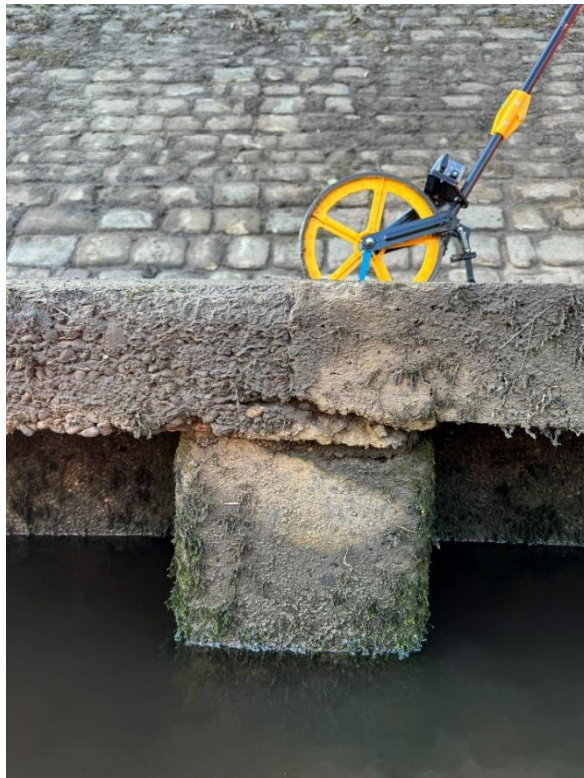
12 Cracking on the bottom of the capping beam.

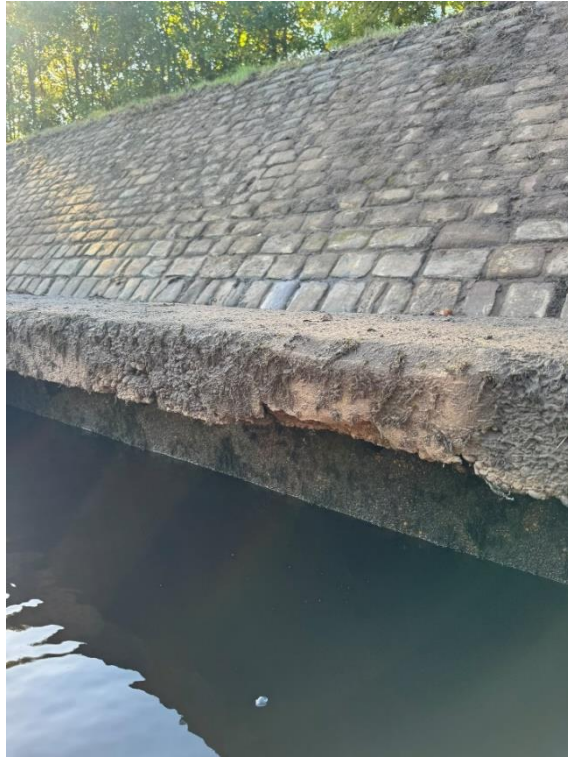
13 Photo of concrete spalling on the bottom of the capping beam.

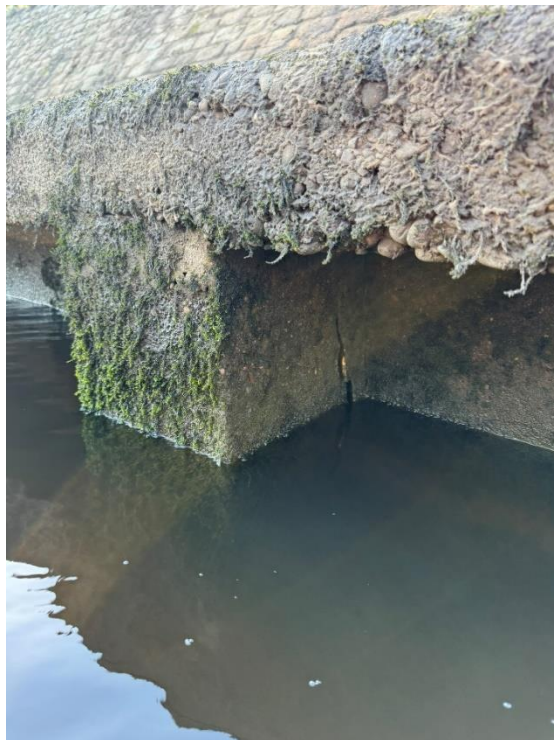
- 16 Aggregate visible at the surface of the capping beam. Crack at the back of the pile.

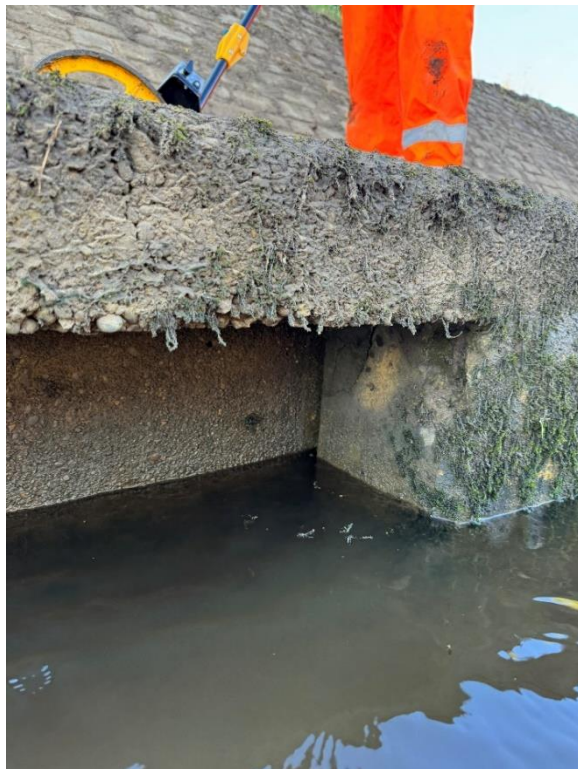
18 Aggregate visible at the surface of the capping beam. Gap between the retaining wall and pile.

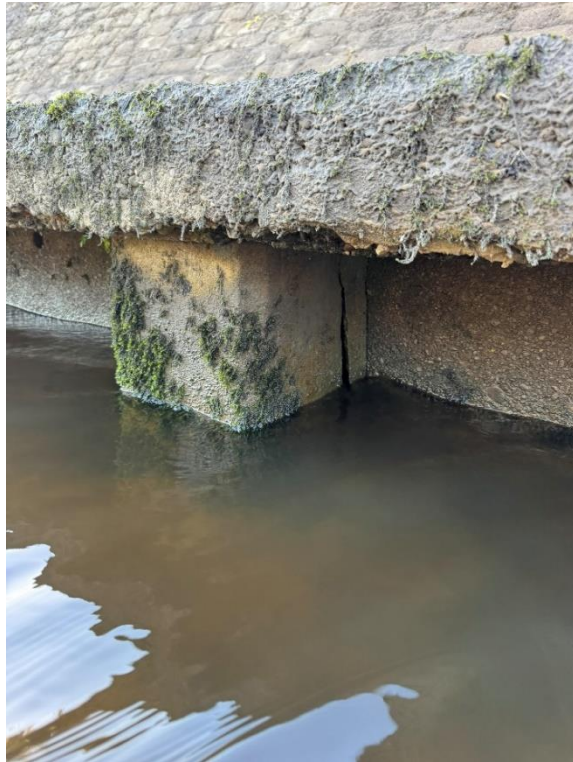
19 Aggregate visible at the surface of the capping beam. Crack at the back of the pile.

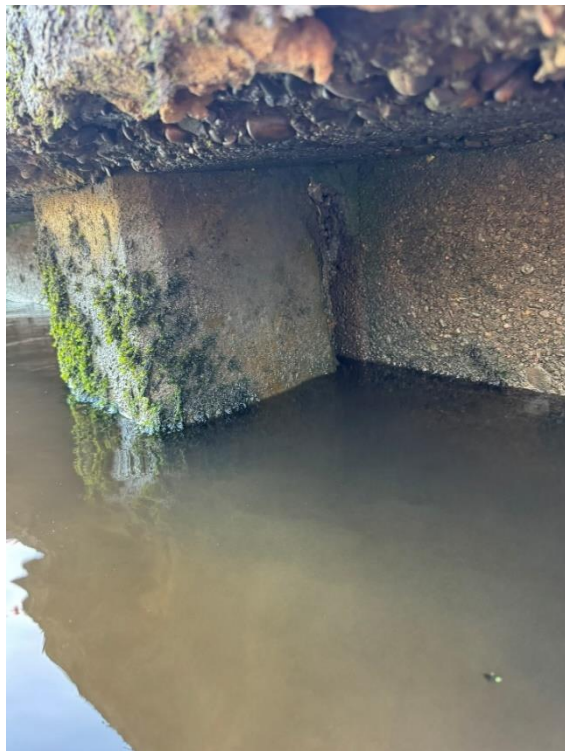
20 Aggregate visible at the surface of the capping beam. Spalling at the back of the pile with exposed and corroded steel reinforcement.

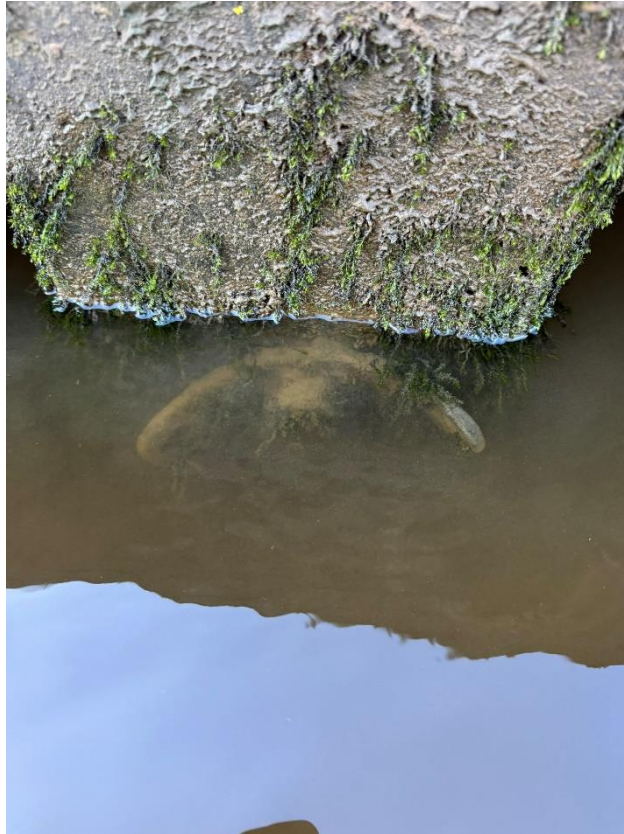
27 Steel anchor threaded through concrete pile.

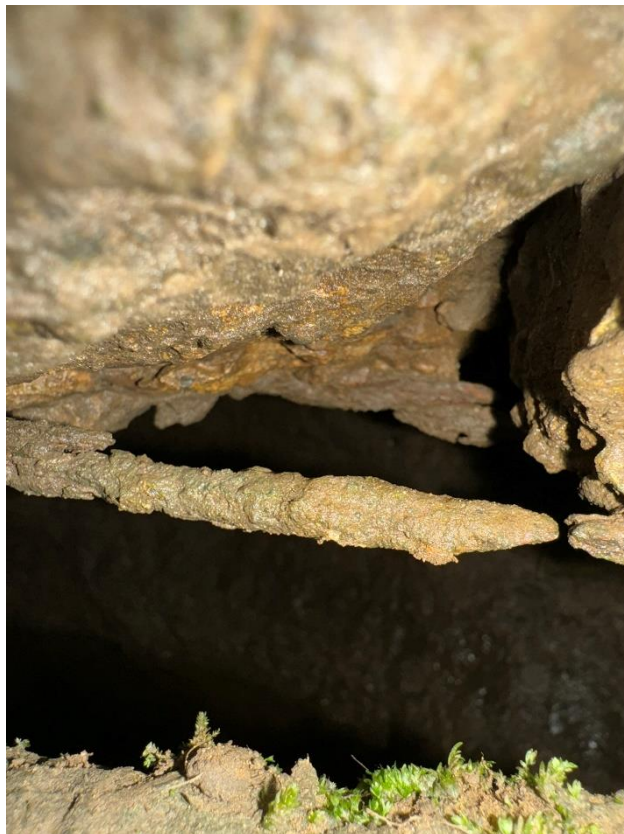
- 32** Top of retaining wall is visible through the capping beam. There is a void behind the retaining wall.

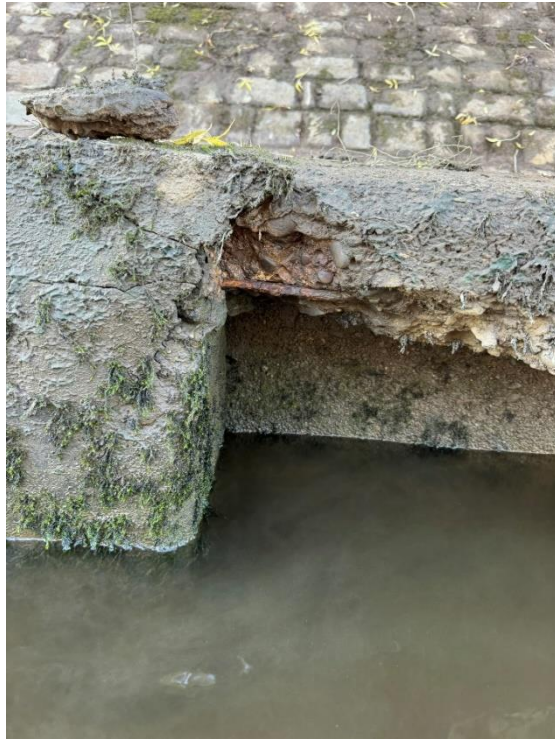
33 Concrete spalling and exposed corroded steel reinforcement in the capping beam. Surface cracks on the pile.

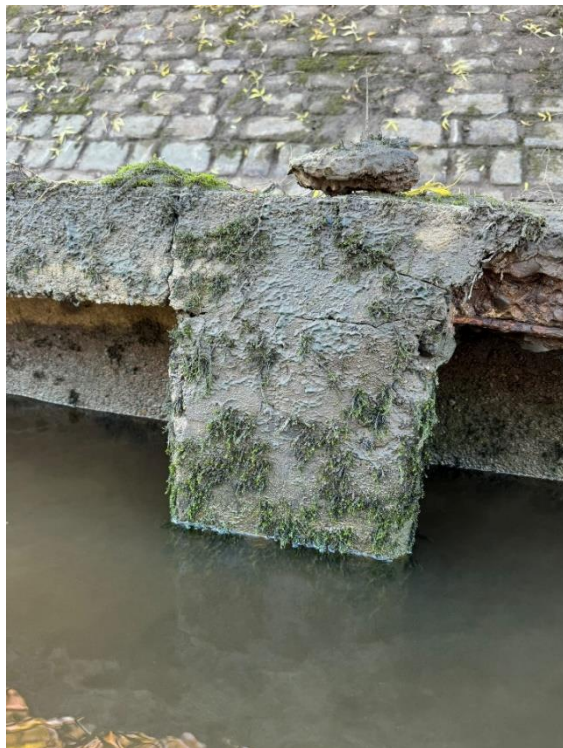
34 Concrete spalling and exposed corroded steel reinforcement in the capping beam. Surface cracks on the pile.

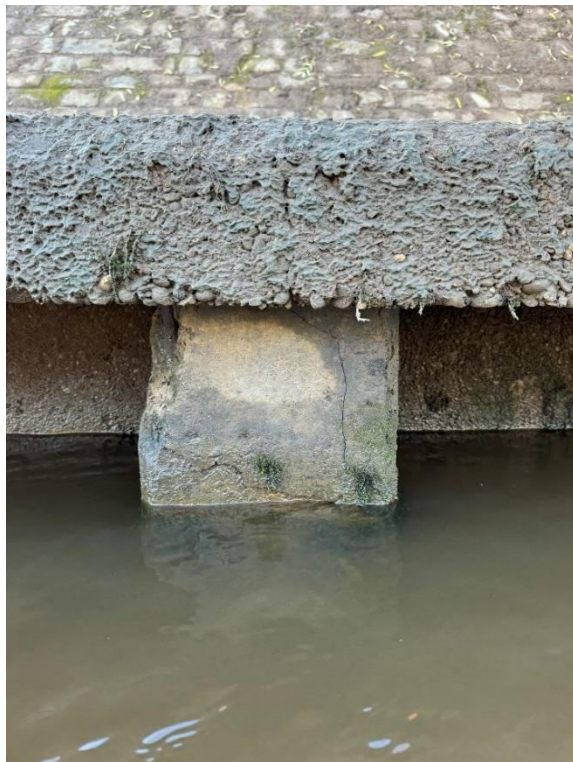
36 Cracking at the top of the pile. Spalling on on the top of the concrete pile, exposed steel reinforcement.

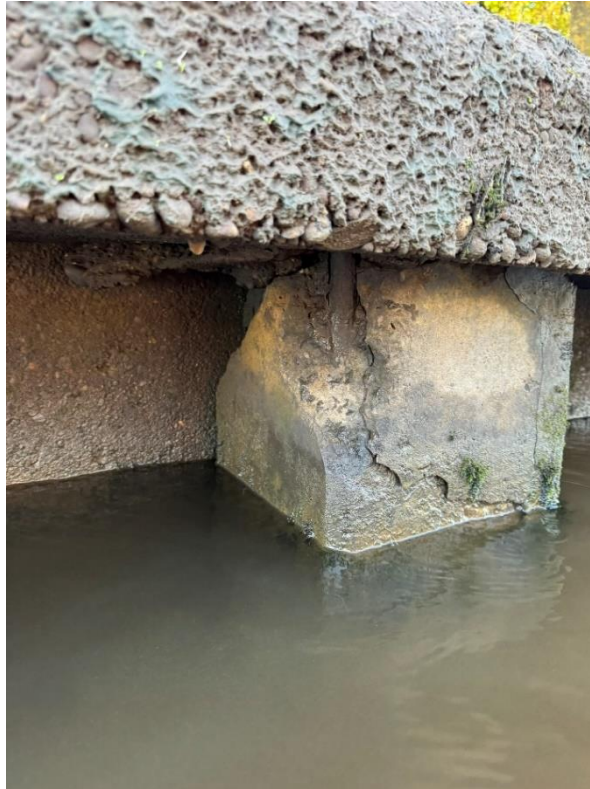
37 Cracking at the top of the pile. Spalling on on the top of the concrete pile, exposed steel reinforcement.

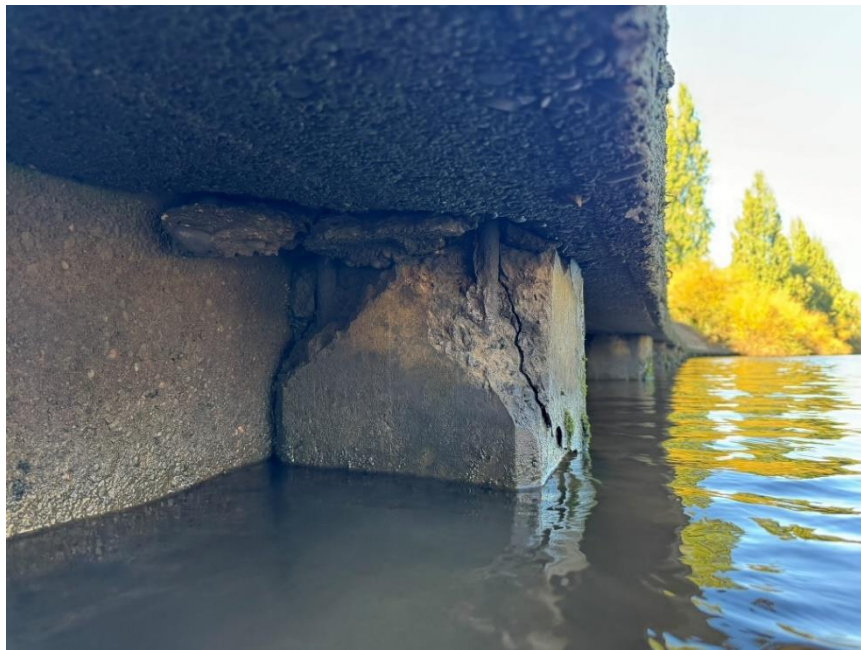
38 Cracking at the top of the pile. Spalling on on the top of the concrete pile, exposed steel reinforcement.

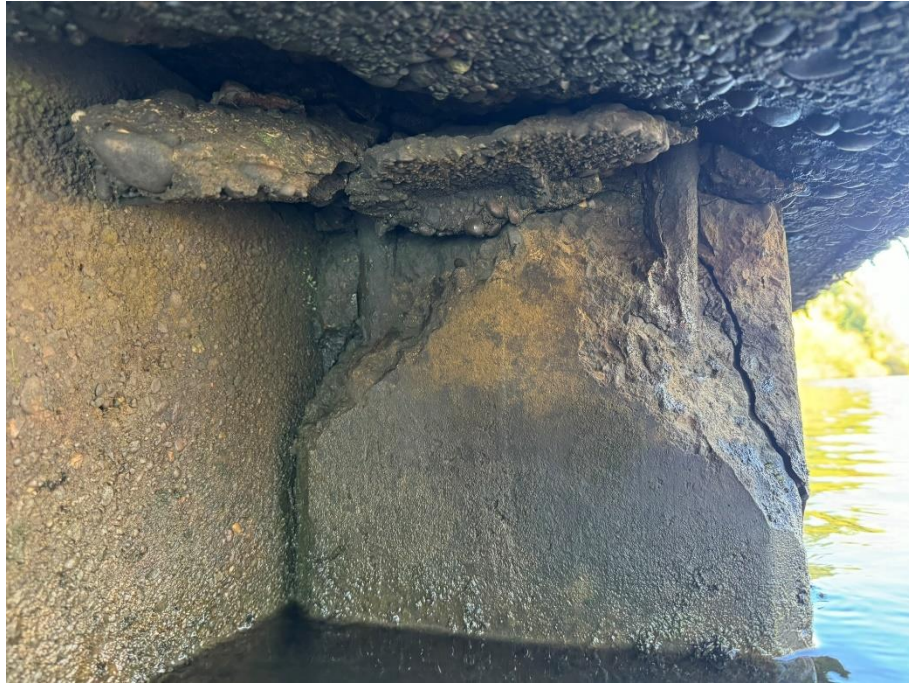
39 Cracking at the top of the pile. Spalling on on the top of the concrete pile, exposed steel reinforcement.

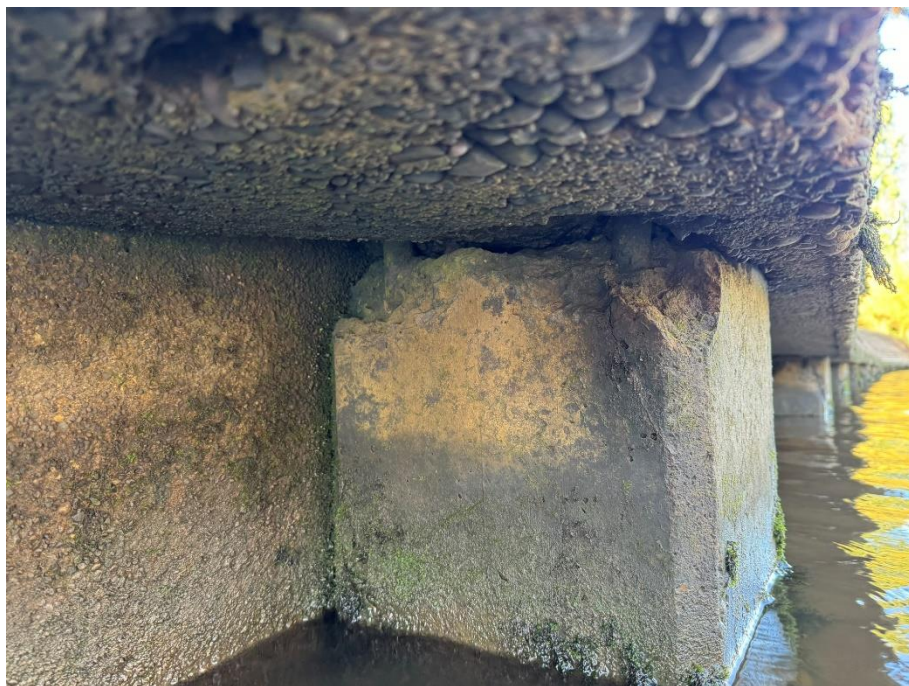
40 Spalling on on the top of the concrete pile, exposed steel reinforcement.

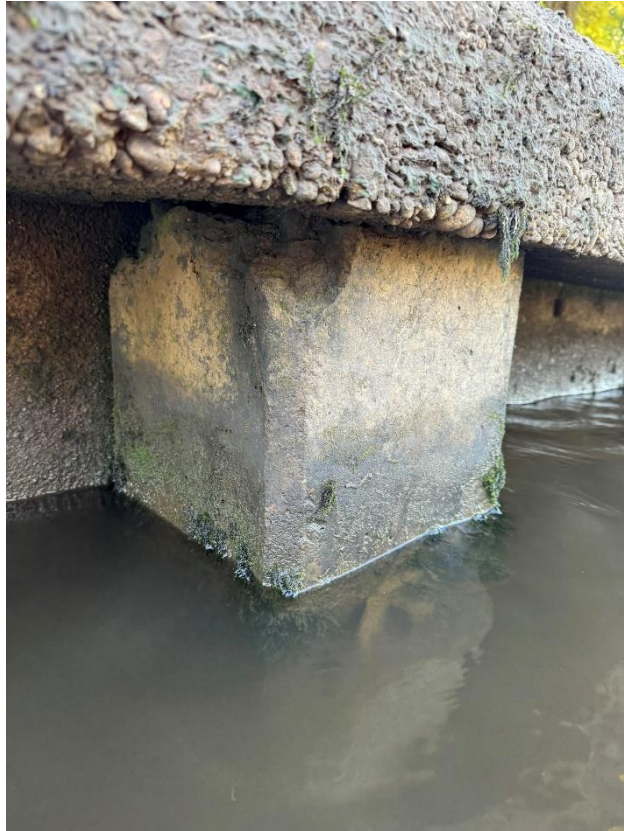
41 Spalling on on the top of the concrete pile, exposed steel reinforcement.

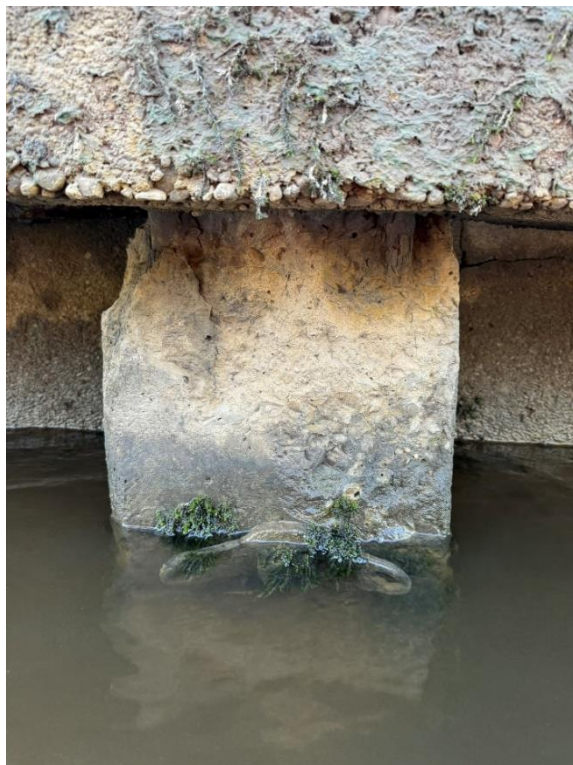
42 Spalling on on the top of the concrete pile, exposed steel reinforcement.

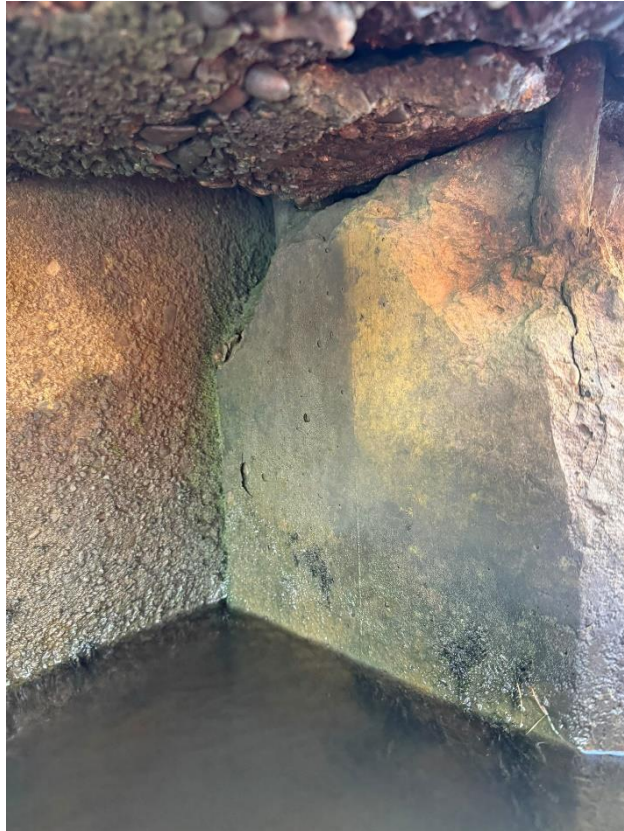
43 Spalling on on the top of the concrete pile, exposed steel reinforcement.

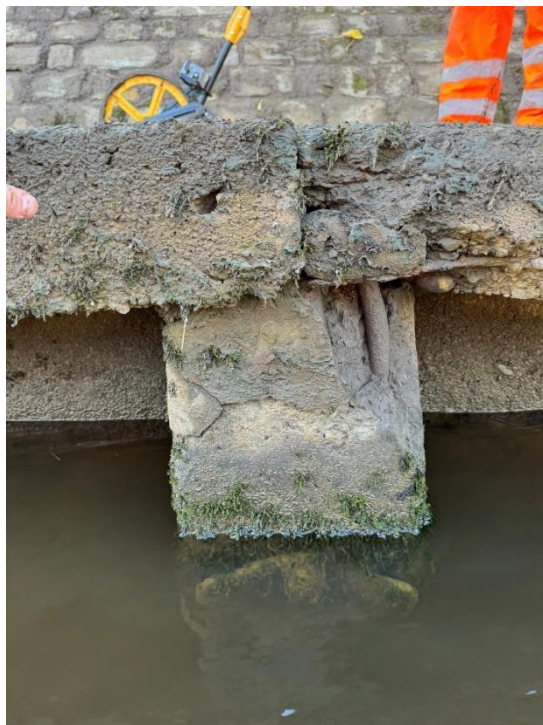
44 Concrete spalling on the side of the concrete capping beam and top of the pile. Spalling has exposed the steel reinforcement. The reinforcement is corroded.

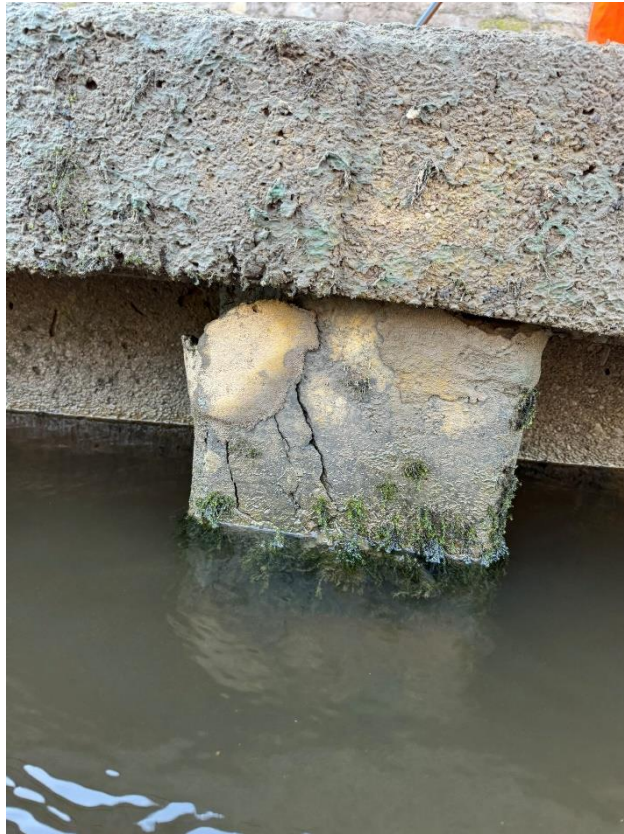
45 Cracking on the top of the pile, concrete is loose.

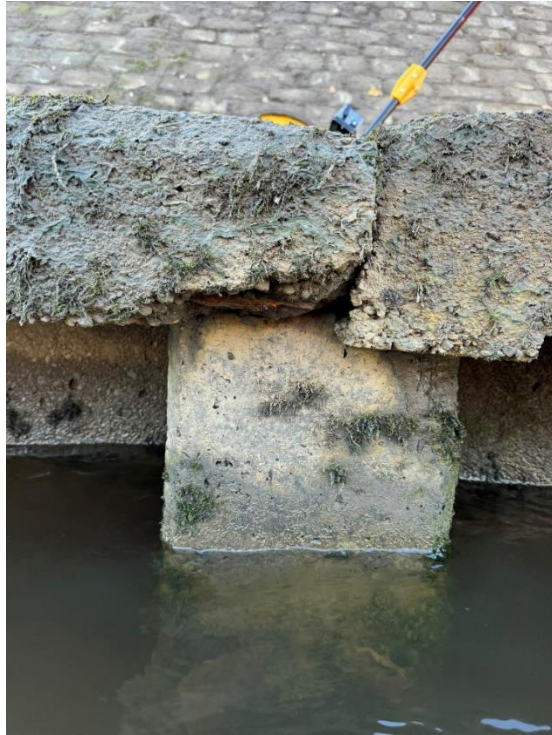
47 Spalling of concrete to the underside of the capping beam. Corroded steel reinforcement is exposed.

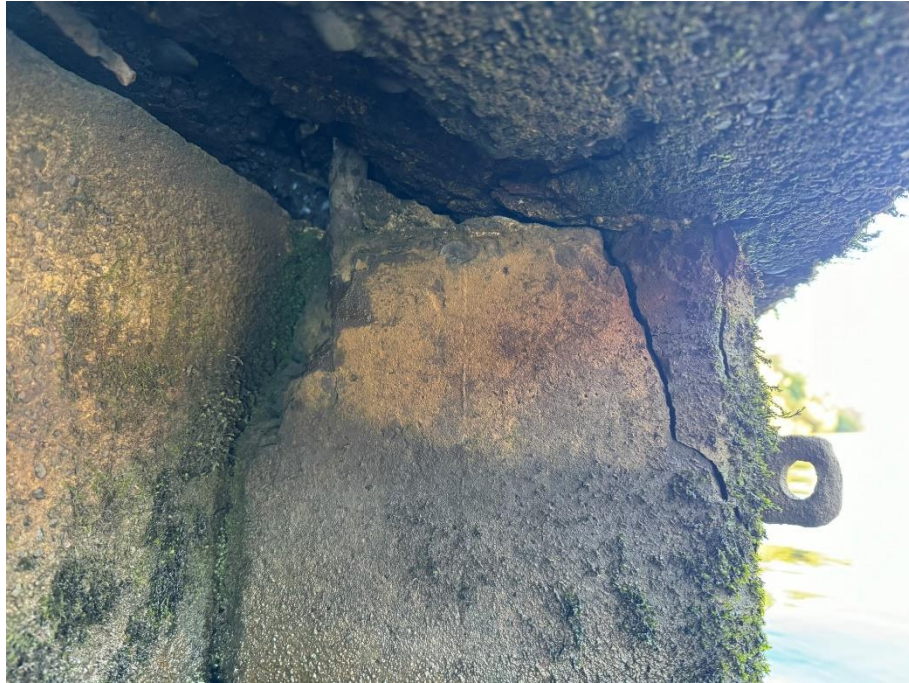
49 Spalling of concrete at the top of the pile. Steel reinforcement bars are exposed.

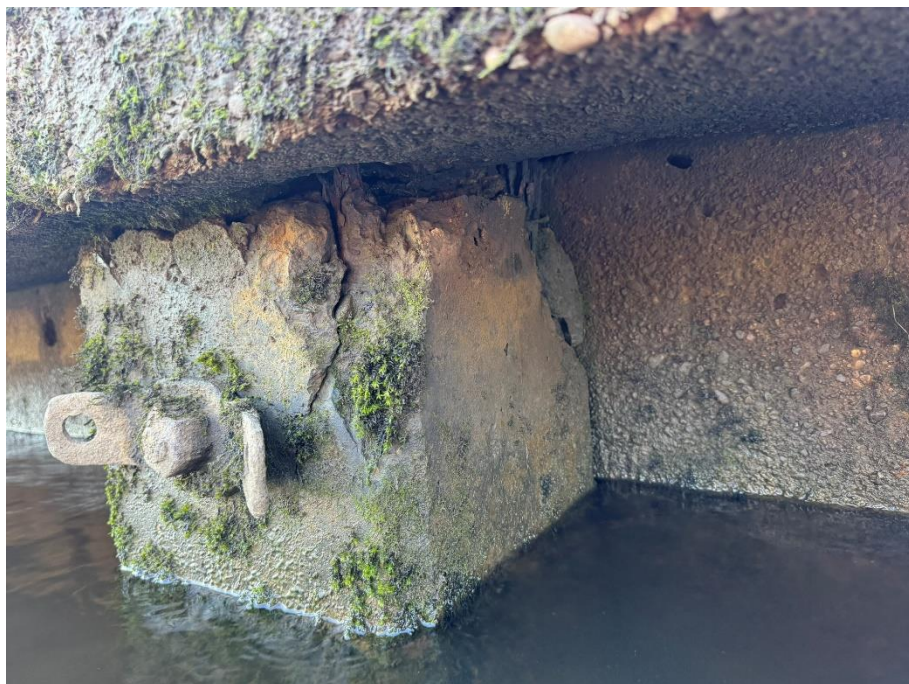
50 Spalling of concrete at the top of the pile. Corroded steel reinforcement bars are exposed.

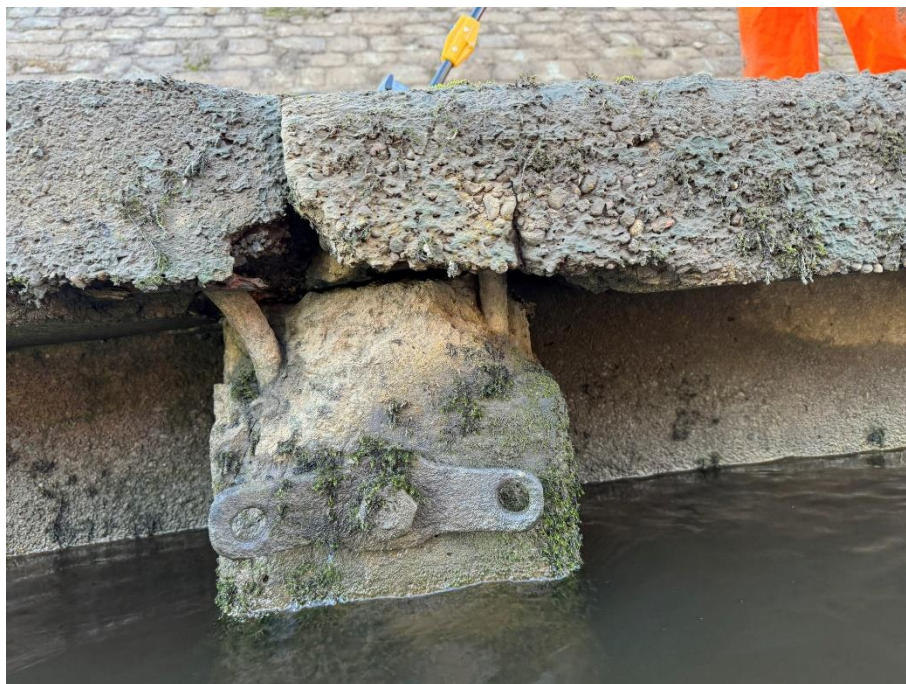
51 Spalling of concrete at the top of the pile. Corroded steel reinforcement bars are exposed.

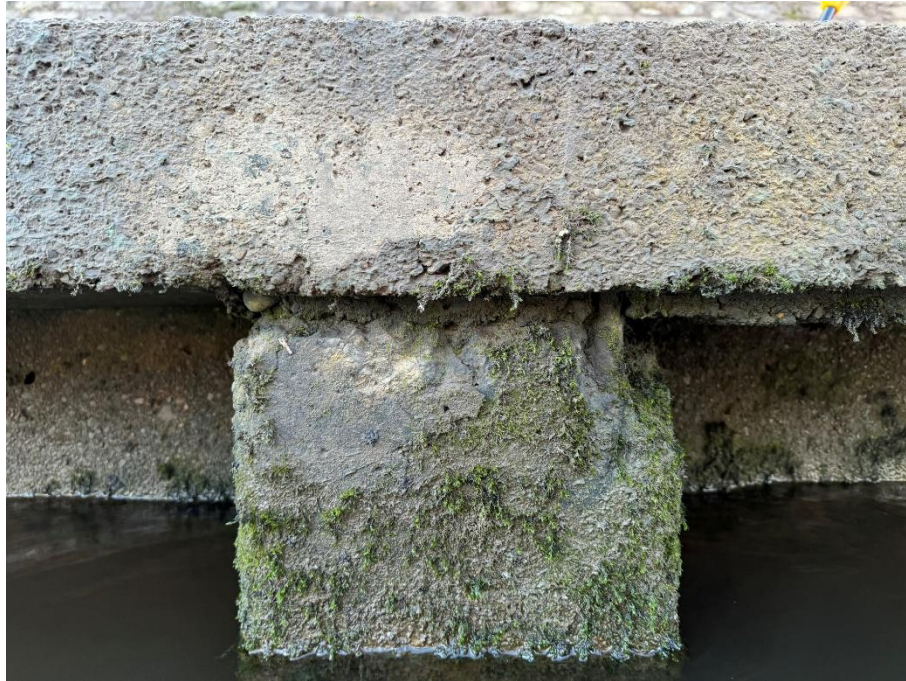
52 Spalling of concrete at the top of the pile and underside of the capping beam. Corroded steel reinforcement bars are deformed and exposed.

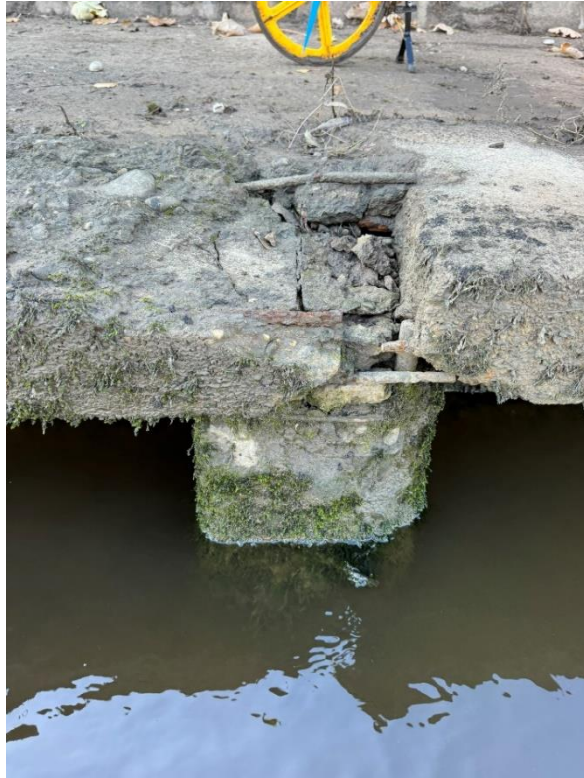
54 Spalled and loose concrete on top of the capping beam and pile, with corroded and deformed steel exposed.

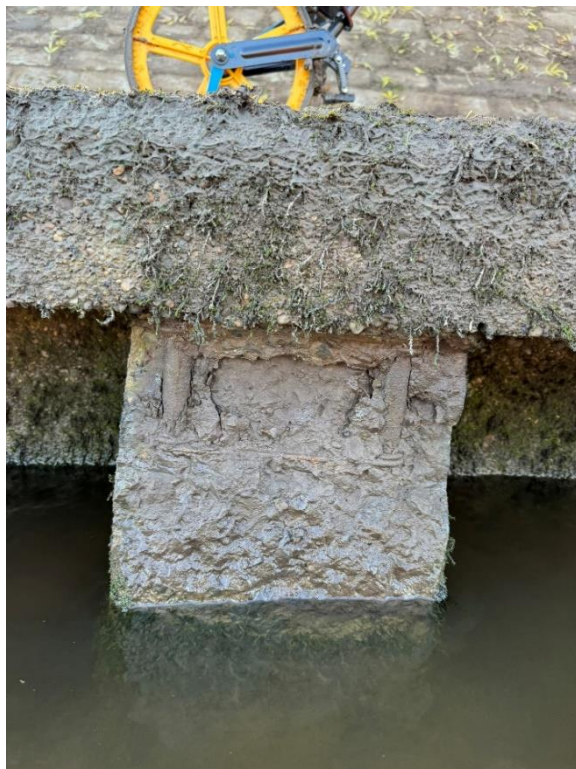
55 Spalled and loose concrete on top of the capping beam and pile, with corroded and deformed steel exposed.

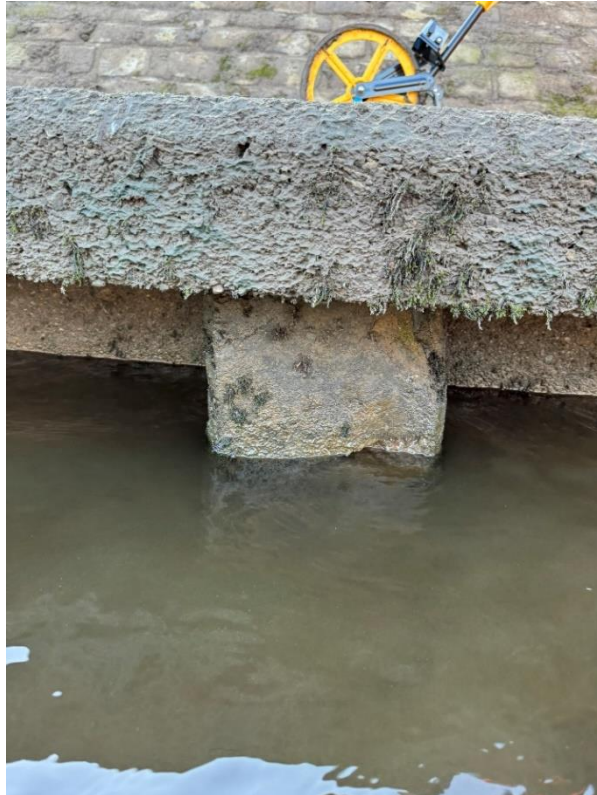
60 Crack between the concrete path and capping beam.

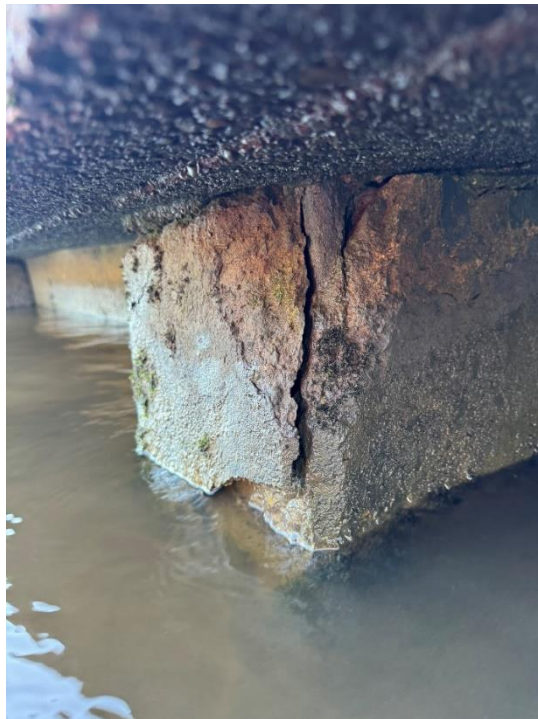
61 Capping beam and pile in ok condition.

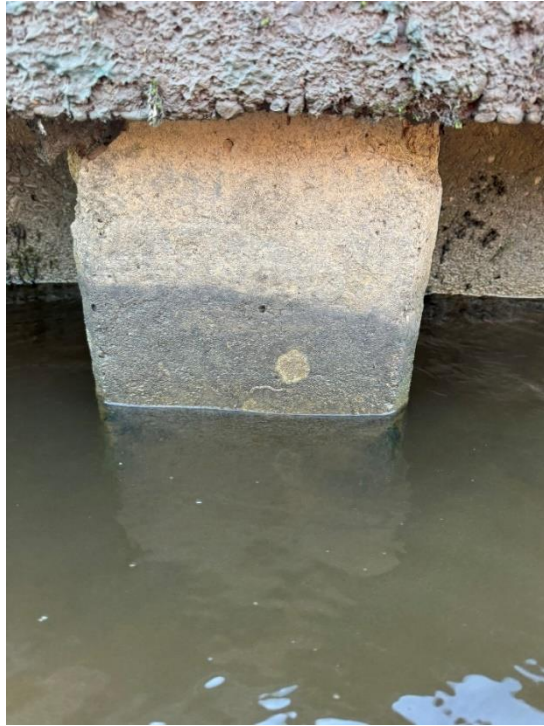
62 Spalled concrete at the top of the pile, with corroded steel reinforcement exposed.

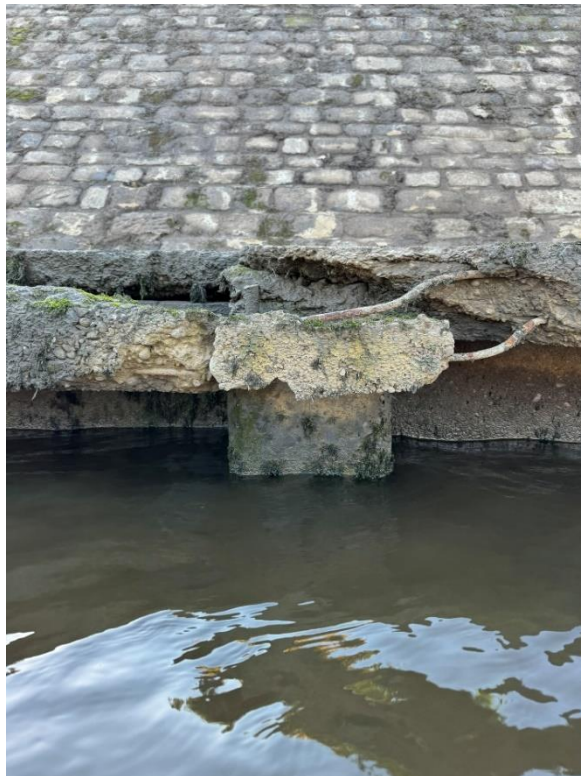
63 Minor spalling to top corners of the pile.

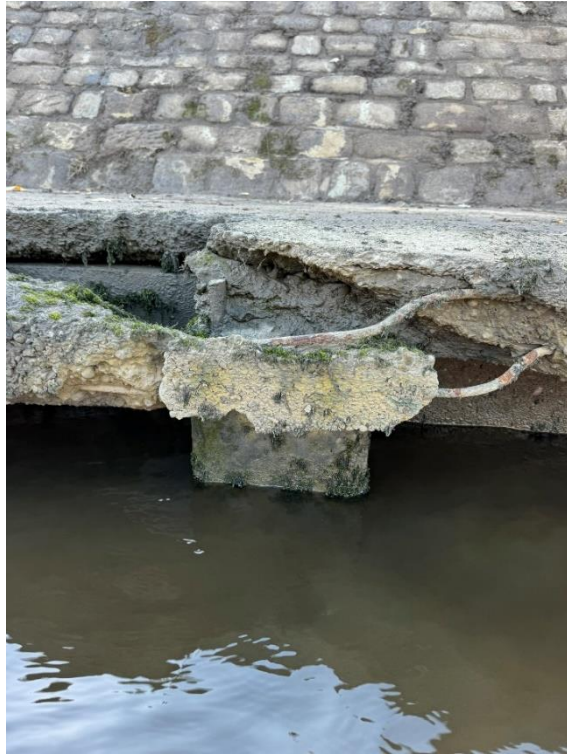
64 Failed capping beam, no longer sufficiently supported and breaking away from concrete path. Large cracking and deformed steel reinforcement exposed in the capping beam and pile.

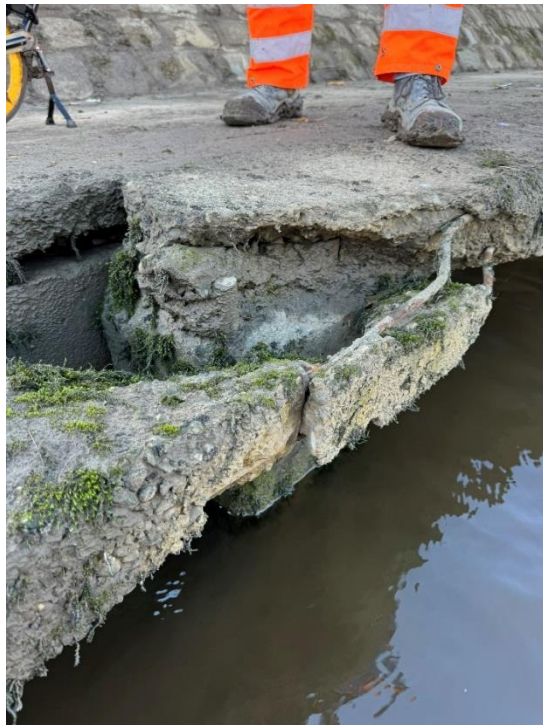
- 65 Failed capping beam, no longer sufficiently supported and breaking away from concrete path. Large cracking and deformed steel reinforcement exposed in the capping beam and pile.

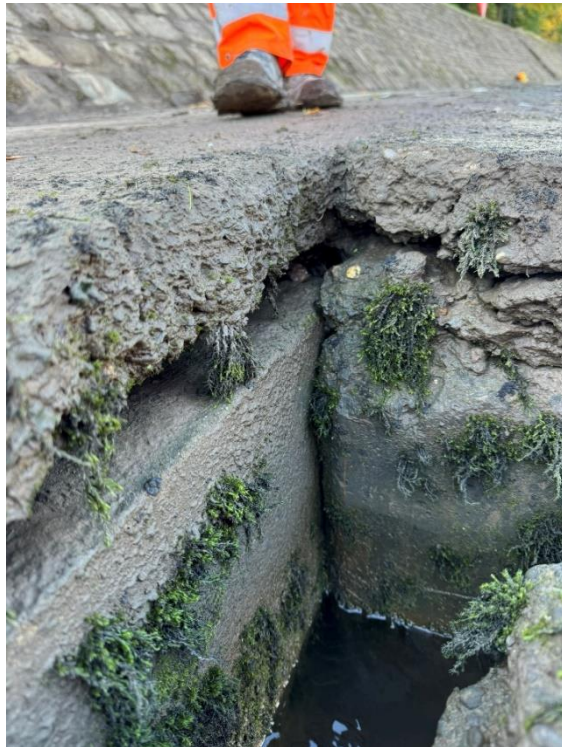
- 67** Failed capping beam, no longer sufficiently supported and breaking away from concrete path. Large cracking and deformed steel reinforcement exposed in the capping beam and pile.

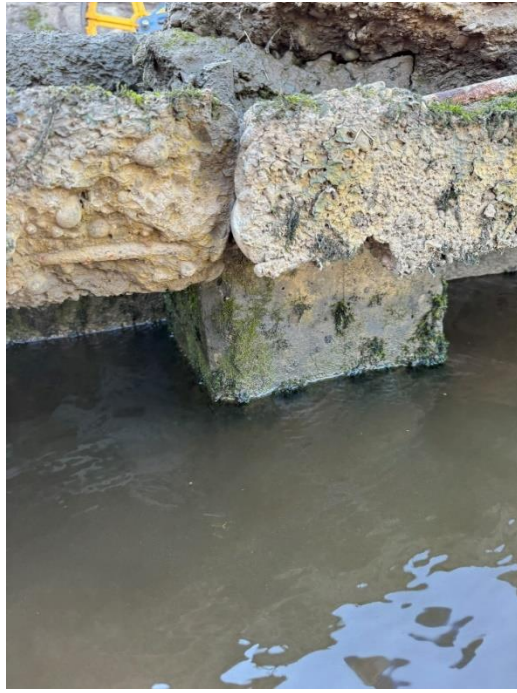
- 68** Gap between the concrete path and top of the retaining wall.

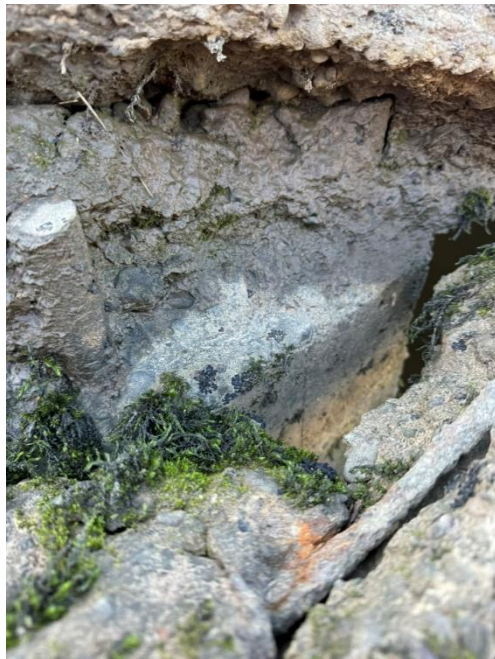
- 69 Failed capping beam, no longer sufficiently supported and breaking away from concrete path. Large cracking and deformed steel reinforcement exposed in the capping beam and pile.

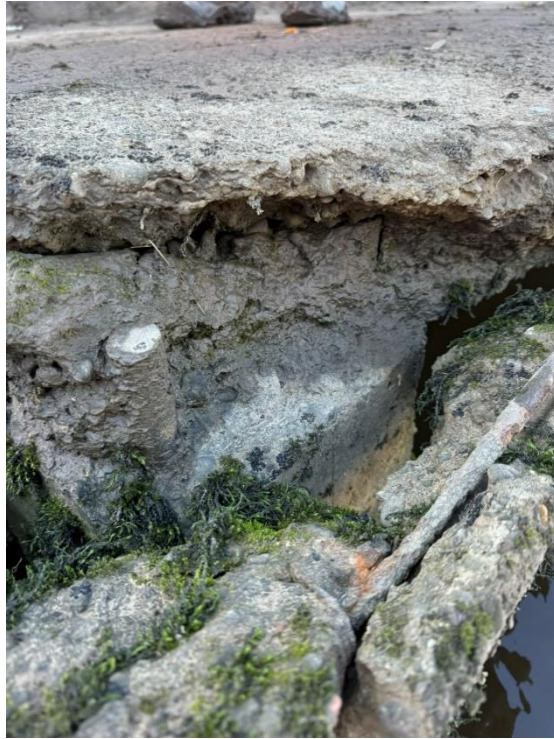
- 70 Failed capping beam, no longer sufficiently supported and breaking away from concrete path. Large cracking and deformed steel reinforcement exposed in the capping beam and pile.

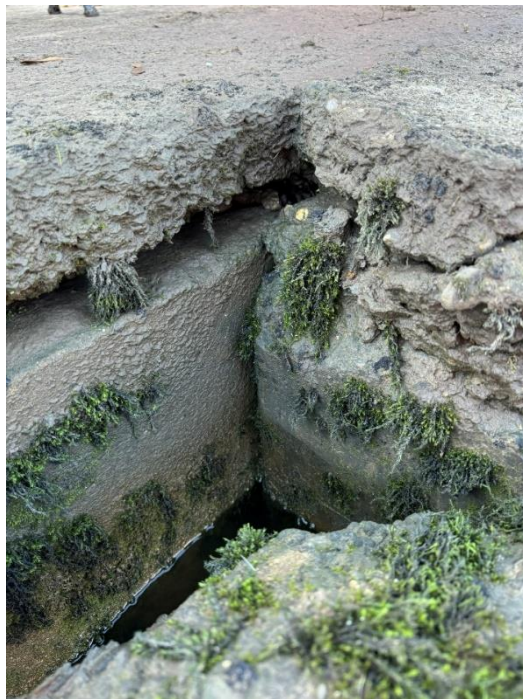
- 71** Failed capping beam, no longer sufficiently supported and breaking away from concrete path. Large cracking and deformed steel reinforcement exposed in the capping beam and pile.

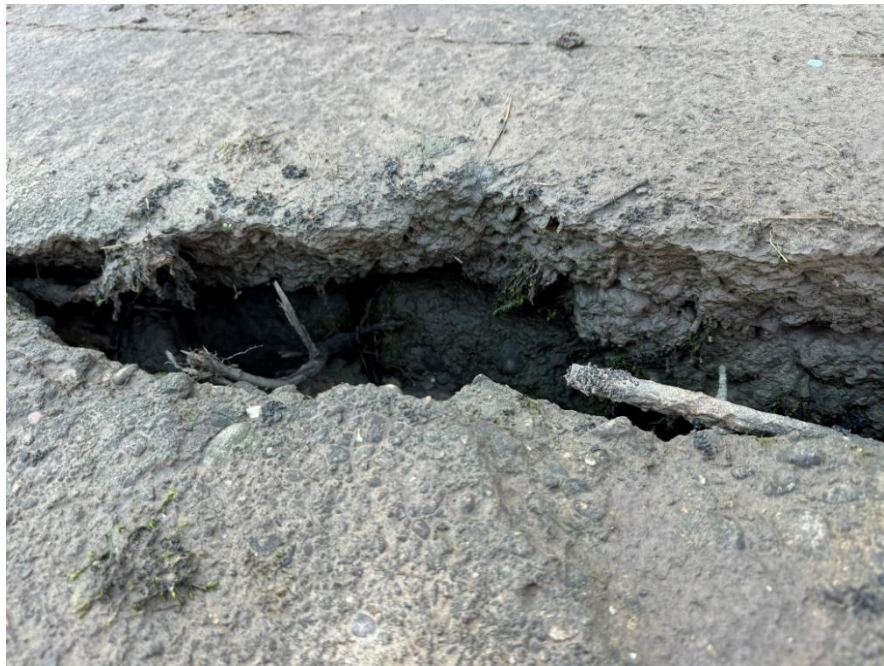
75 Capping beam in ok condition.

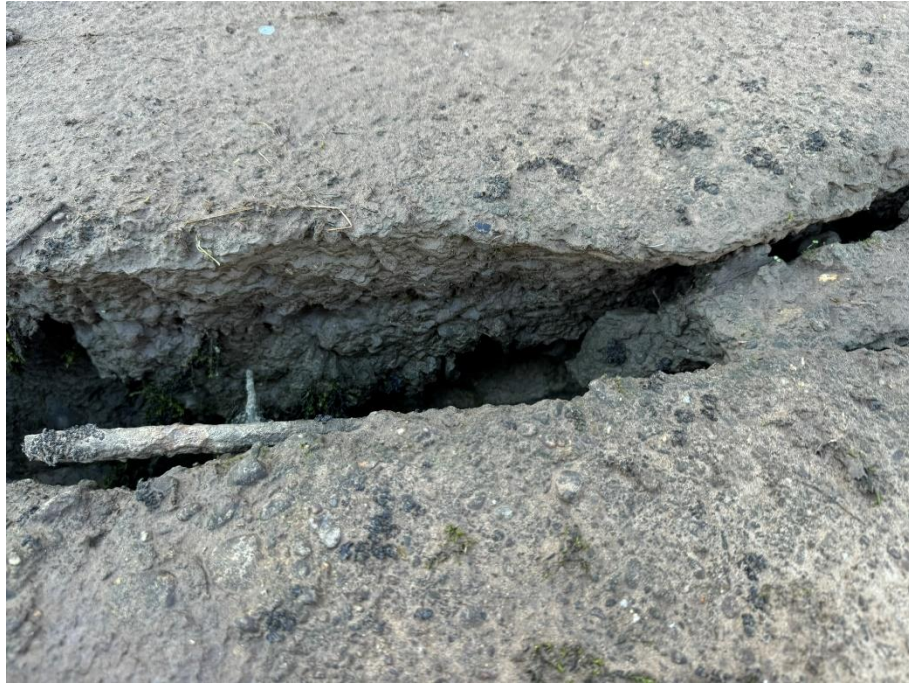
76 Large gap between the capping beam and concrete path. Exposed steel reinforcement.
