**INSPECTION REPORT
River Ouse Riverbank**

**Report 22594-H-RP-001-R0
20 November 2024**

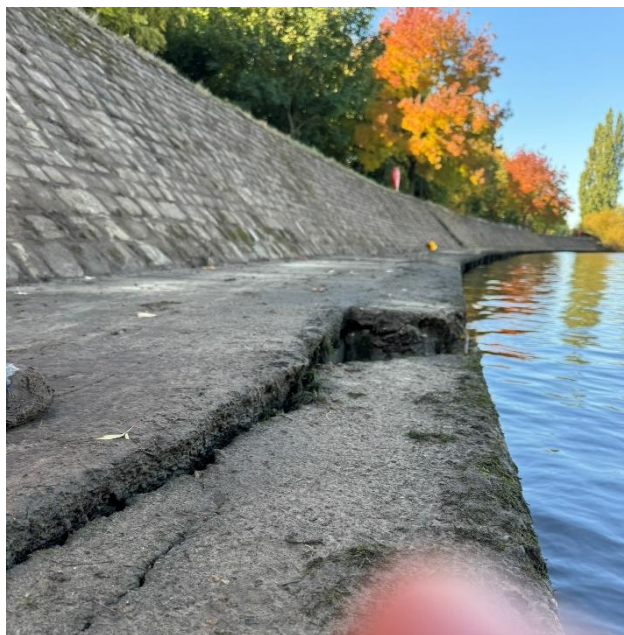
77 Large gap between the capping beam and concrete path. Exposed steel reinforcement.

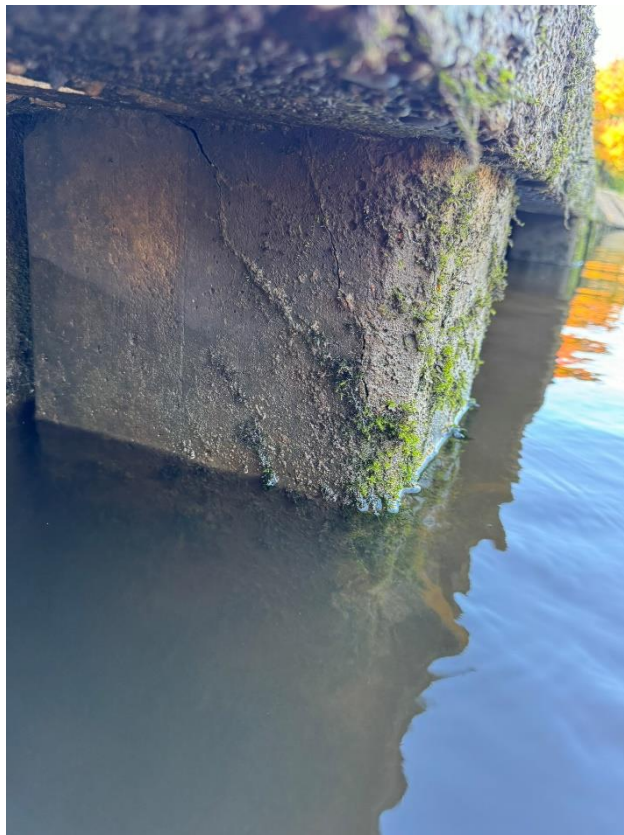
81 Large section loss in capping beam with exposed steel reinforcement. Crack through the width of the capping beam.

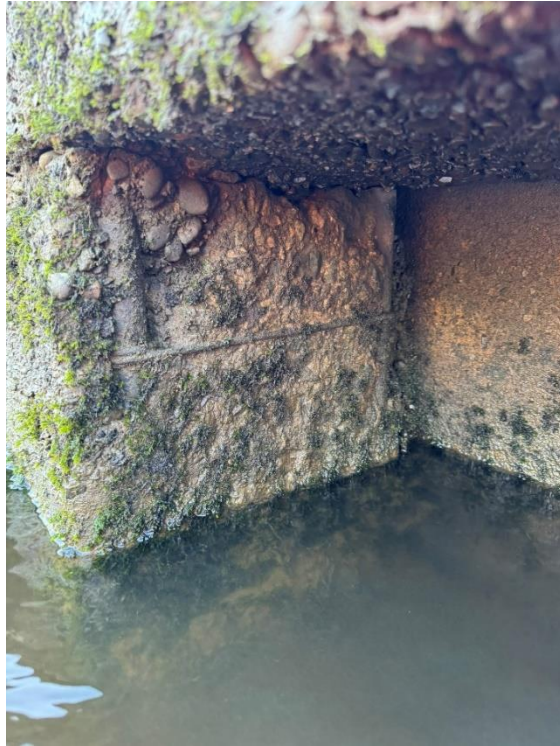
82 Surface cracking at the top of the pile.

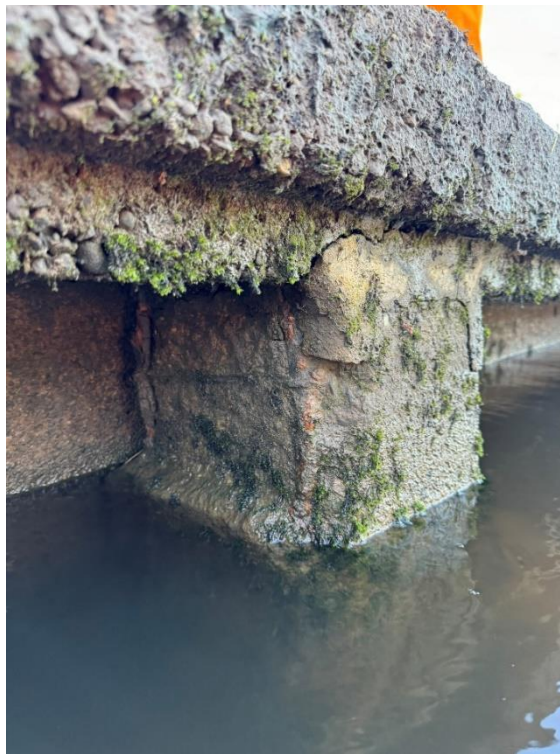
83 Concrete spalled and exposed steel reinforcement at the top of the pile.

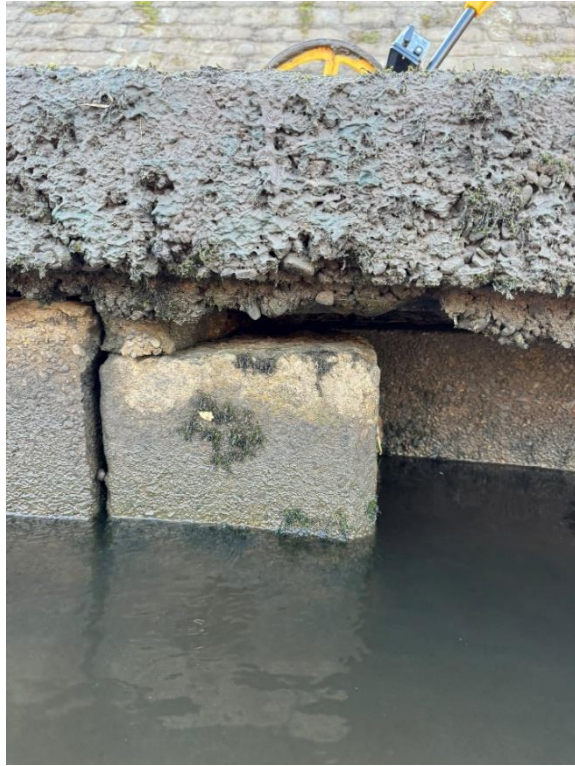
84 Concrete spalled and exposed steel reinforcement at the top of the pile.

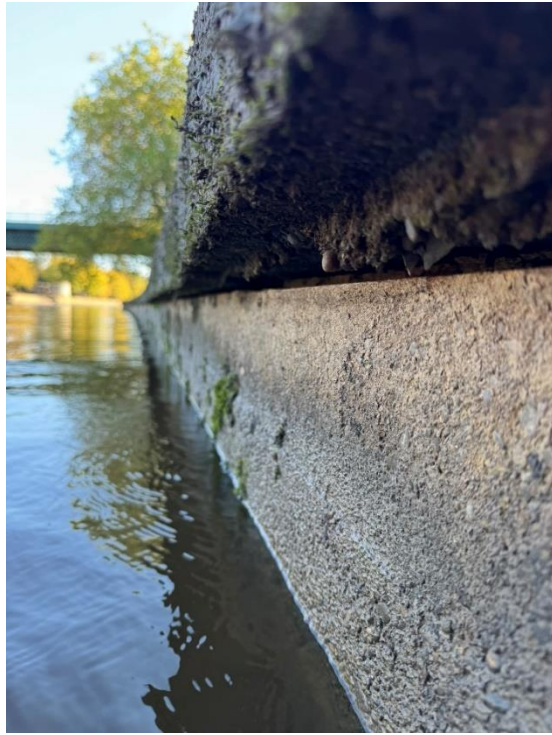
- 86 Change in construction, piles are replaced by concrete retaining wall. Looking downstream towards the Scarborough Rail Bridge.

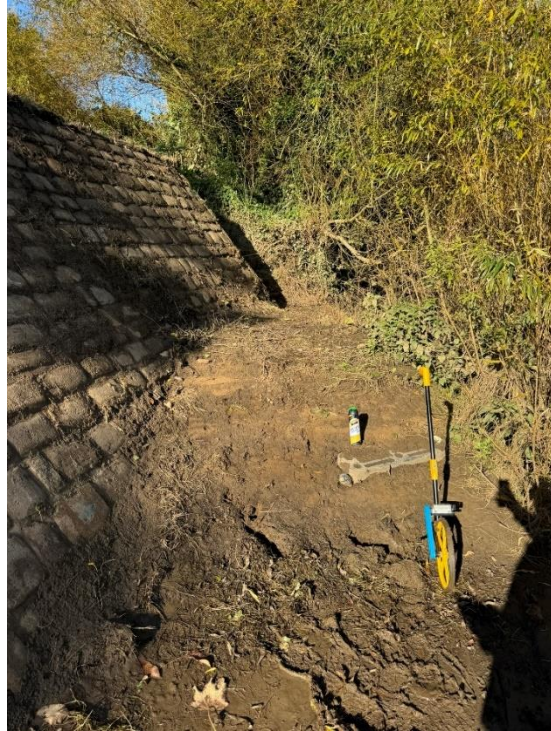
01

Overgrown vegetation and large build-up of earth at the base of the pitched stone, on top of the concrete path.

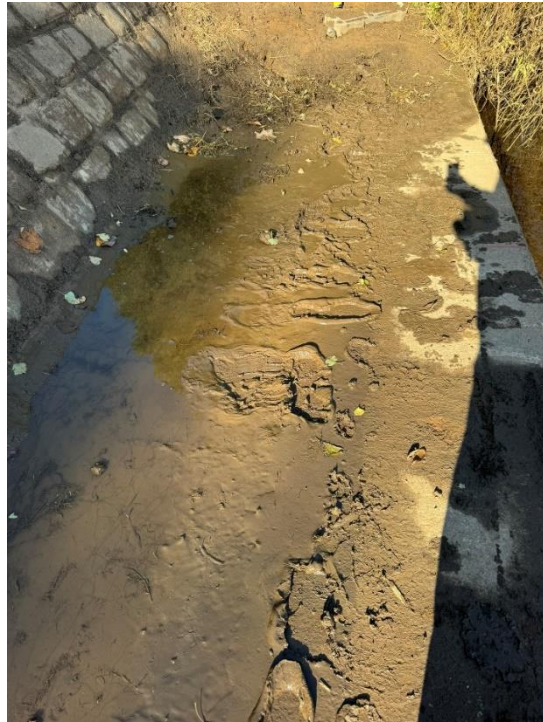
03

Build-up of silt on top of concrete path.

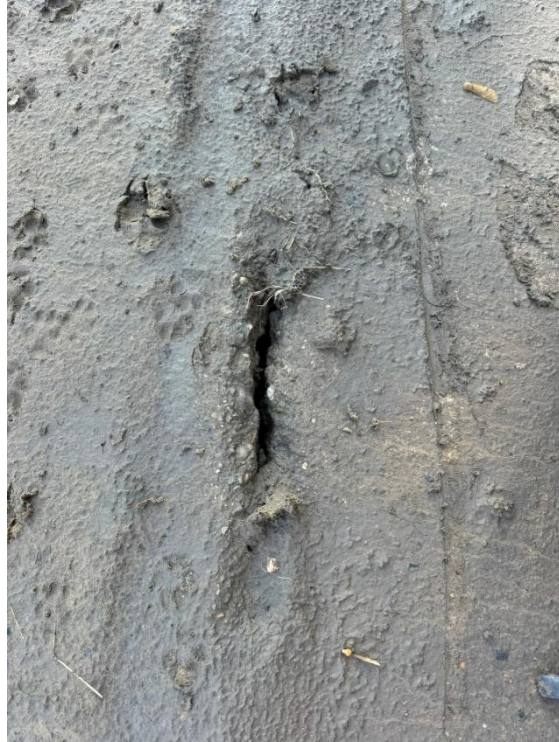
06

Build-up of silt on top of concrete path and pooling water.

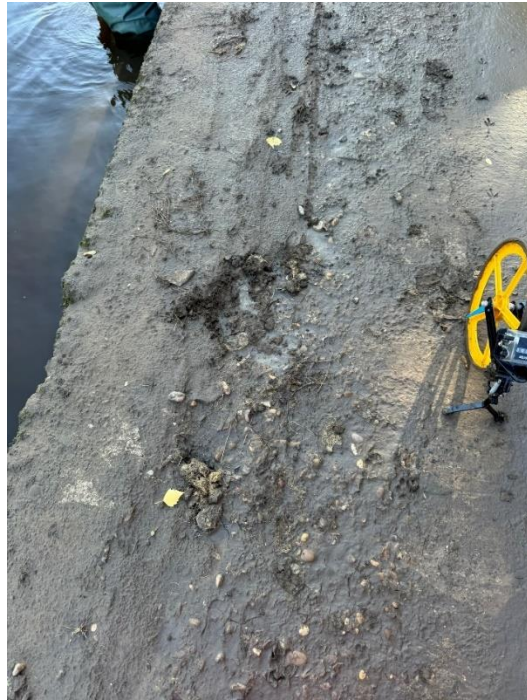
08

Loose aggregate on concret slab surface.

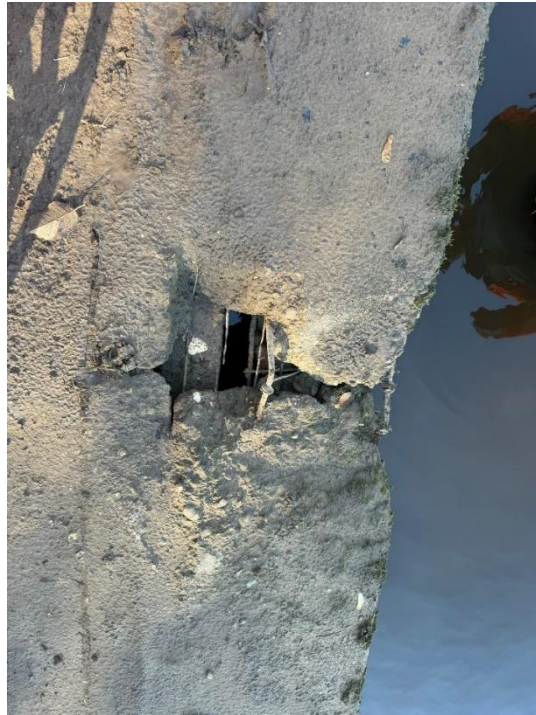
10 Loss of section on the capping beam, concrete spalled and broken away exposing deformed steel reinforcement. Can see through the capping beam to the top of the pile underneath.

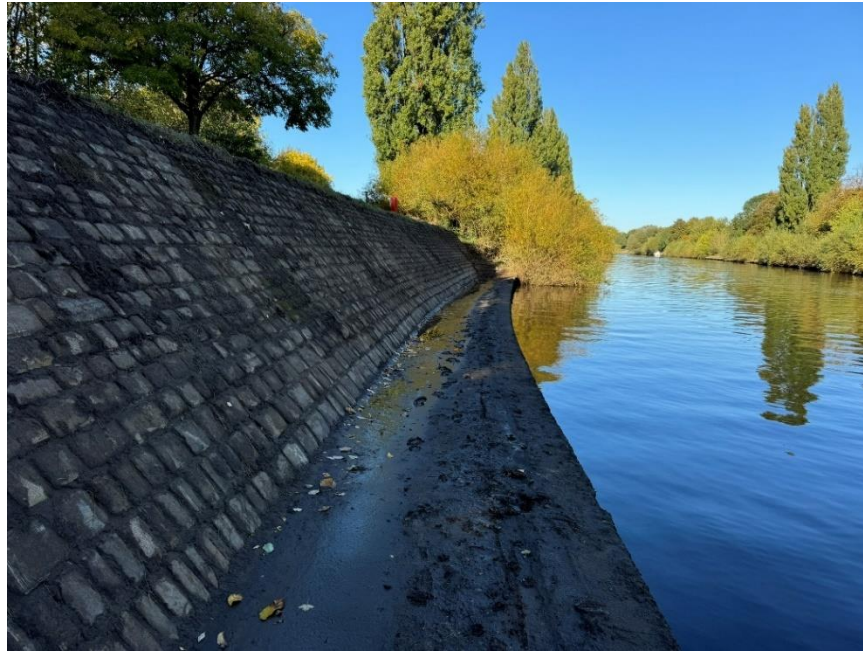
- 12** View from the concrete path looking eastwards, towards the Scarborough Rail Bridge that is visible in the background. Silt build-up on path.

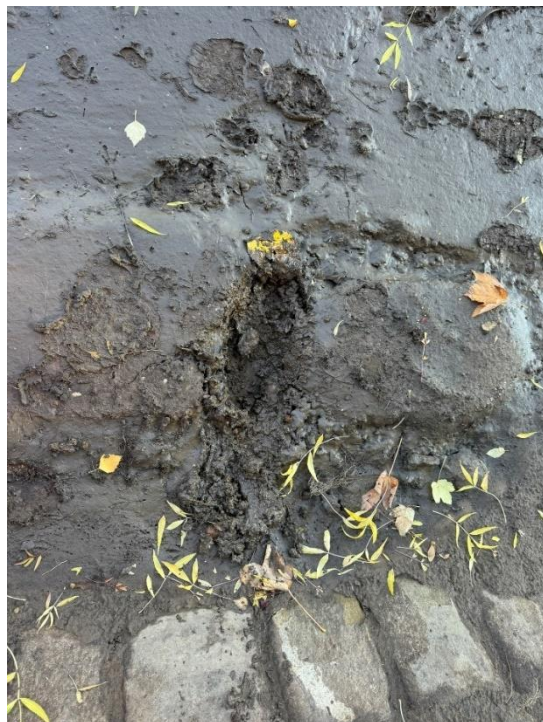
- 15** Silt build-up on the path. Crack between the concrete path and capping beam.

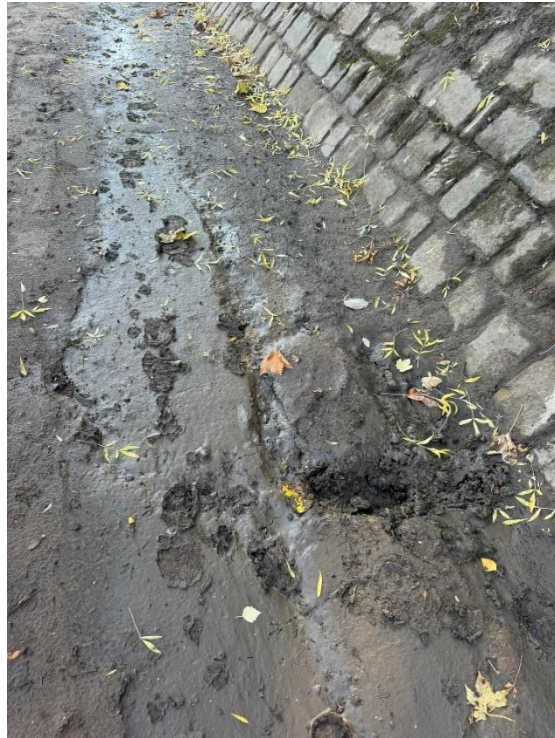
- 16** Concrete path covered in silt. The concrete is broken up and easily displaced when agitated by foot.

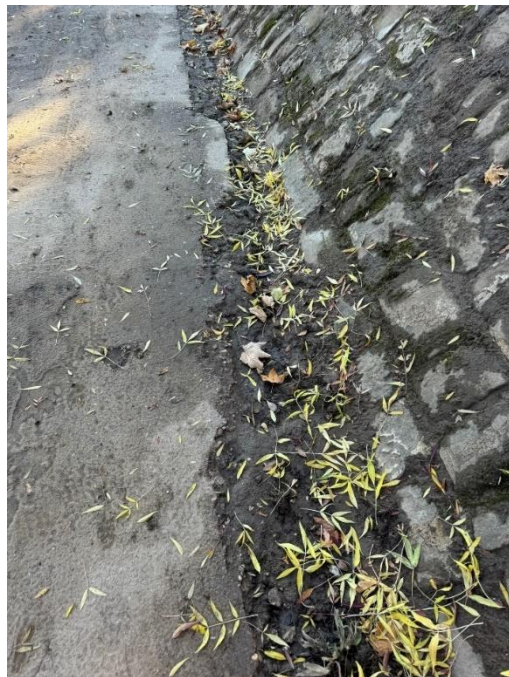
- 19** Void and broken up concrete slab at the base of the pitched stone. Areas of loose concrete at the surface.

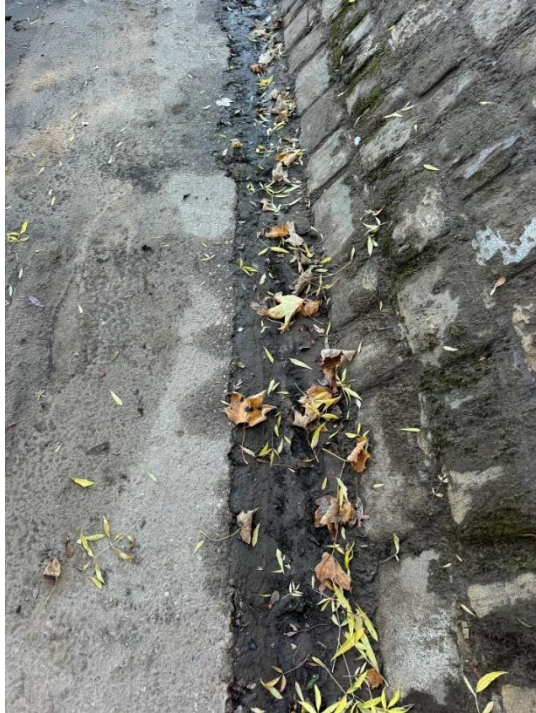
- 20** Void and broken up concrete slab at the base of the pitched stone. Areas of loose concrete at the surface.

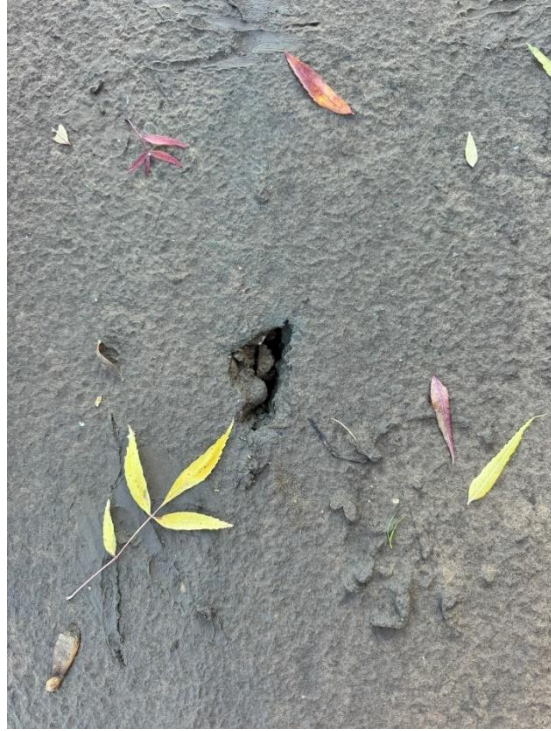
- 22** Void and broken up concrete slab at the base of the pitched stone. Areas of loose concrete at the surface.

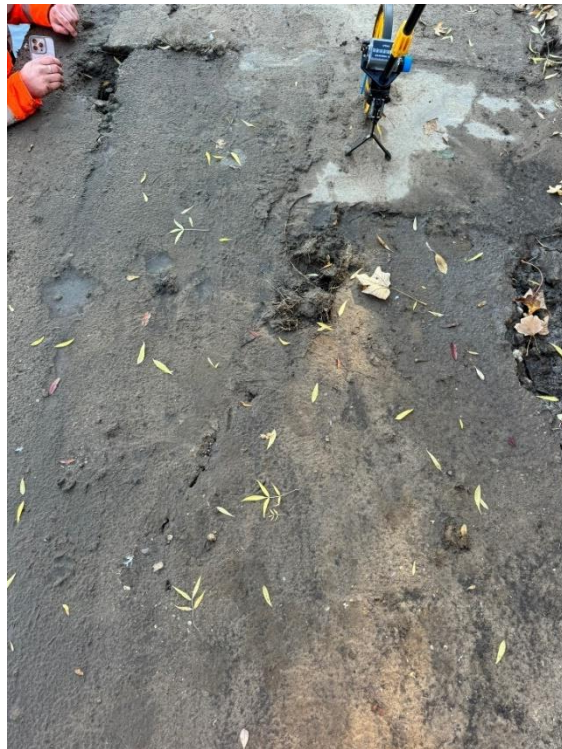
23

Small gap in joint between the concrete path and capping beam.

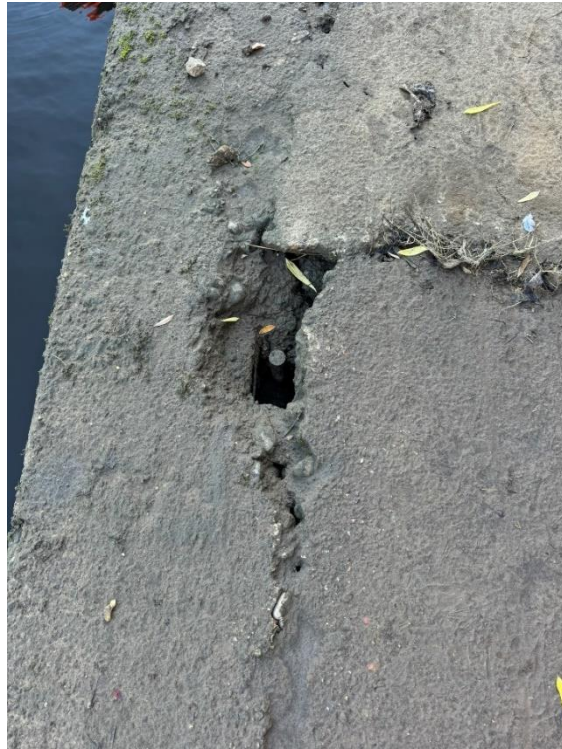
24

Cracks in the slab and various patches of slab construction.

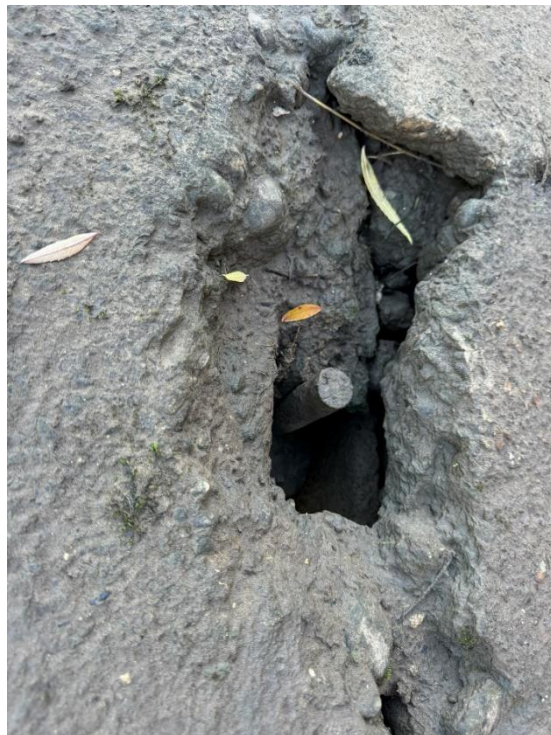
25

Exposed pile steel reinforcement, protruding through gap in capping beam and concrete path.

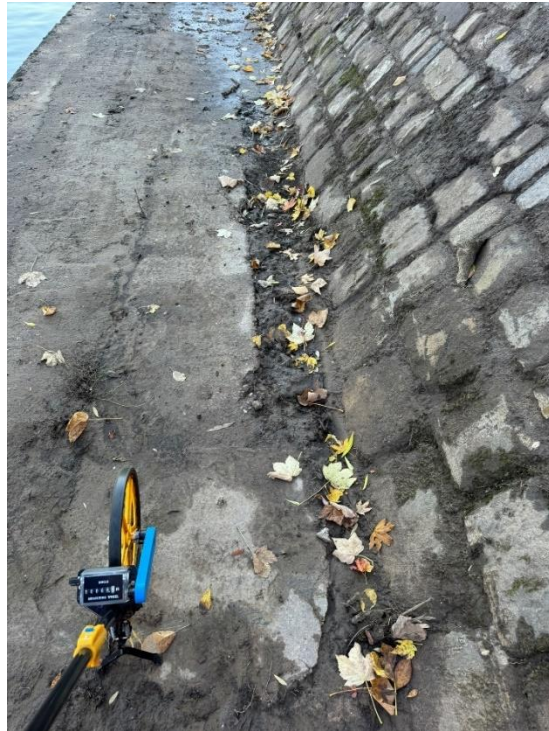
28

Small gap in joint between the concrete path and capping beam.

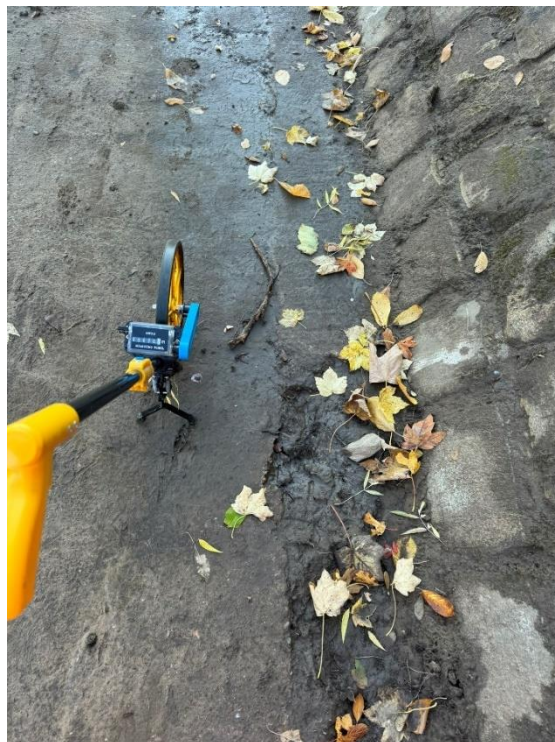
29

Void and broken up concrete slab at the base of the pitched stone. Areas of loose concrete at the surface.

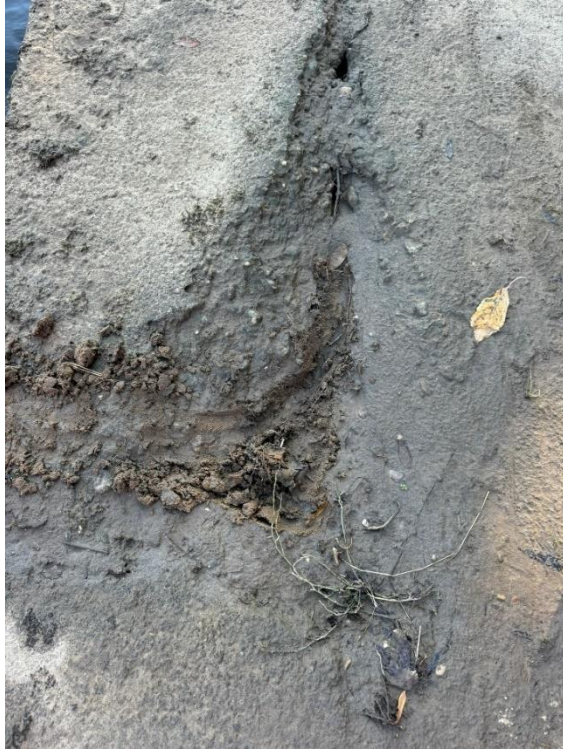
30

Void and broken up concrete slab at the base of the pitched stone. Areas of loose concrete at the surface.

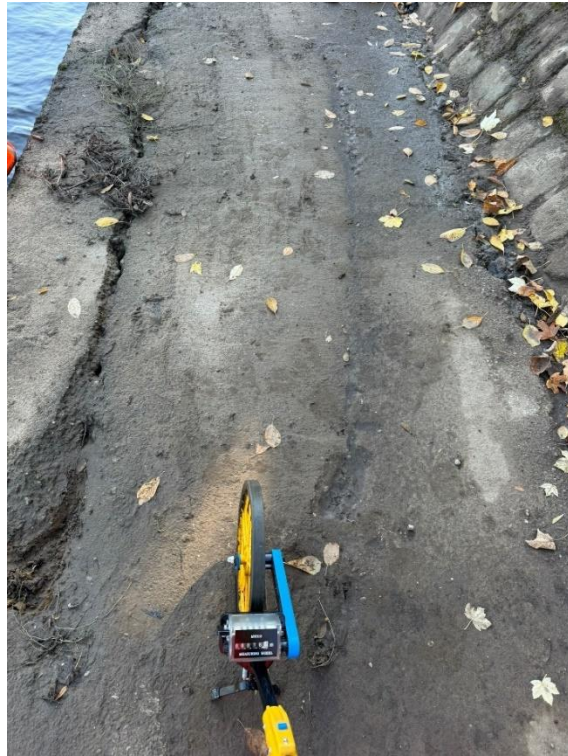
32

Large crack between the capping beam and concrete path.

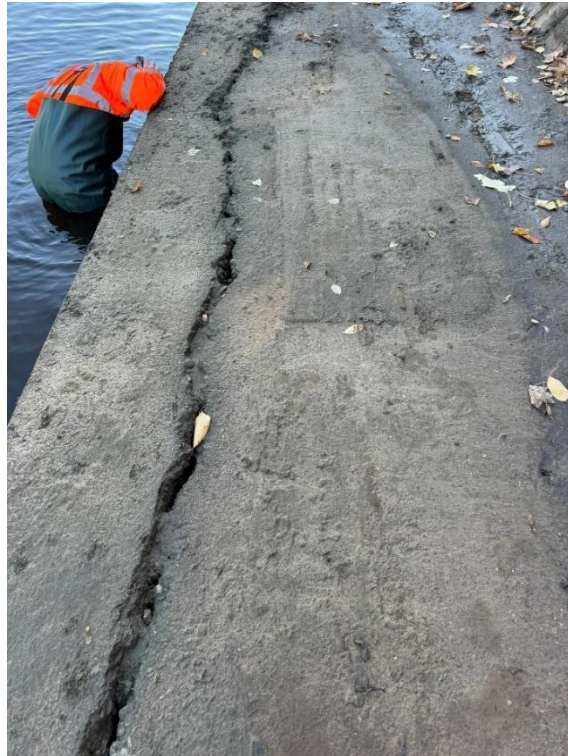
34

Large crack between the capping beam and concrete path.

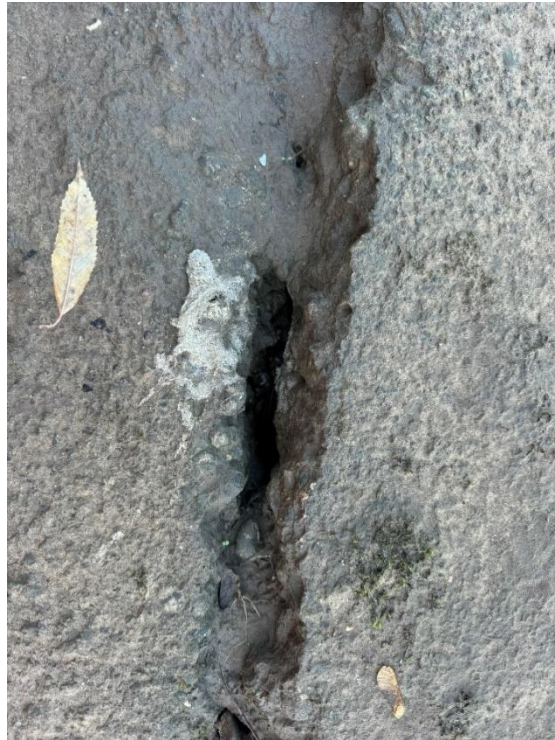
36

Build up of silt on the concrete path.

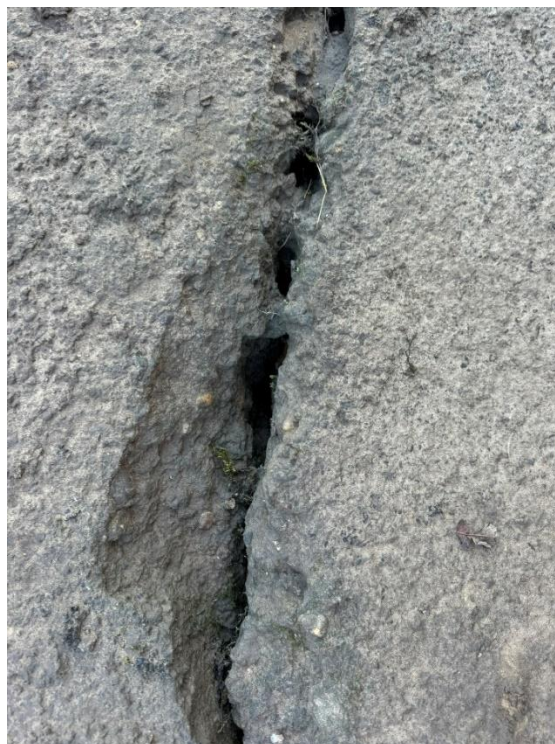
37

Large crack between the capping beam and concrete path.

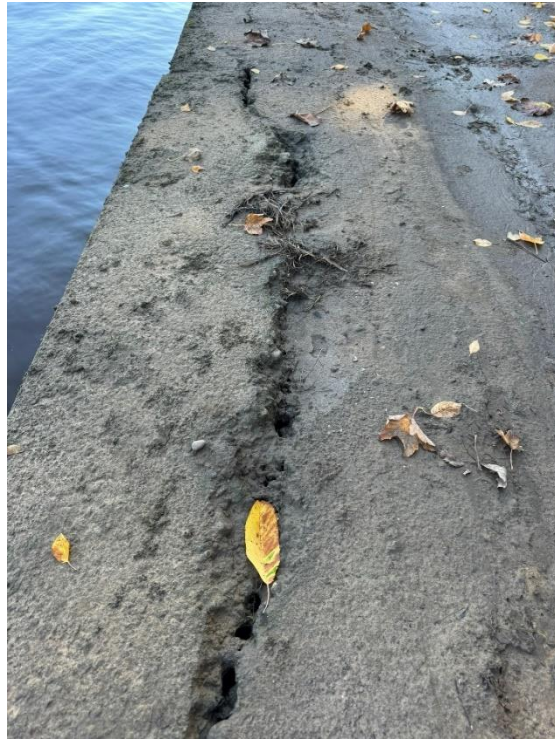
38

Large crack between the capping beam and concrete path.

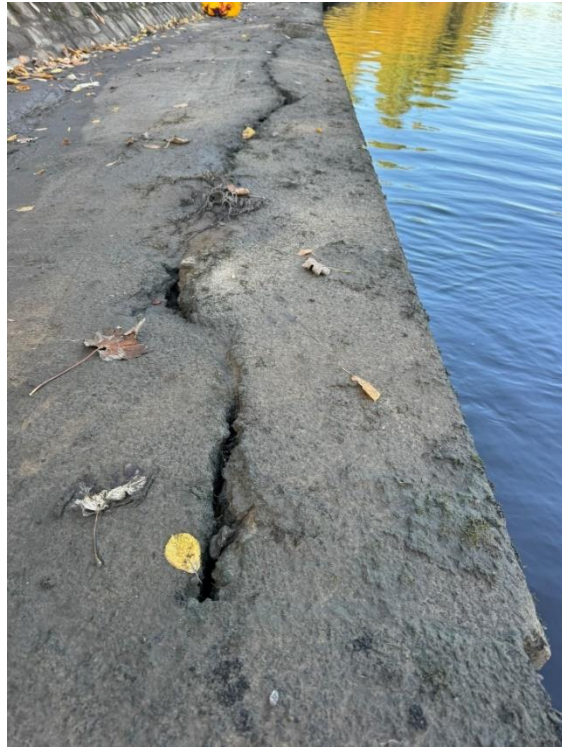
40

Large crack between the capping beam and concrete path. The capping beam is tilting towards the river, breaking away from the concrete path.

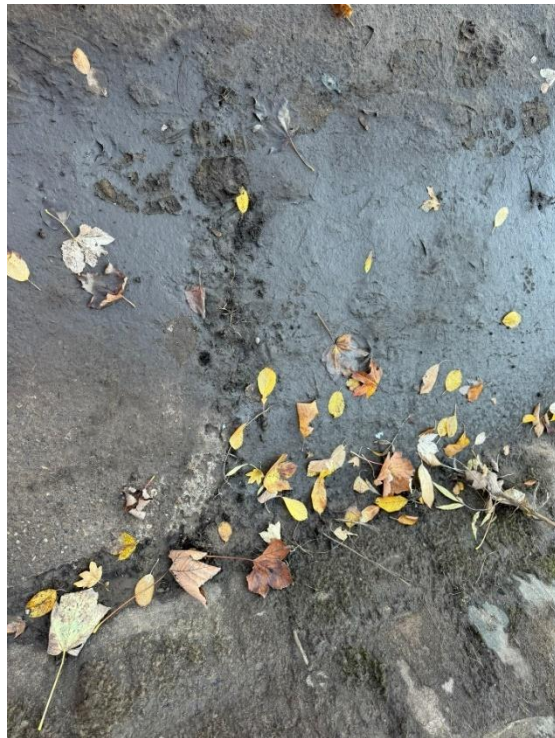
- 41** Large crack between the capping beam and concrete path. The capping beam is tilting towards the river, braking away from the concrete path.

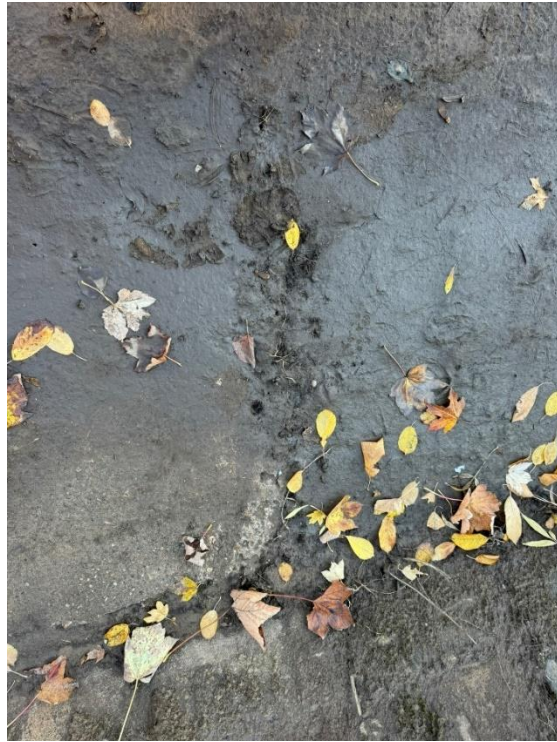
- 42** Build up of silt on the concrete path.

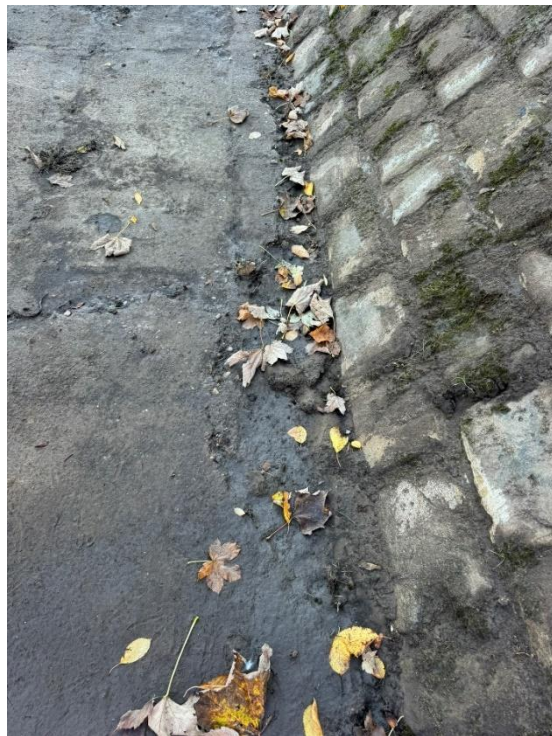
43

Build up of silt on the concrete path.

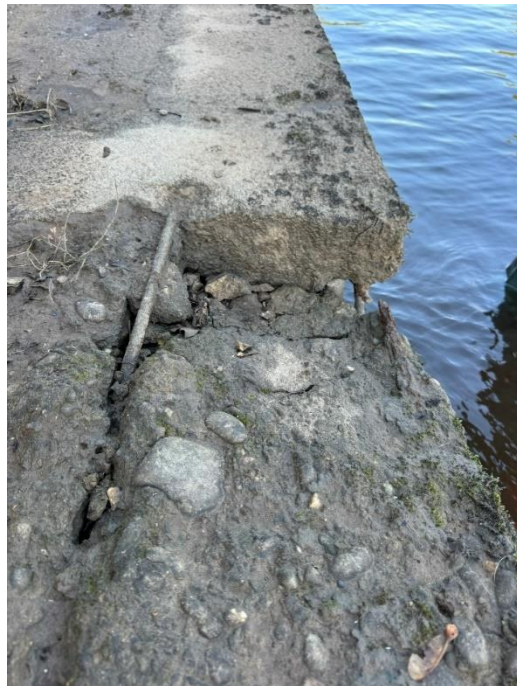
- 45** Loss of section on the capping beam, concrete spalled and broken away exposing deformed steel reinforcement.

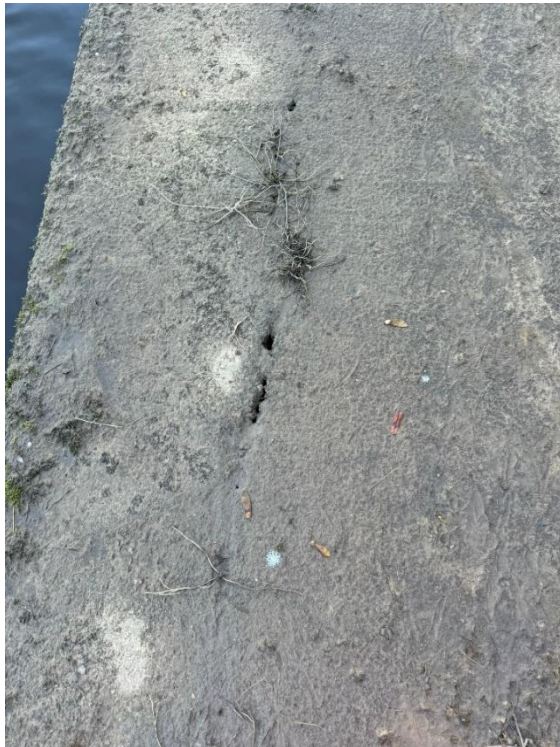
47

Gap forming between the concrete path and capping beam.

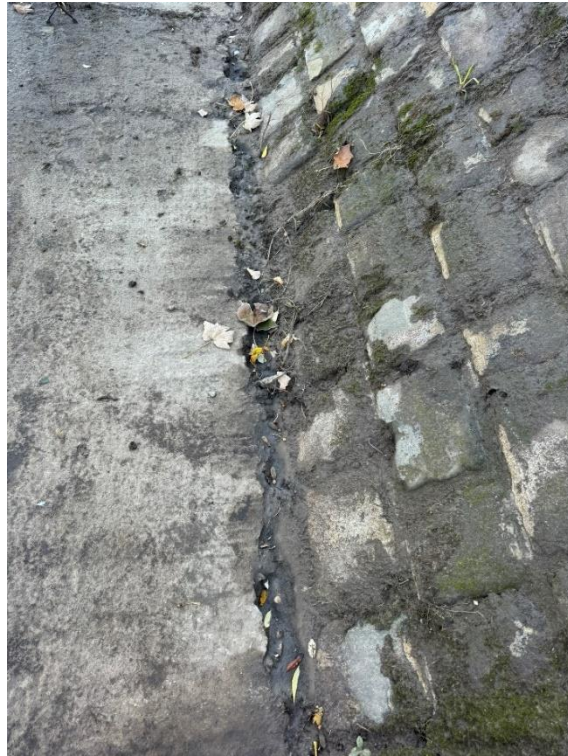
50

Wide spread cracking and loose areas of concrete at the surface of the concrete path. Build-up of silt and loose aggregate.

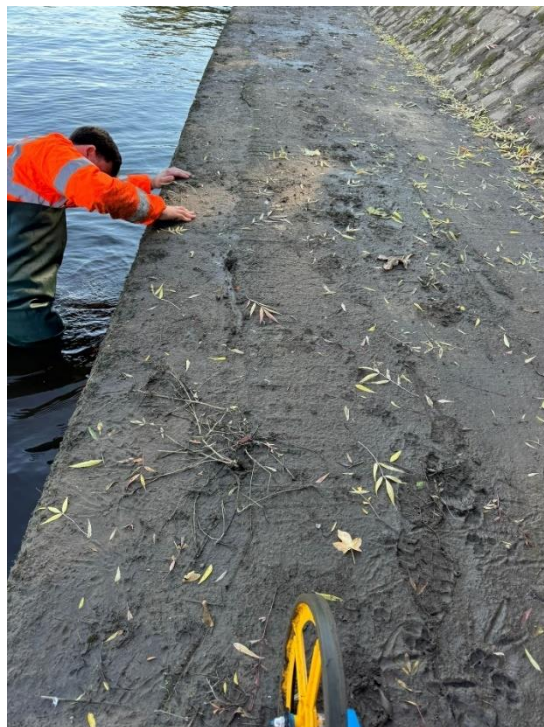
51

Void in concrete slab at the base of the pitched stone.

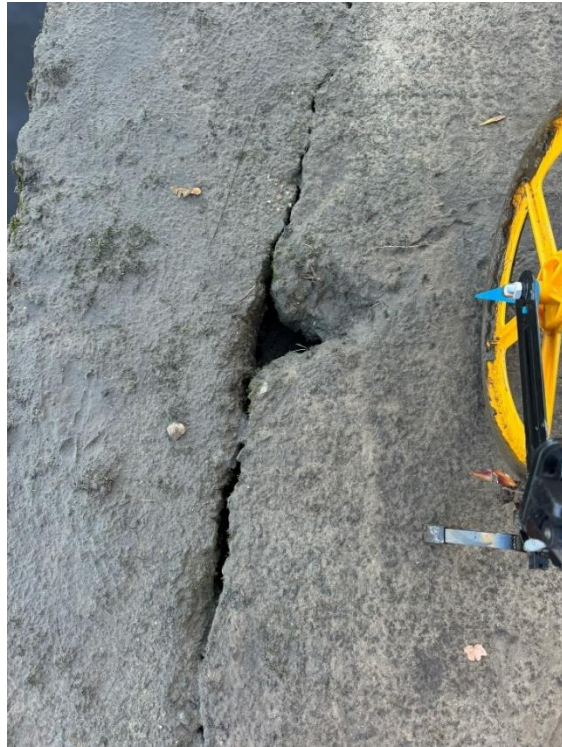
52

Top of concrete path and capping beam in ok condition.

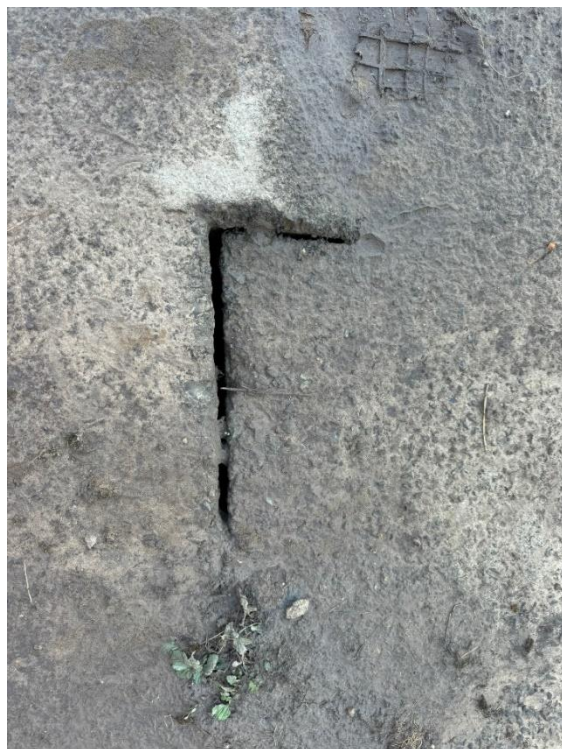
53

Gap between the concrete path and capping beam.

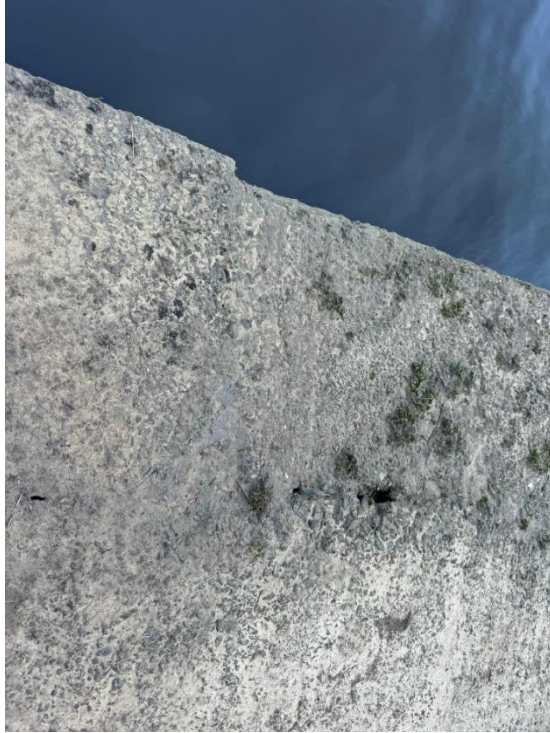
54

Gap between the concrete path and capping beam. Step in the path.

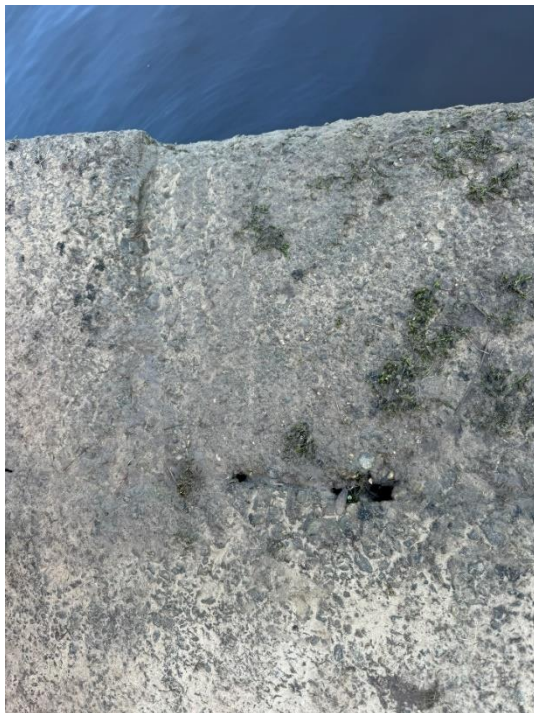
55

Crack forming between the concrete path and capping beam. Step in the capping beam.

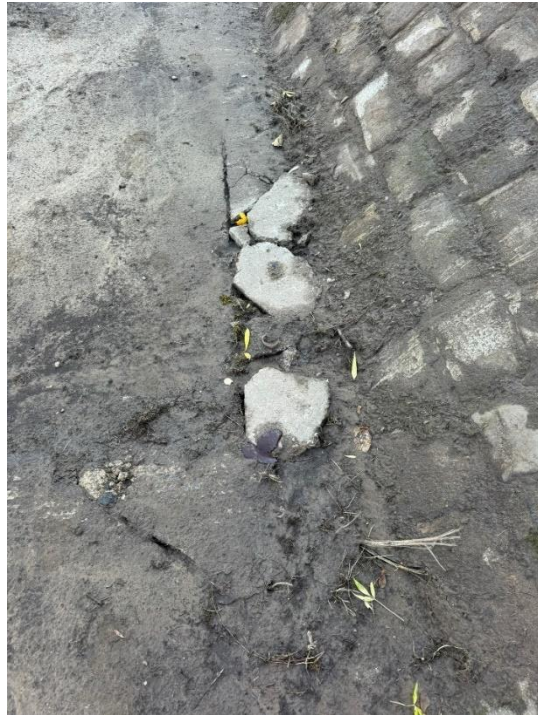
56

Crack forming between the concrete path and capping beam. Step in the capping beam.

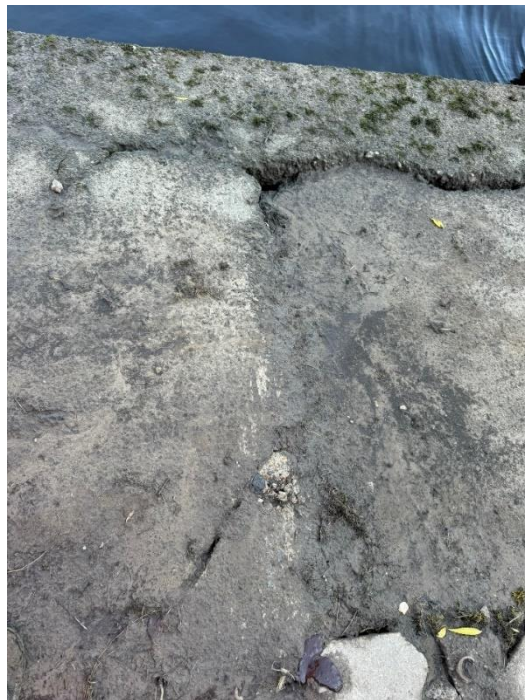
- 57** Void and broken up concrete slab at the base of the pitched stone. Areas of loose concrete at the surface.

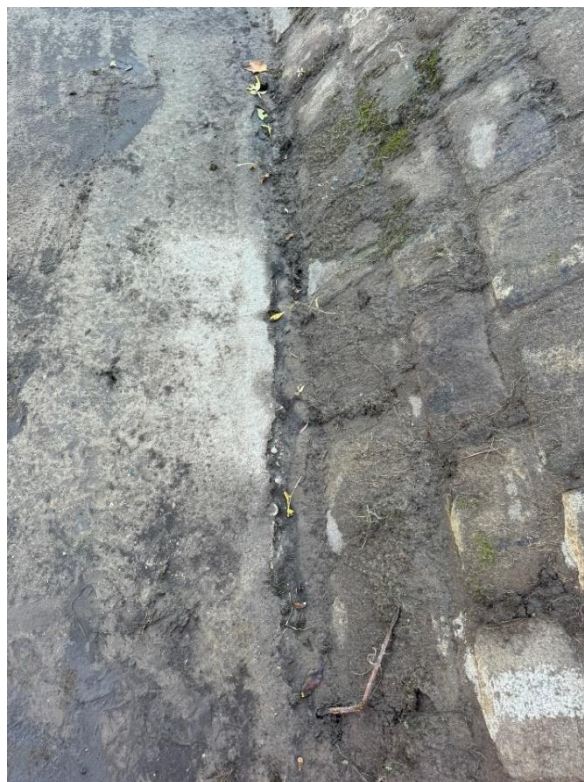
59

Build-up of silt on top of the concrete path.

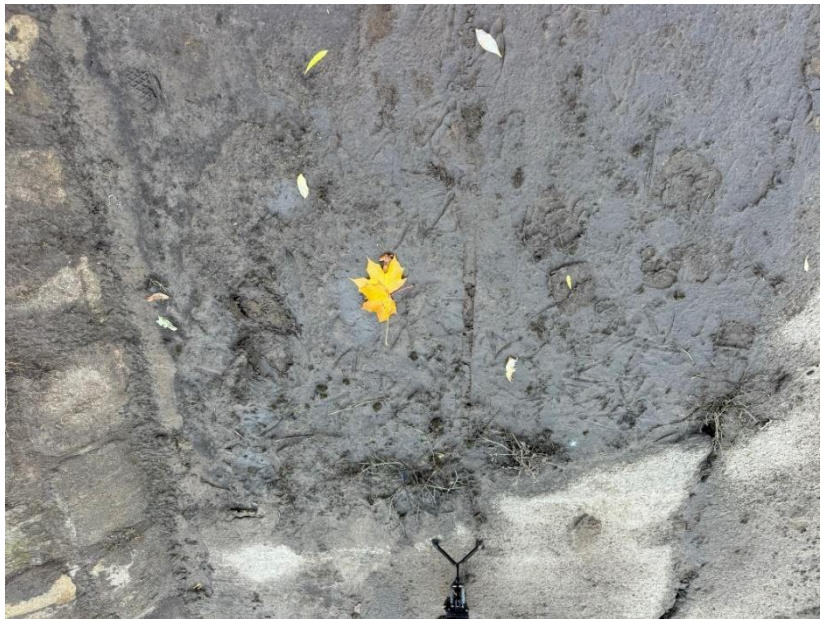
61 Build-up of silt on top of the concrete path. Large crack in the slab propagating from the capping beam to the bottom of the pitched stone.

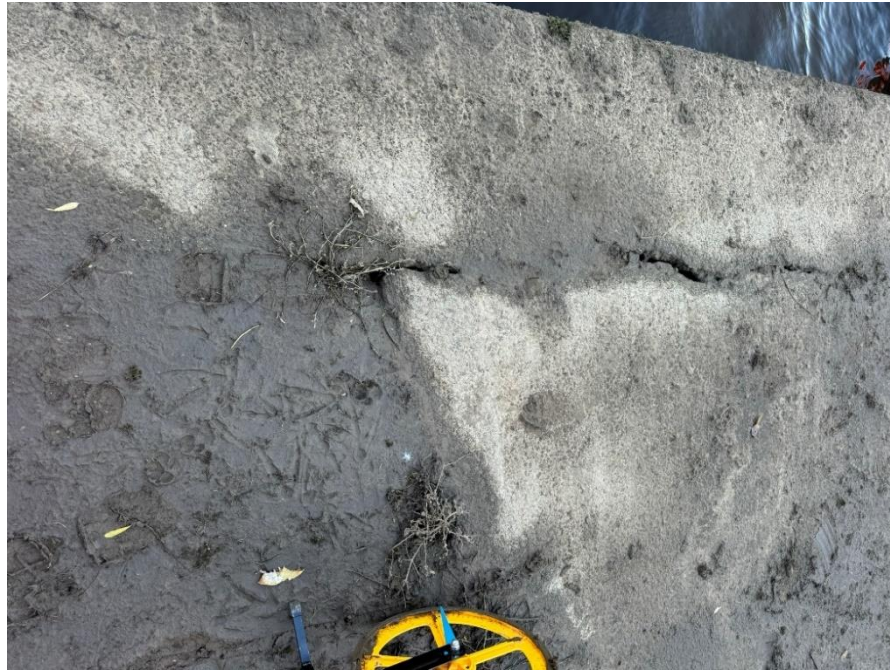
62 Build-up of silt on top of the concrete path. Large crack in the slab propagating from the capping beam to the bottom of the pitched stone.

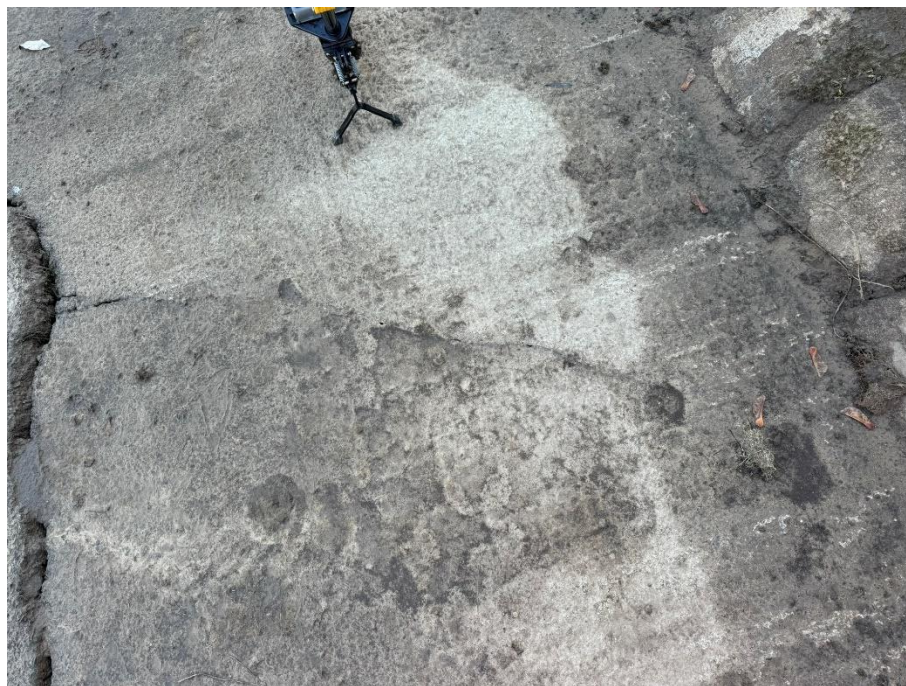
63

Crack between the capping beam and concrete path.

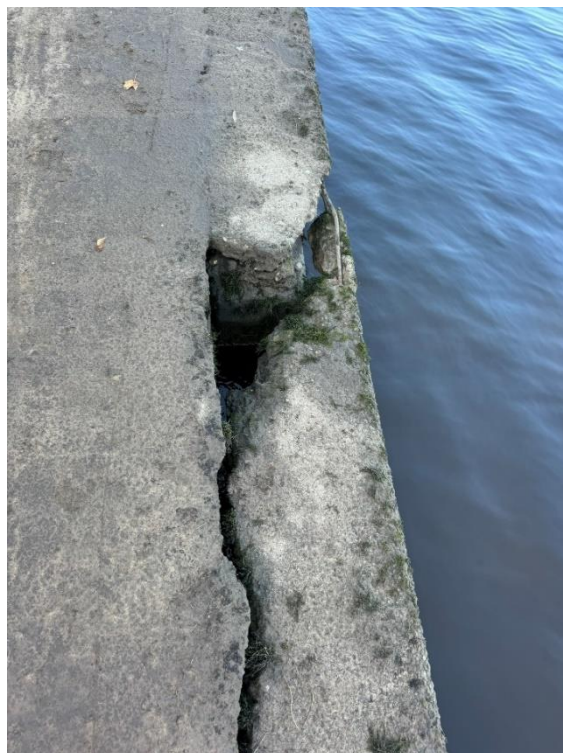
- 65** Crack between the capping beam and concrete path. The capping beam is moving away from the concrete path.

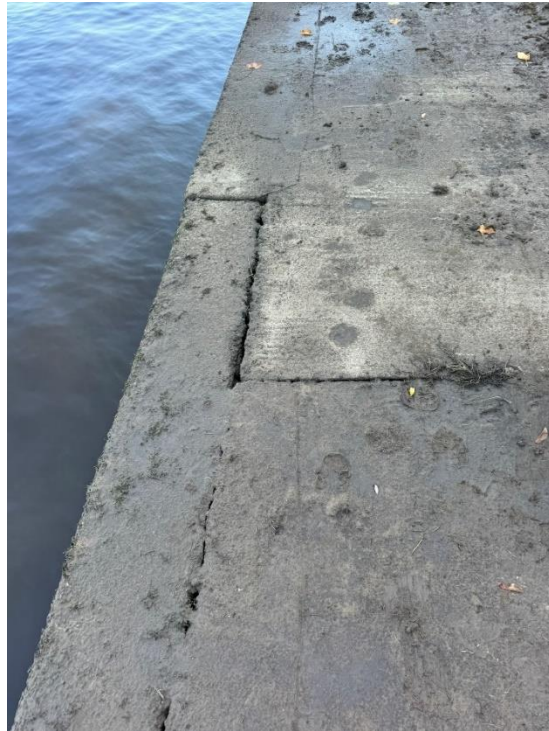
- 66** Failed capping beam, no longer sufficiently supported and breaking away from the concrete path. Large cracking, exposed and deformed steel reinforcement in capping beam.

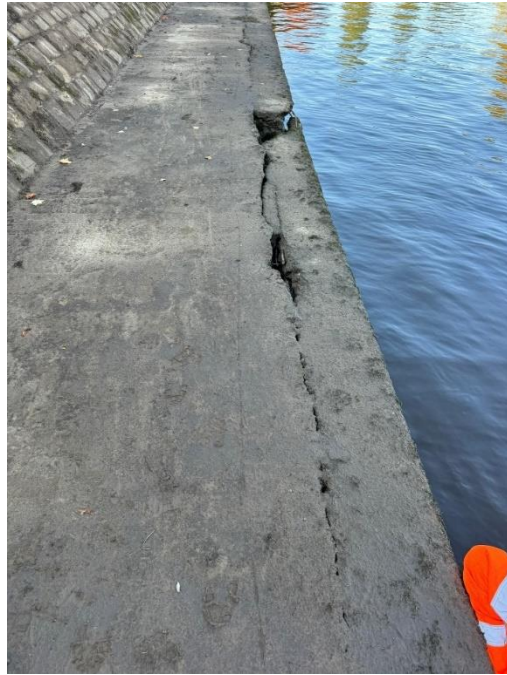
68

Gap between the concrete slab and capping beams. Gap between two slabs.

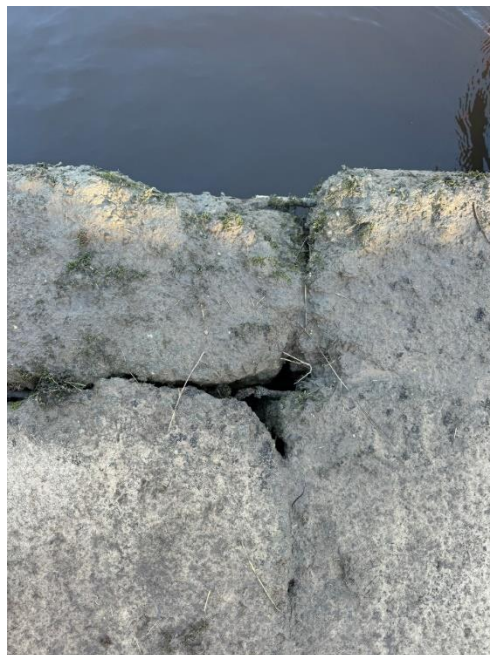
- 69** Failed capping beam, no longer sufficiently supported and breaking away from the concrete path. Large cracking, exposed and deformed steel reinforcement in capping beam.

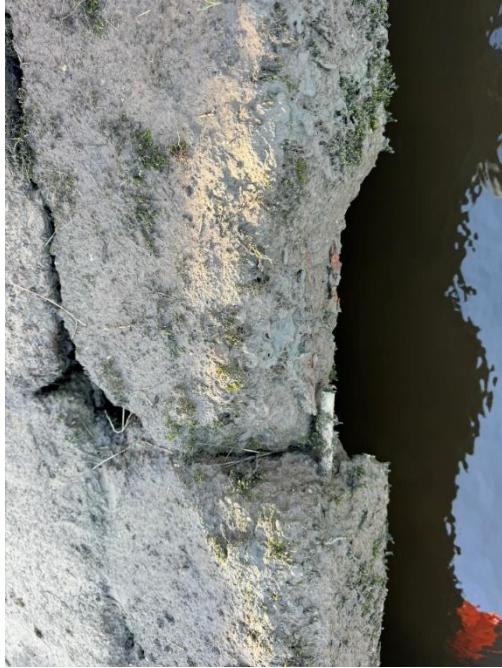
- 70** Cracking between two capping beams with exposed steel reinforcement over the pile support. Gap between the capping beam and concrete path formed.

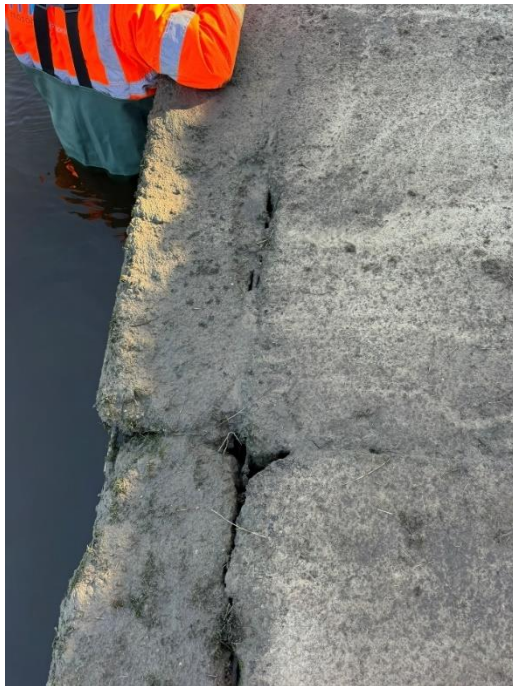
71

Cracking between two capping beams with exposed steel reinforcement over the pile support. Gap between the capping beam and concrete path formed.
