**INSPECTION REPORT
River Ouse Riverbank**

**Report 22594-H-RP-001-R0
20 November 2024**

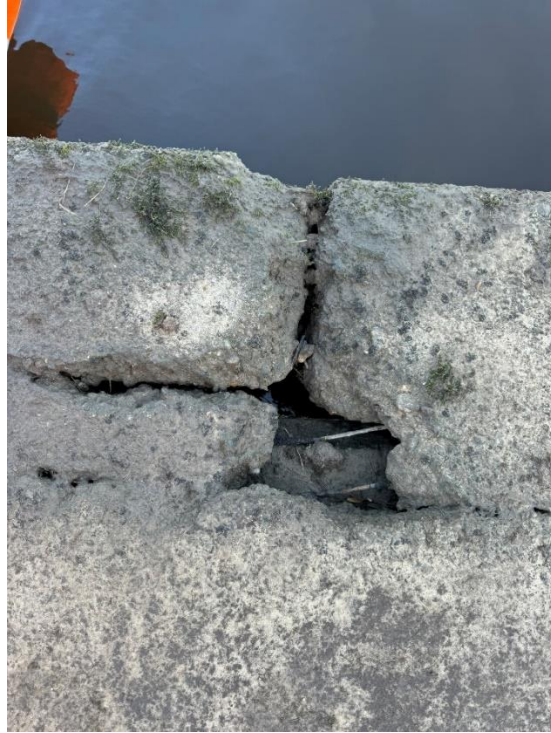
72

Cracking between two capping beams with exposed steel reinforcement over the pile support. Gap between the capping beam and concrete path formed.

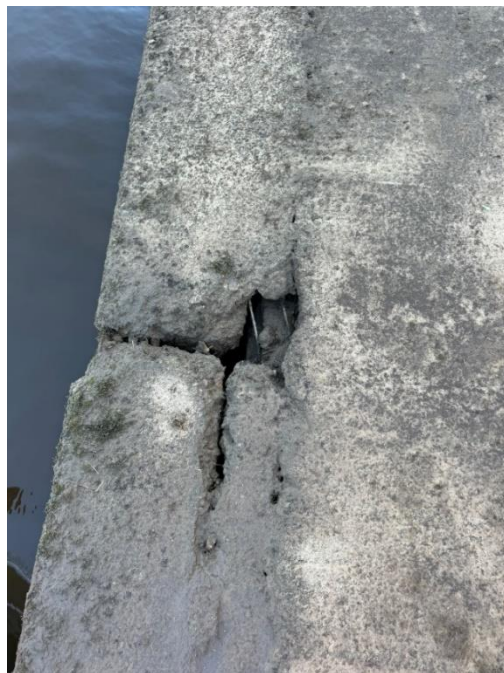
73

Cracking between two capping beams with exposed steel reinforcement over the pile support. Large gap between the capping beam and concrete path formed, can see the top of the retaining wall.

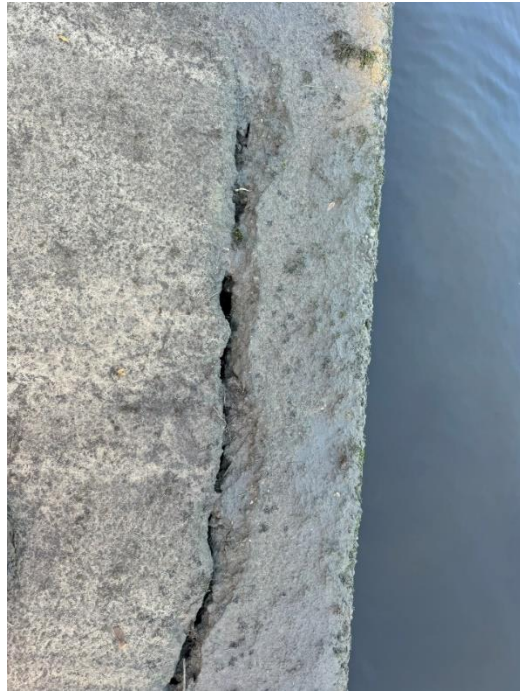
74

Cracking between two capping beams with exposed steel reinforcement over the pile support. Large gap between the capping beam and concrete path formed, can see the top of the retaining wall.

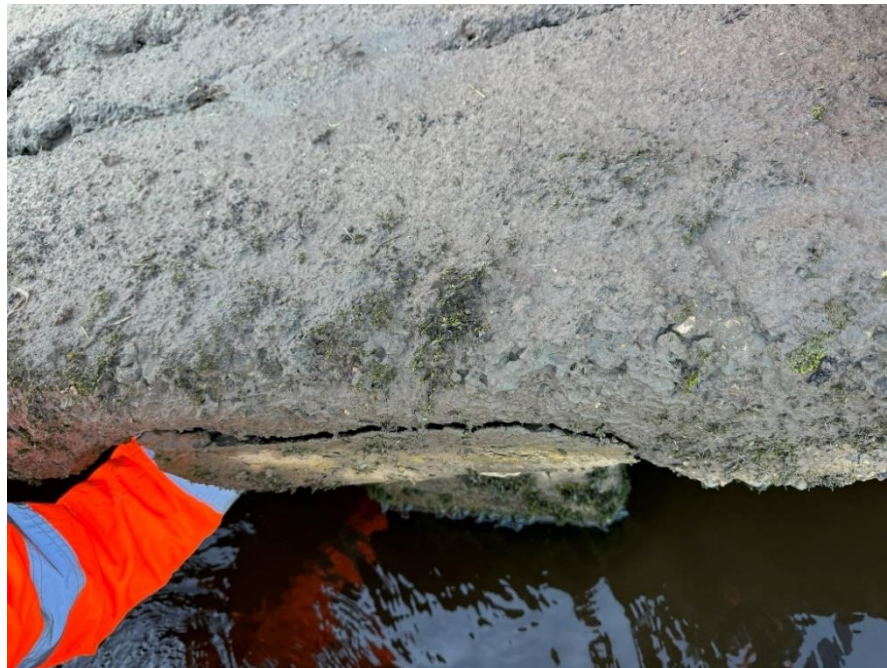
75 Large crack between the capping beam and concrete path.

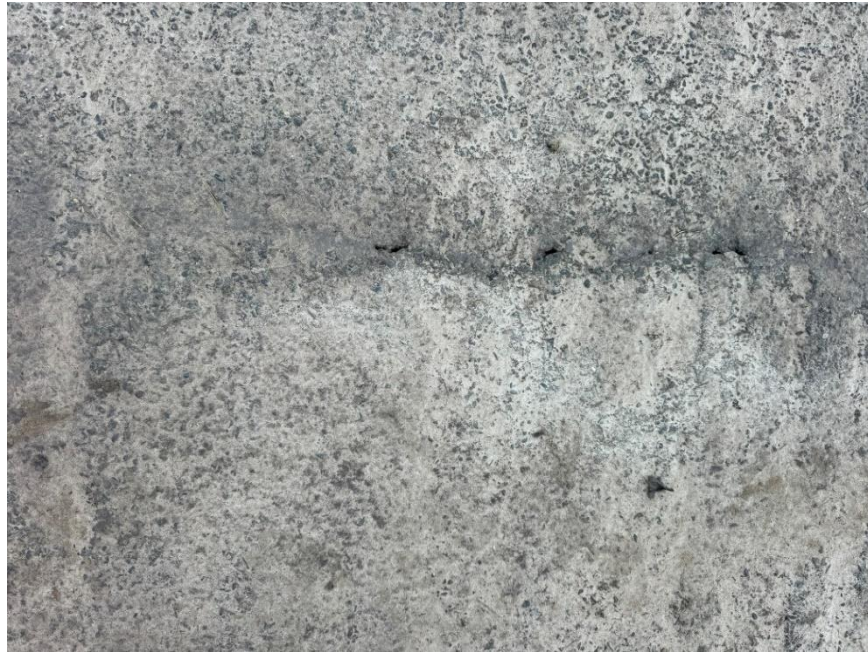
76 Cracking and loose concrete on the side of the capping beam above the pile.

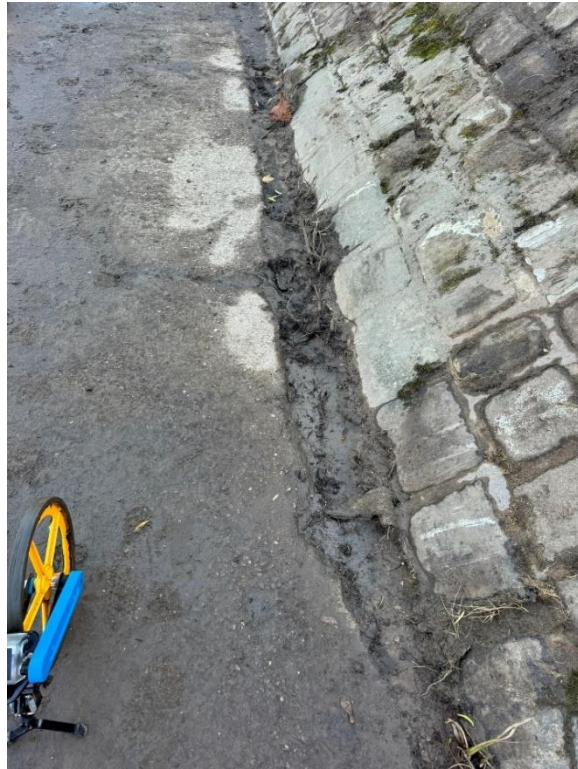
80 Top of the concrete path in ok condition.

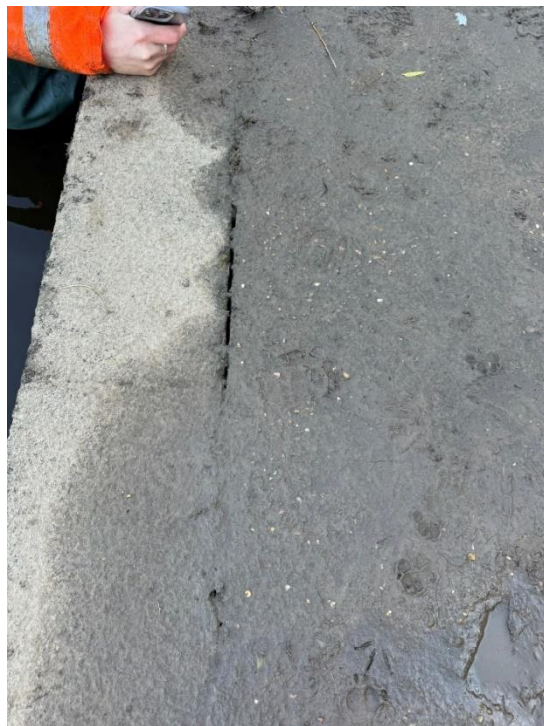
81

Gap forming between the pitched stone and concrete path.

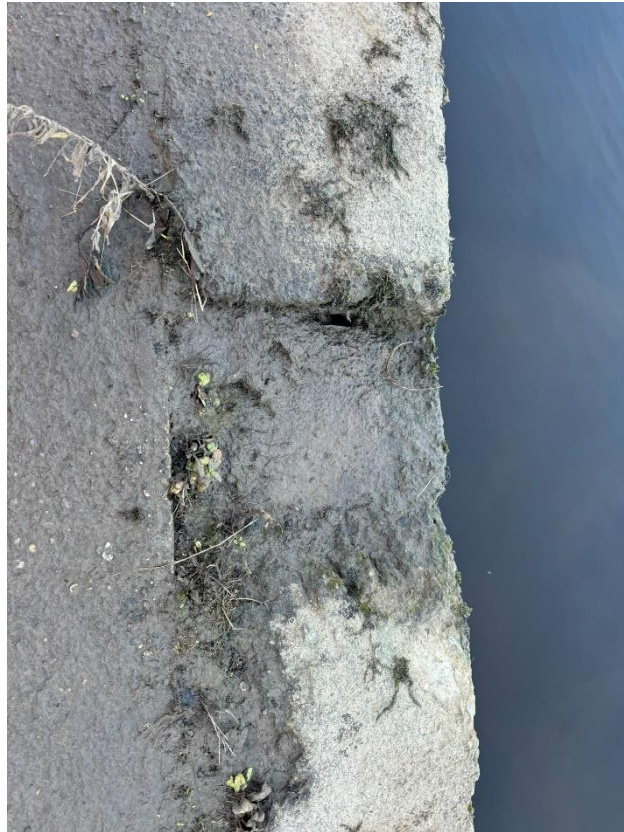
82

Gap between the concrete path and capping beam.

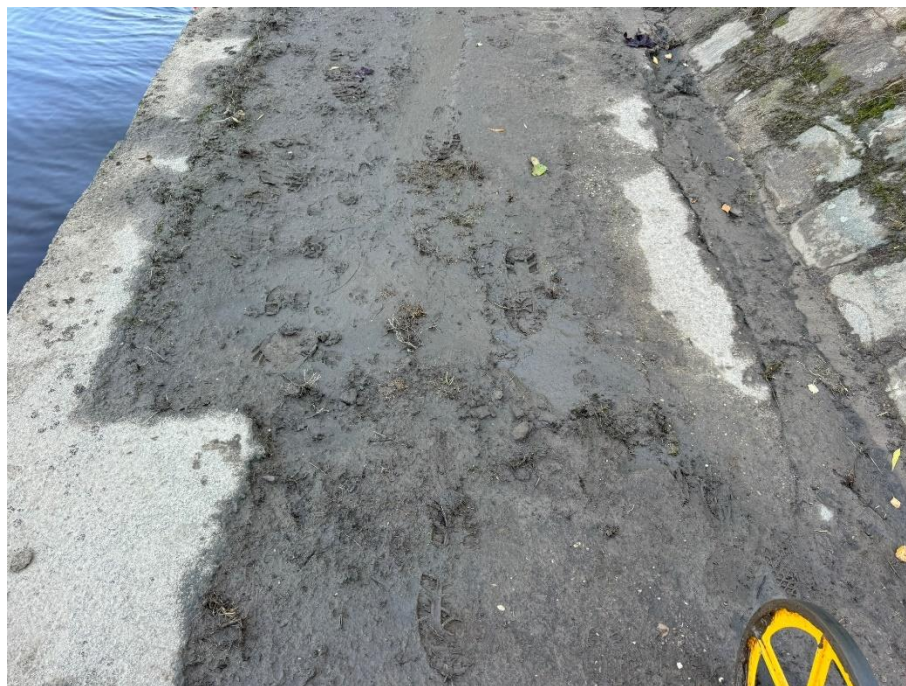
83

Step in the capping beam.

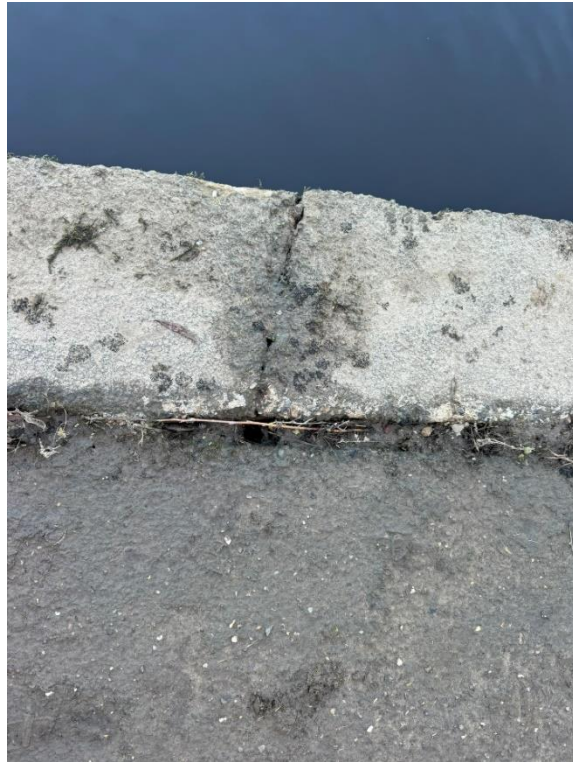
84

Top of the concrete path covered in silt.

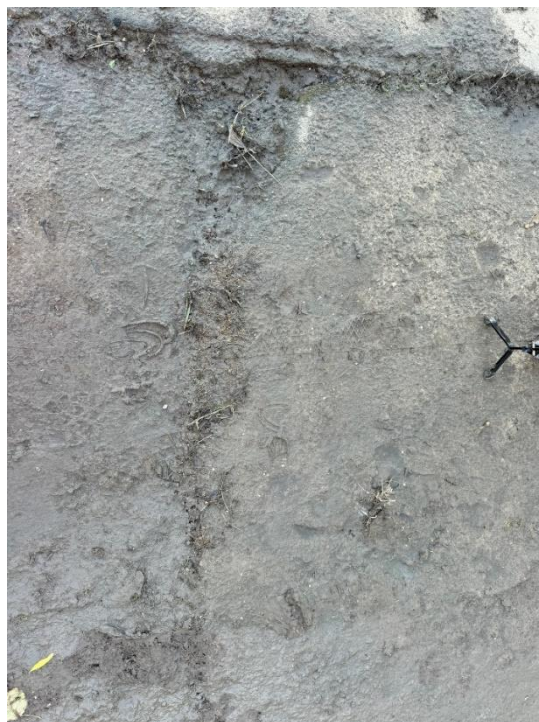
85 Crack in the top of the capping beam.

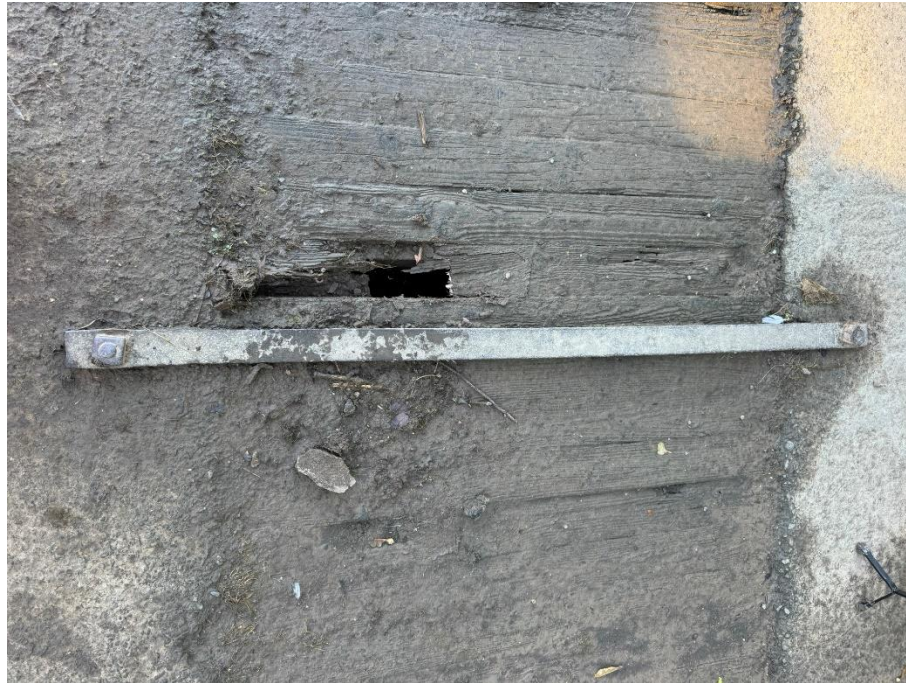
86 Crack in the concrete path, propogating from the capping beam to the pitched stone.

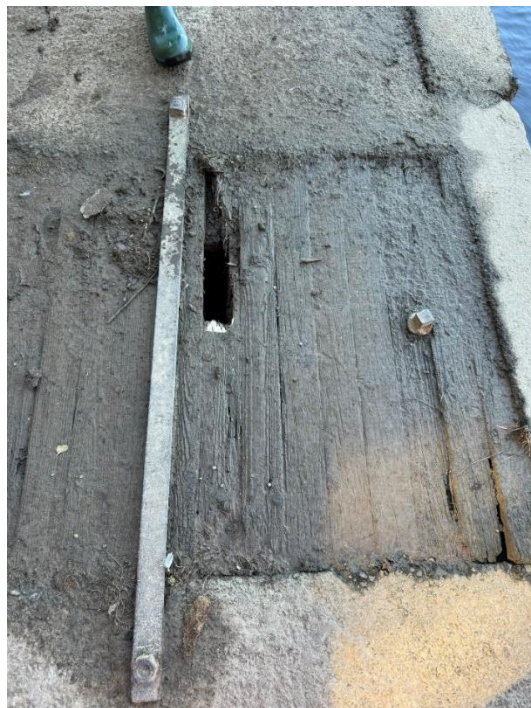
87 Timber service cover in poor condition, timber is rotting.

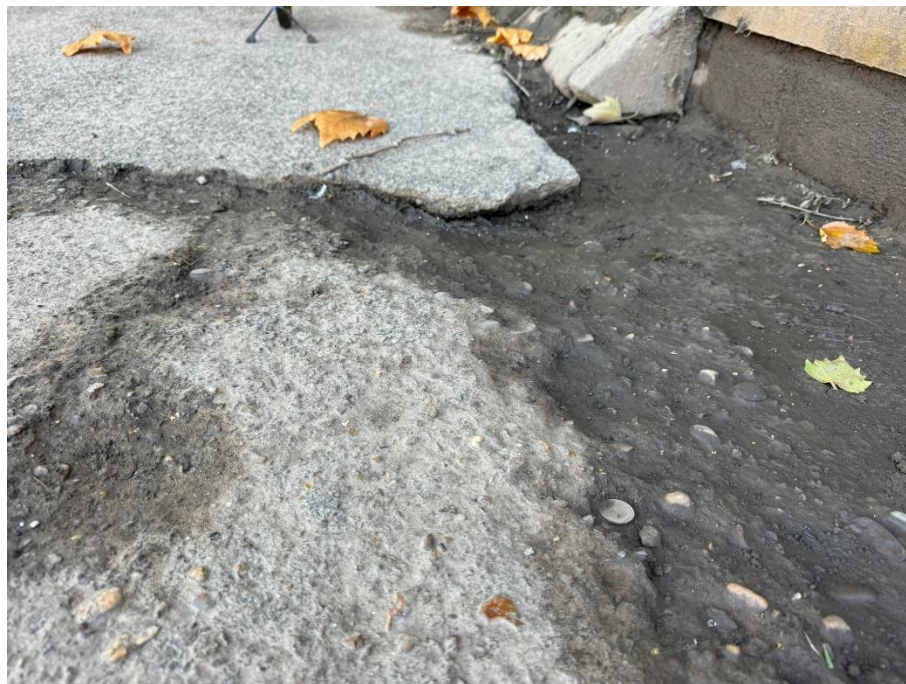
89

Step in the concrete path, corner is a trip hazard.

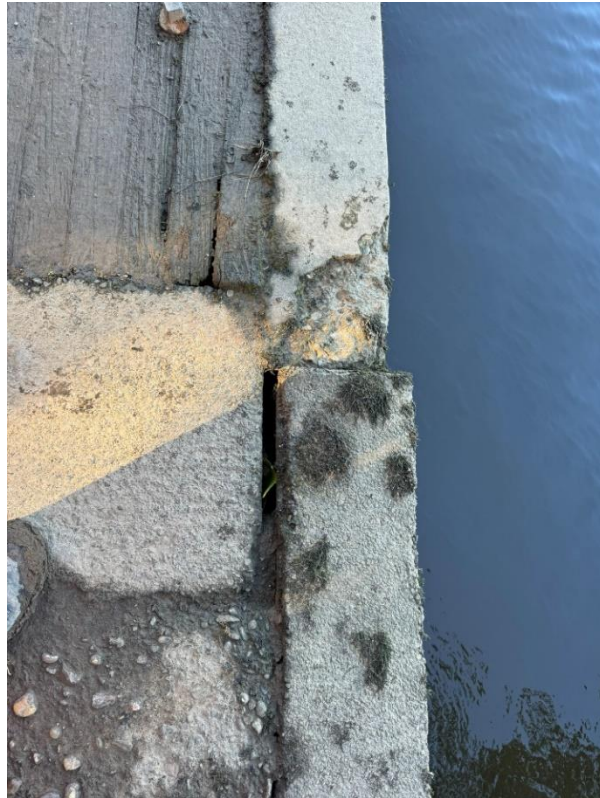
90

Step in the concrete path, corner is a trip hazard.

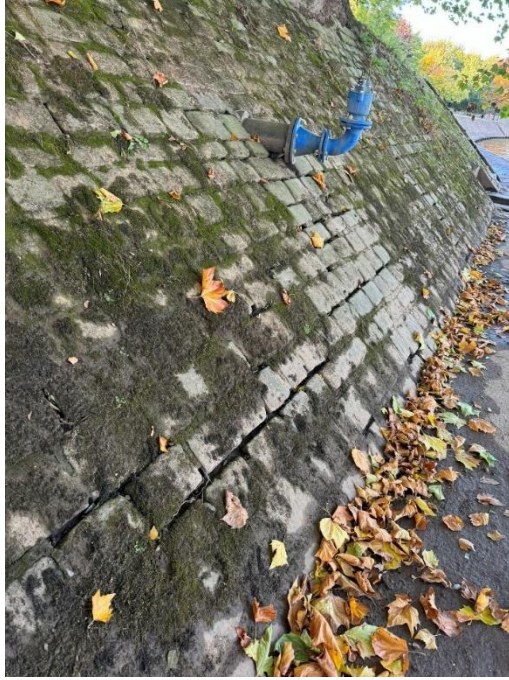
100 Missing mortar between stones on the pitched stone embankment.

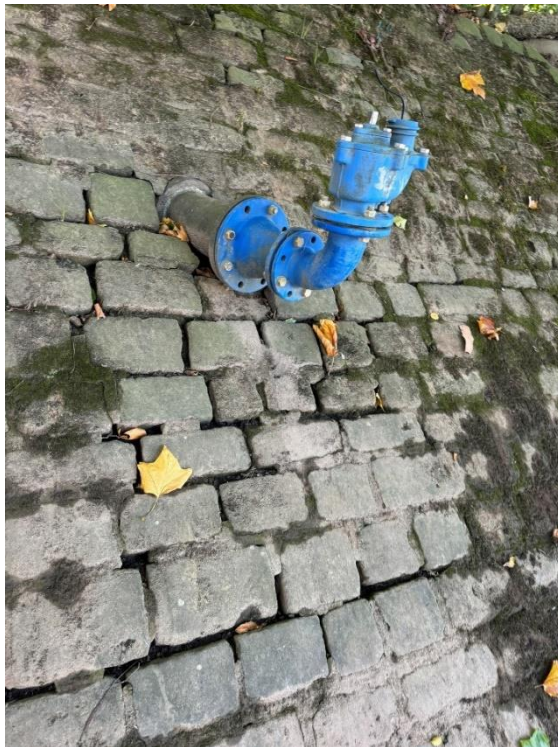
101 Missing mortar between stones on the pitched stone embankment.

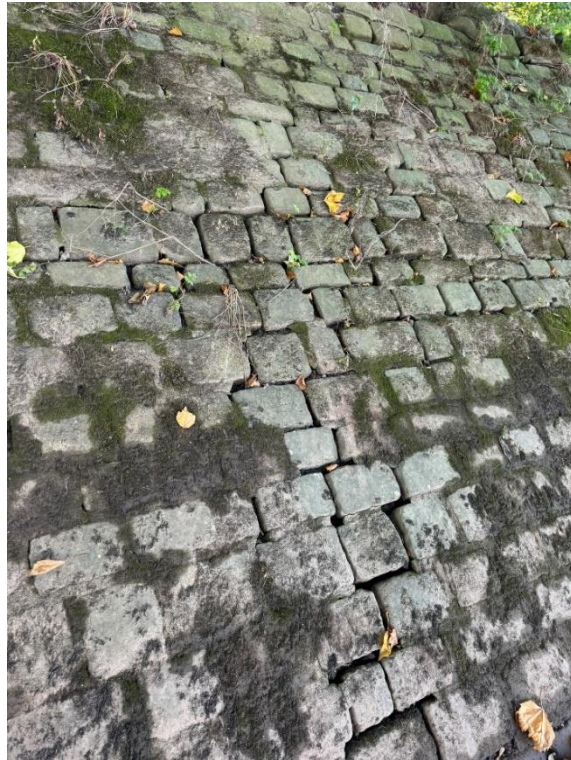
102 Missing mortar between stones on the pitched stone embankment around a service valve.

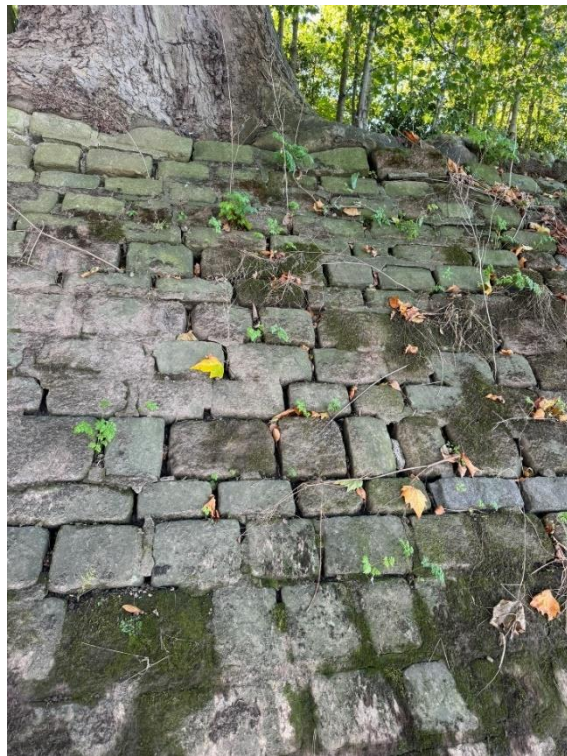
103

Missing mortar between stones on the pitched stone embankment.

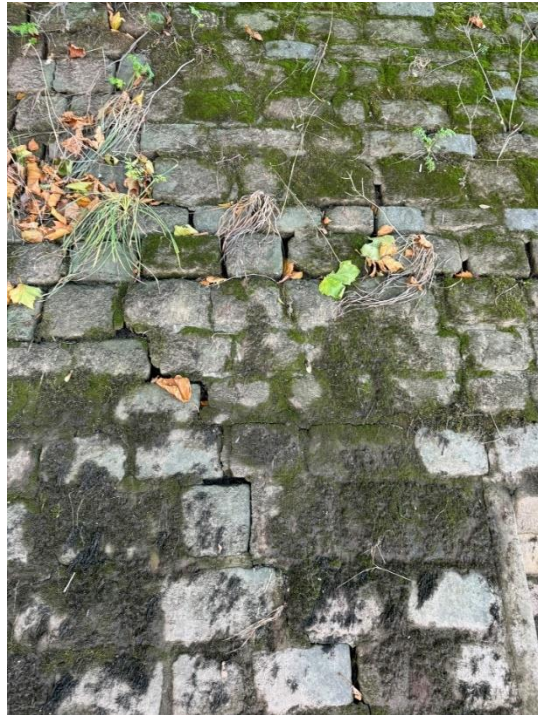
104

Missing mortar between stones on the pitched stone embankment.

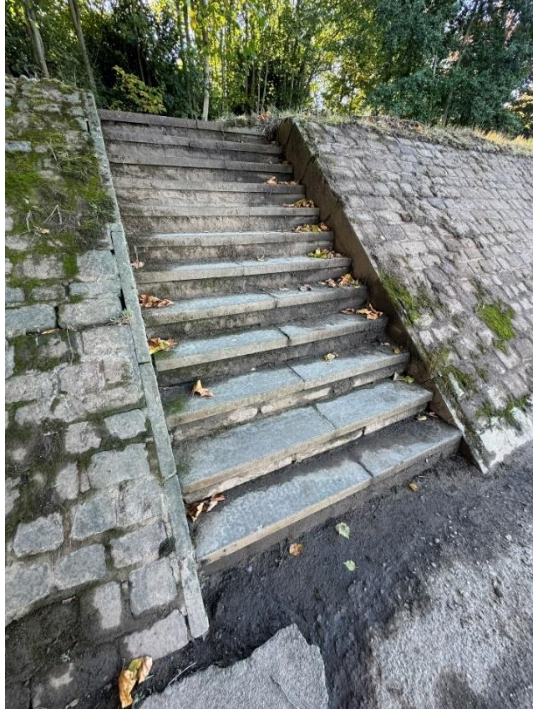
106 Missing mortar between stones on the pitched stone embankment.

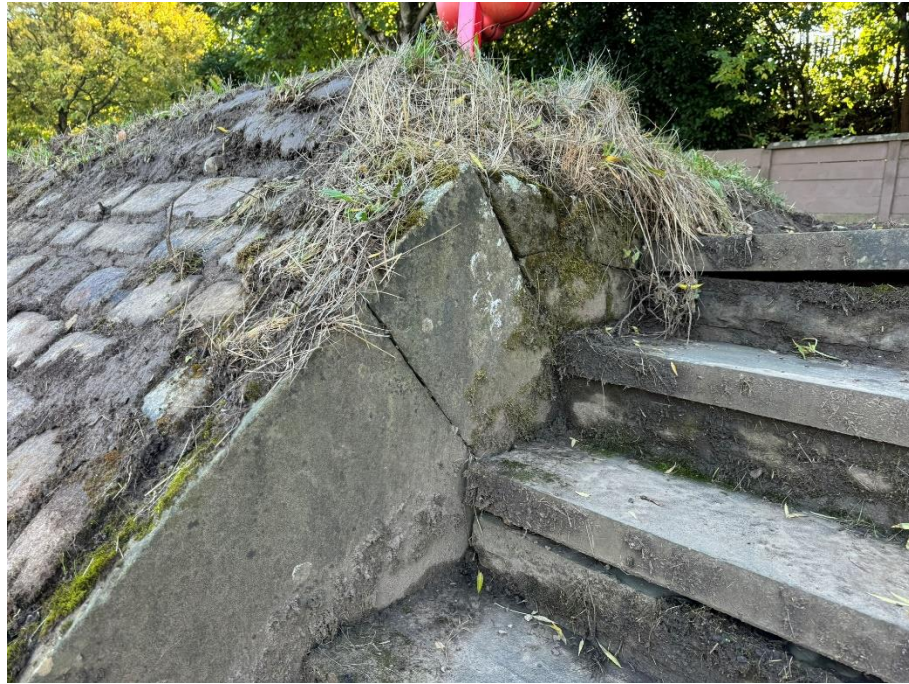
126

Embankment steps, top step needs relaying.

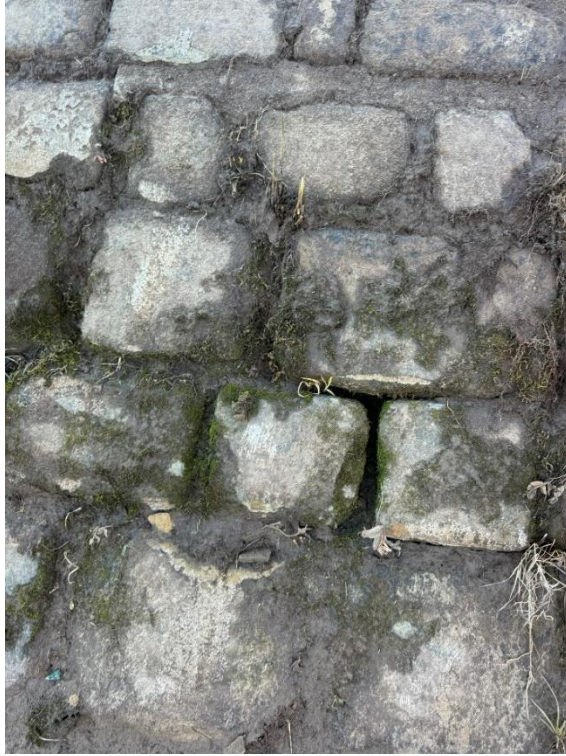
128

Missing mortar on pitched stone embankment.

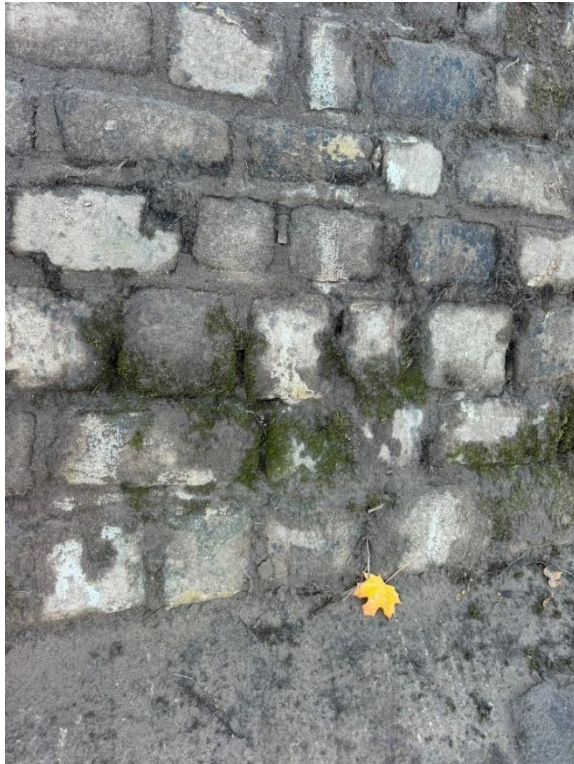
129

Missing mortar on pitched stone embankment.

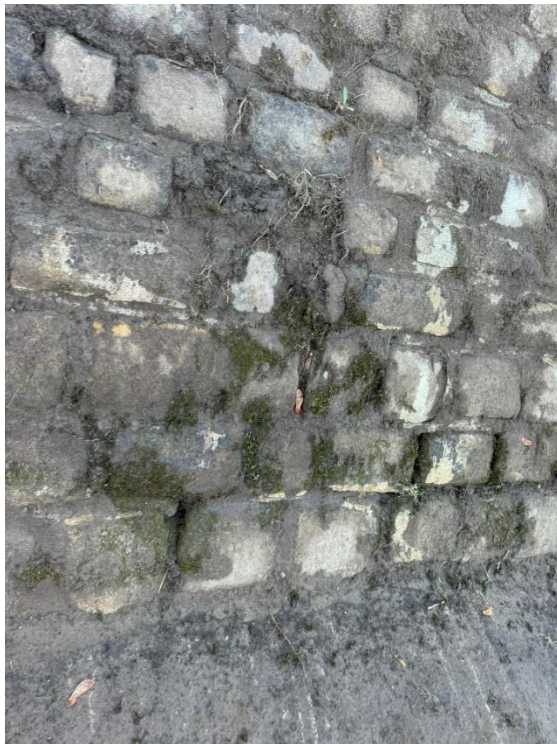
131

Missing mortar on pitched stone embankment.

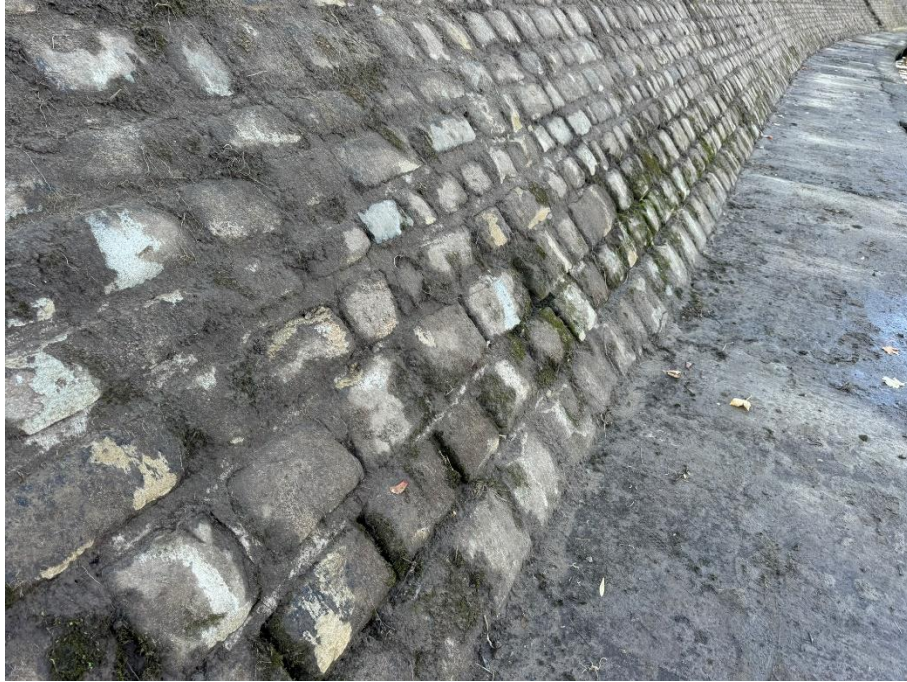
132

Missing mortar on pitched stone embankment.

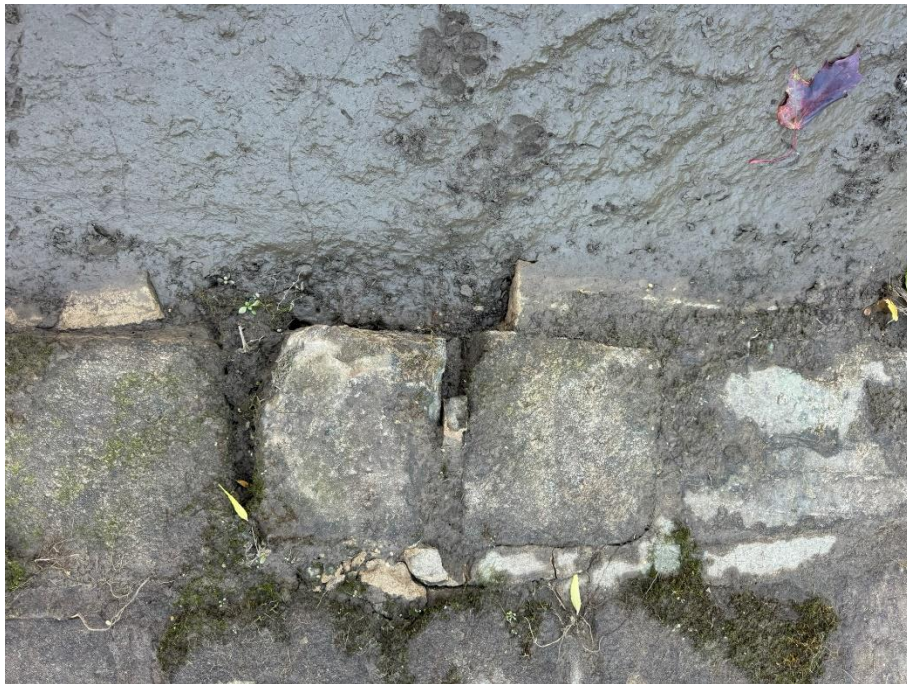
133

Missing mortar on pitched stone embankment.

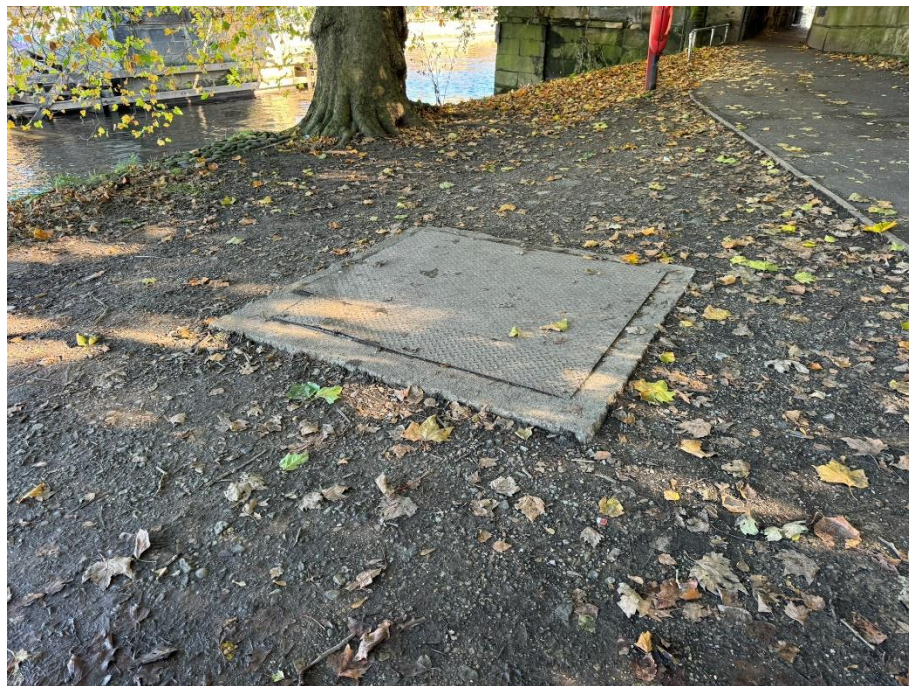
135

Large steel plate cover on top of embankment.

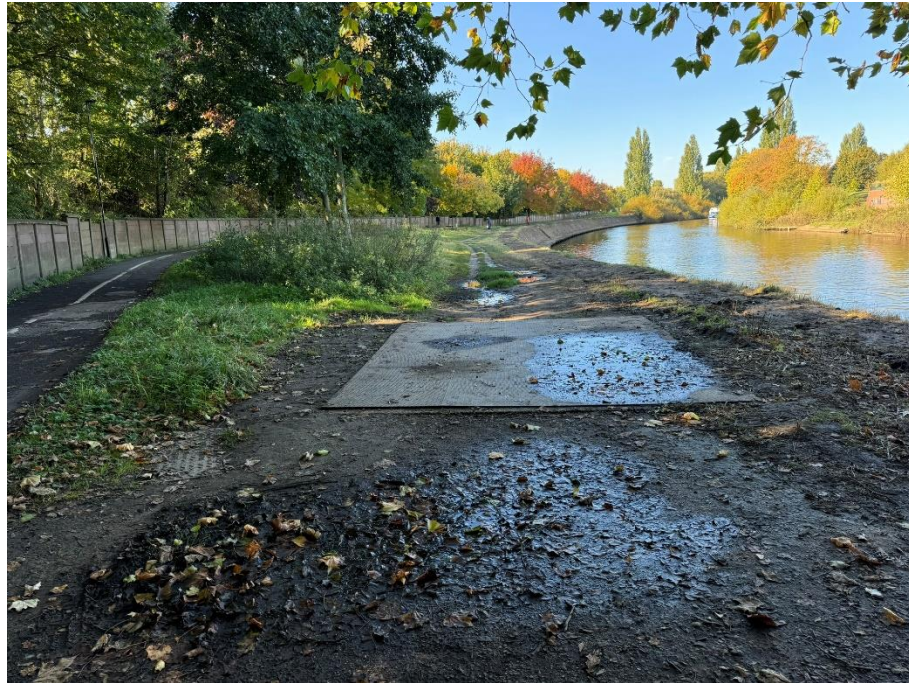
136

Large steel plate cover on top of embankment.

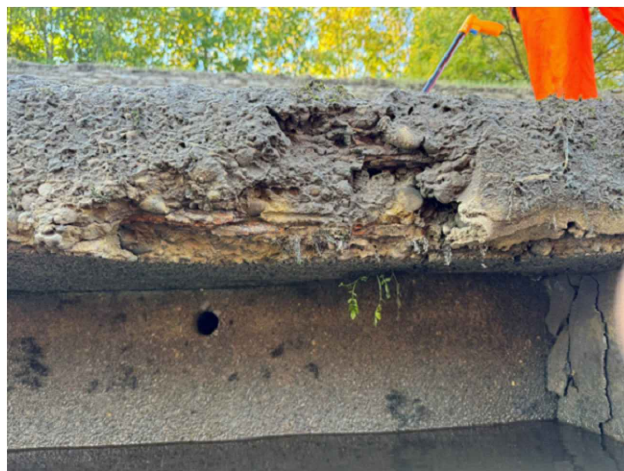
Chainage 26m
Concrete spalling and exposed steel reinforcement on the capping beam. Additionally concrete spalling is visible on the reinforced concrete pile.

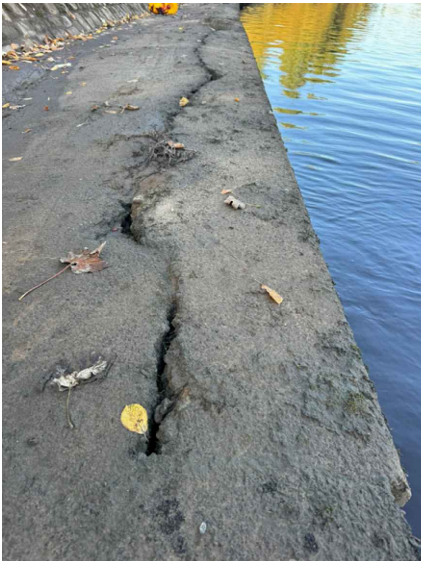
Chainage 76m
Large crack between the concrete path and reinforced concrete capping beam. The capping beam is tilting about its minor axis towards the river.

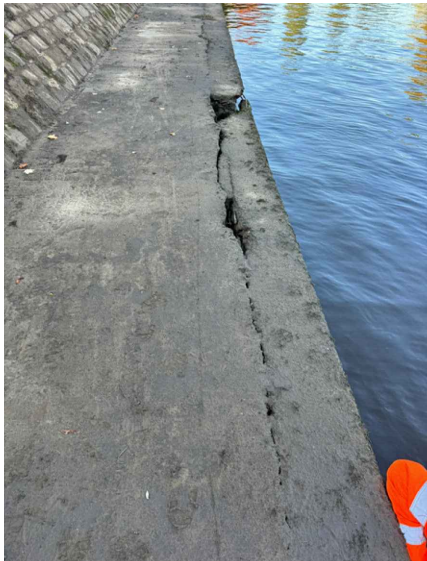
Chainage 176m
Failed capping beam, no longer sufficiently supported and breaking away from concrete path. Large cracking and exposed steel reinforcement in the capping beam.

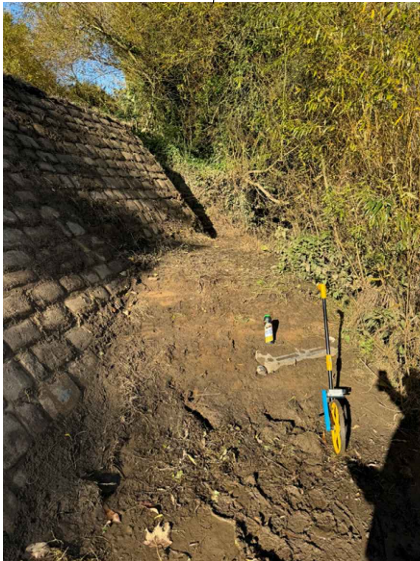
Chainage 0-5m
Overgrown vegetation and large build up of earth at the base of the pitched stone embankment.

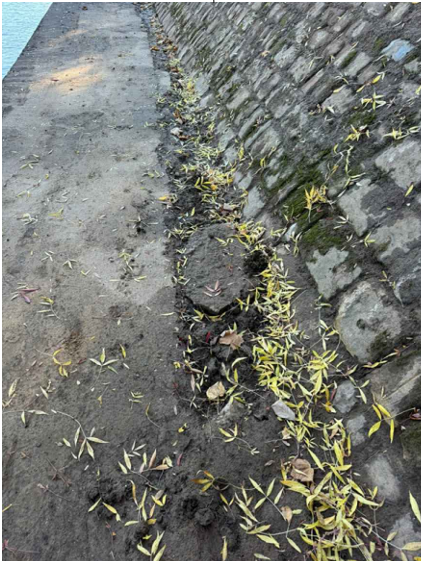
Chainage 55m
Void and broken up concrete slab at the base of the pitched stone retaining wall. Areas of slab loose at the surface.

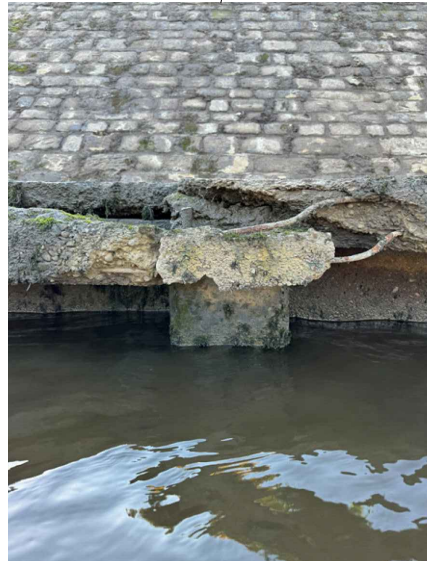
Chainage 176m
Failed capping beam, no longer sufficiently supported and breaking away from concrete path. Large cracking and exposed steel reinforcement in the capping beam.

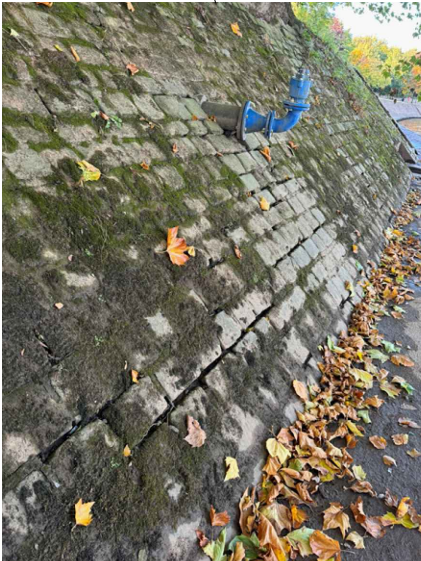
Chainage 255m
Missing mortar and loose stones in the pitched stone embankment.
