**STRUCTURAL INSPECTION AT
REYNARDS GARAGE, 17-21 PICCADILLY, YORK
FOR CITY OF YORK**

JOB NO: 10823/12.0

DATE: APRIL 2015

Document Title: Structural Inspection

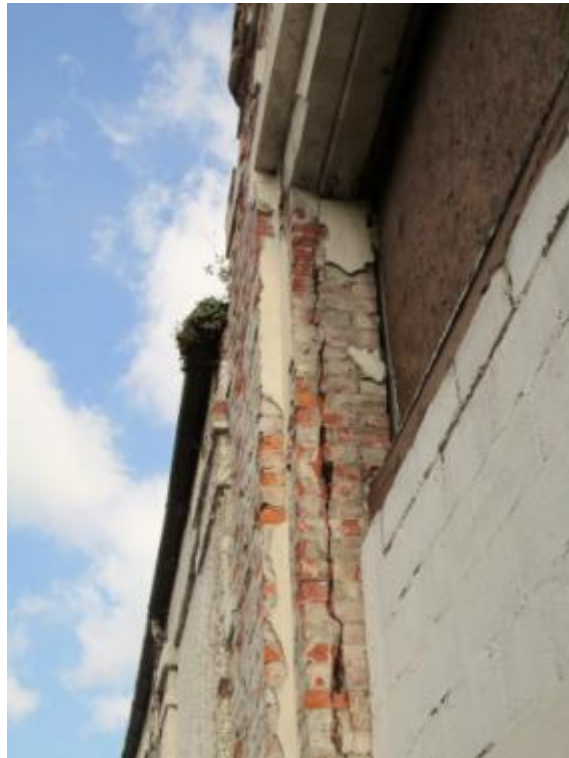
Photograph No. 5 – Old Piccadilly entrance

- 2.3 Cracking around the old Piccadilly entrance was closely inspected and no changes could be observed from the previous inspection.
- 2.4 Internally there are two main items of concern over and above that referred to in our 2009 report. These are as follows:-

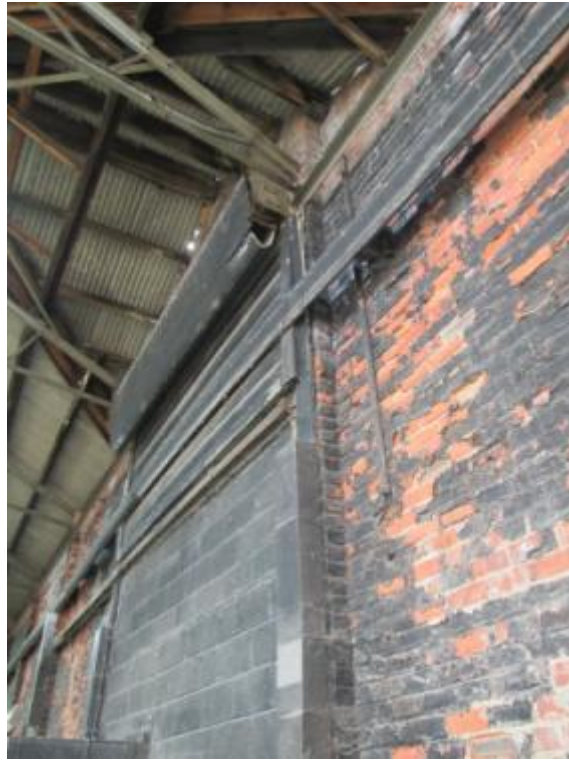
Photograph 36a – Internal view above Piccadilly entrance

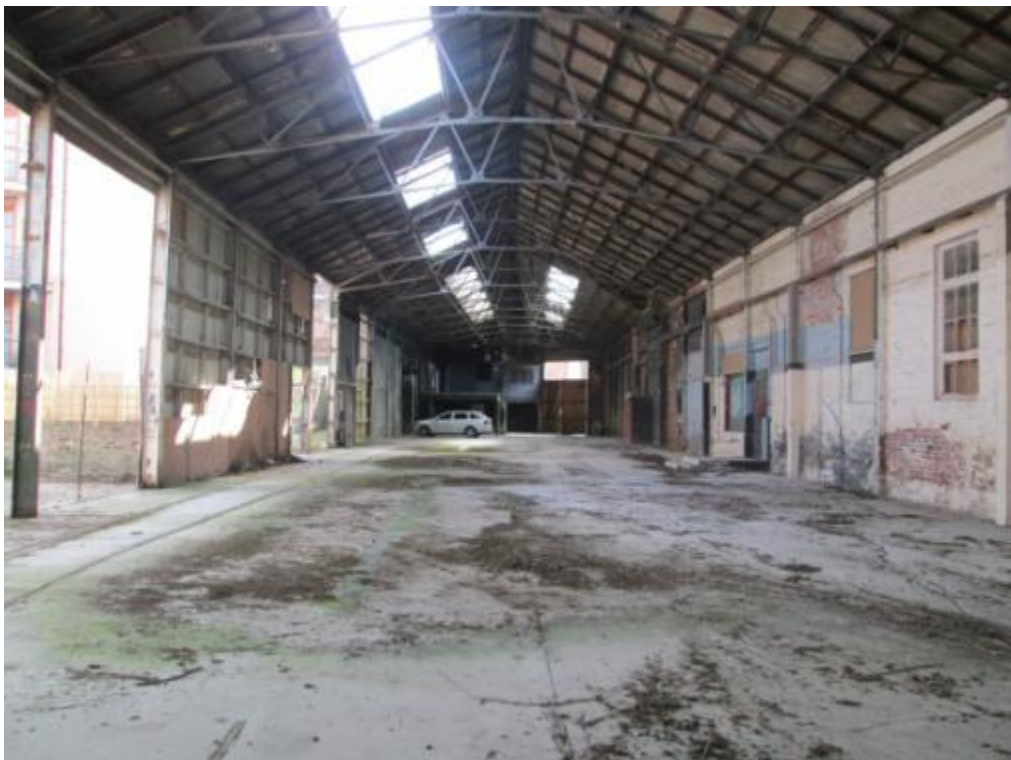
Photograph 60 – Internal view towards Dennis Street

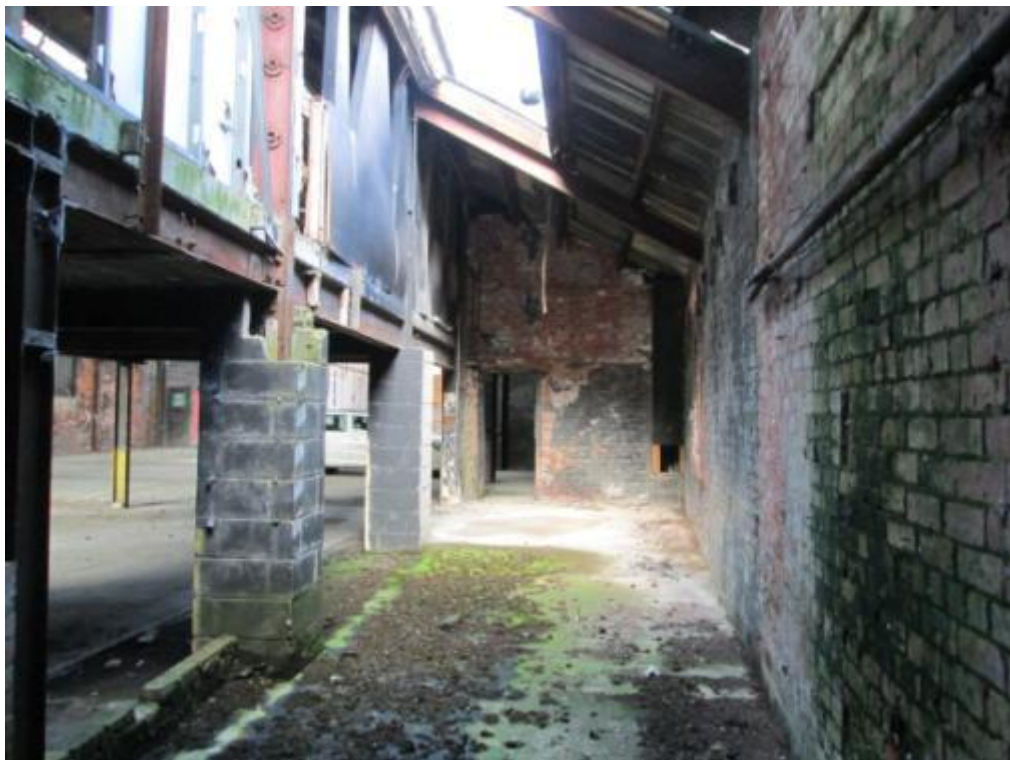
Photograph 62 – Internal view within lean-to looking from Dennis Street end
